RIVERSIDE COUNTY REGIONAL PARK AND OPEN SPACE DISTRICT

# ACCESSIBILITY COMPLIANCE REPORT- 2018 UPDATE

MAY 31, 2018

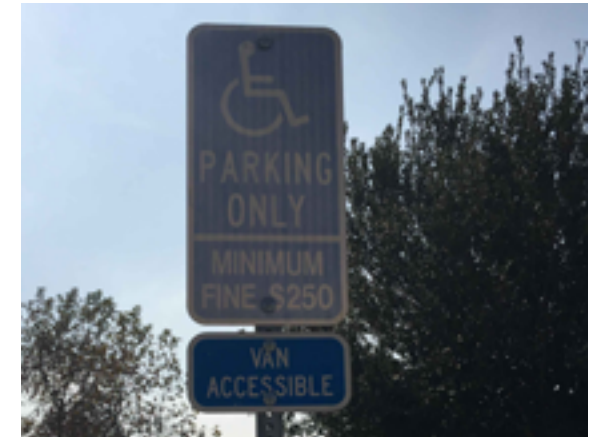
Evidence of older signage supplemented with newer addition at Rancho Jurupa Park.

*ACTION ITEM: Remove all non-compliant signage and replace with standardized Towing, Reserved Parking, Accessible Building, etc. signage as noted throughout this report.*

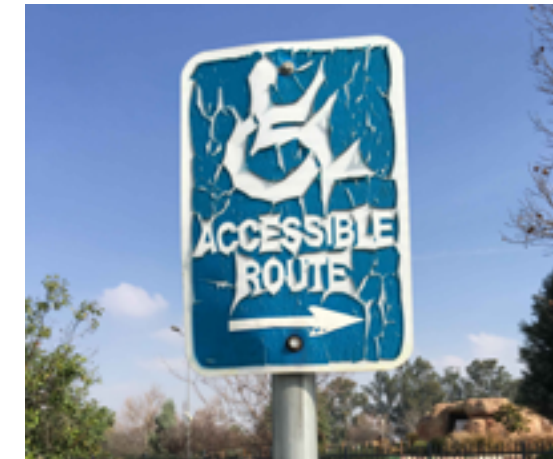
Above: Dilapidated sign at Rancho Jurupa Park  
 Below: Accessible walkway hindered by plant litter.

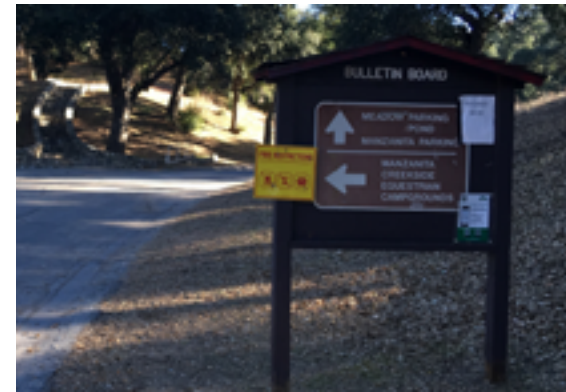
*Pictured: One of several bulletin boards at Bogart Park..*

3) POSTINGS AT NON-ACCESSIBLE VIEWING OR REACH RANGE: Message boards are present at all County Park facilities. Many messages on these boards are posted in 12 point or similar sized font, and posted as high as 72" above finish floor. It is not reasonable to expect a wheelchair user to read such messages, especially when the message boards are located on non-accessible surfaces.

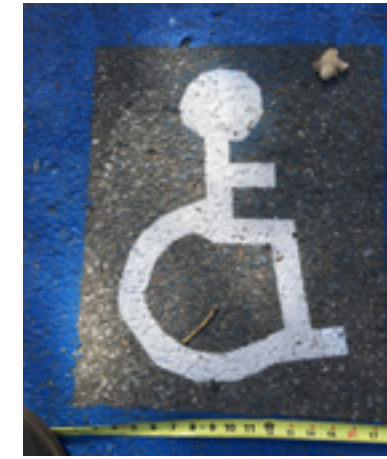
*Idyllwild Park*

4) PARKING SPACE MARKINGS: Accessibility is designated with a graphic logo representing a wheelchair user. This symbol is officially known as the International Symbol of Accessibility, or ISA. For Designated Accessible Parking Spaces, the ISA is required to be square in shape, 36" minimum, centered at the leading edge of the parking space, so that it is still visible when a vehicle is occupying the space. Stencil templates for the ISA are readily available online. Here are a few examples of free-formed ISA markings present at various parks within the Riverside County system:

*ACTION ITEM: Obtain and utilize a stencil that conforms to the size and proportion requirements for the International Symbol of Accessibility (ISA). Utilize one standardized color code for blue and white paints.*

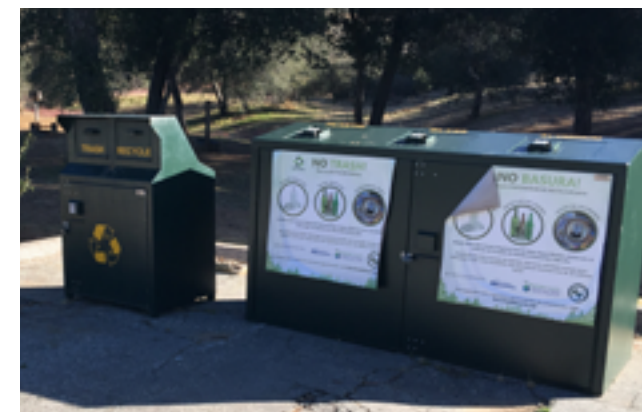
*Non-accessible containers. Pictured at Bogart Park*

5) NON-COMPLIANT SITE FURNISHINGS: Benches, picnic tables, drinking fountains, and waste receptacles are often overlooked in accessibility analysis. One item noted in the Riverside County Parks system is that a commonly used waste and recycling container does not meet accessible reach range requirements. If these models continue to be used, they will continue to need to be supplemented with an accessible counterpart.

*ACTION ITEM: Provide waste receptacles with operable parts within accessible reach ranges in direct proximity to non-compliant receptacles. Replace benches with a standardized accessible model at all sites.*

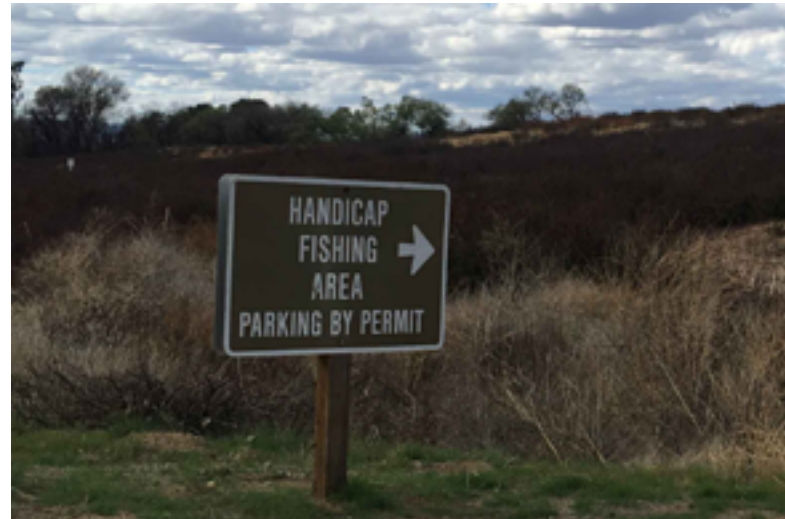
6) OUTDATED TERMINOLOGY: Several sightings of the word “HANDICAP” were observed during our site visits. This term was once the common term to describe individuals with disabilities. However, the current accepted method is to place the focus on “what” is being provided, rather than “whom” is being accommodated. Therefore, parking spaces, restrooms, and other facilities are described as being “ACCESSIBLE”. For future improvements, if there is a need to specifically call out certain features, the word “HANDICAP” should be omitted.

Outdated “HANDICAP” terminology at Designated Accessible Fishing Area; Lake Skinner

*ACTION ITEM: Remove all references to “HANDICAP” in all signage and publications. Replace with “ACCESSIBLE”.*

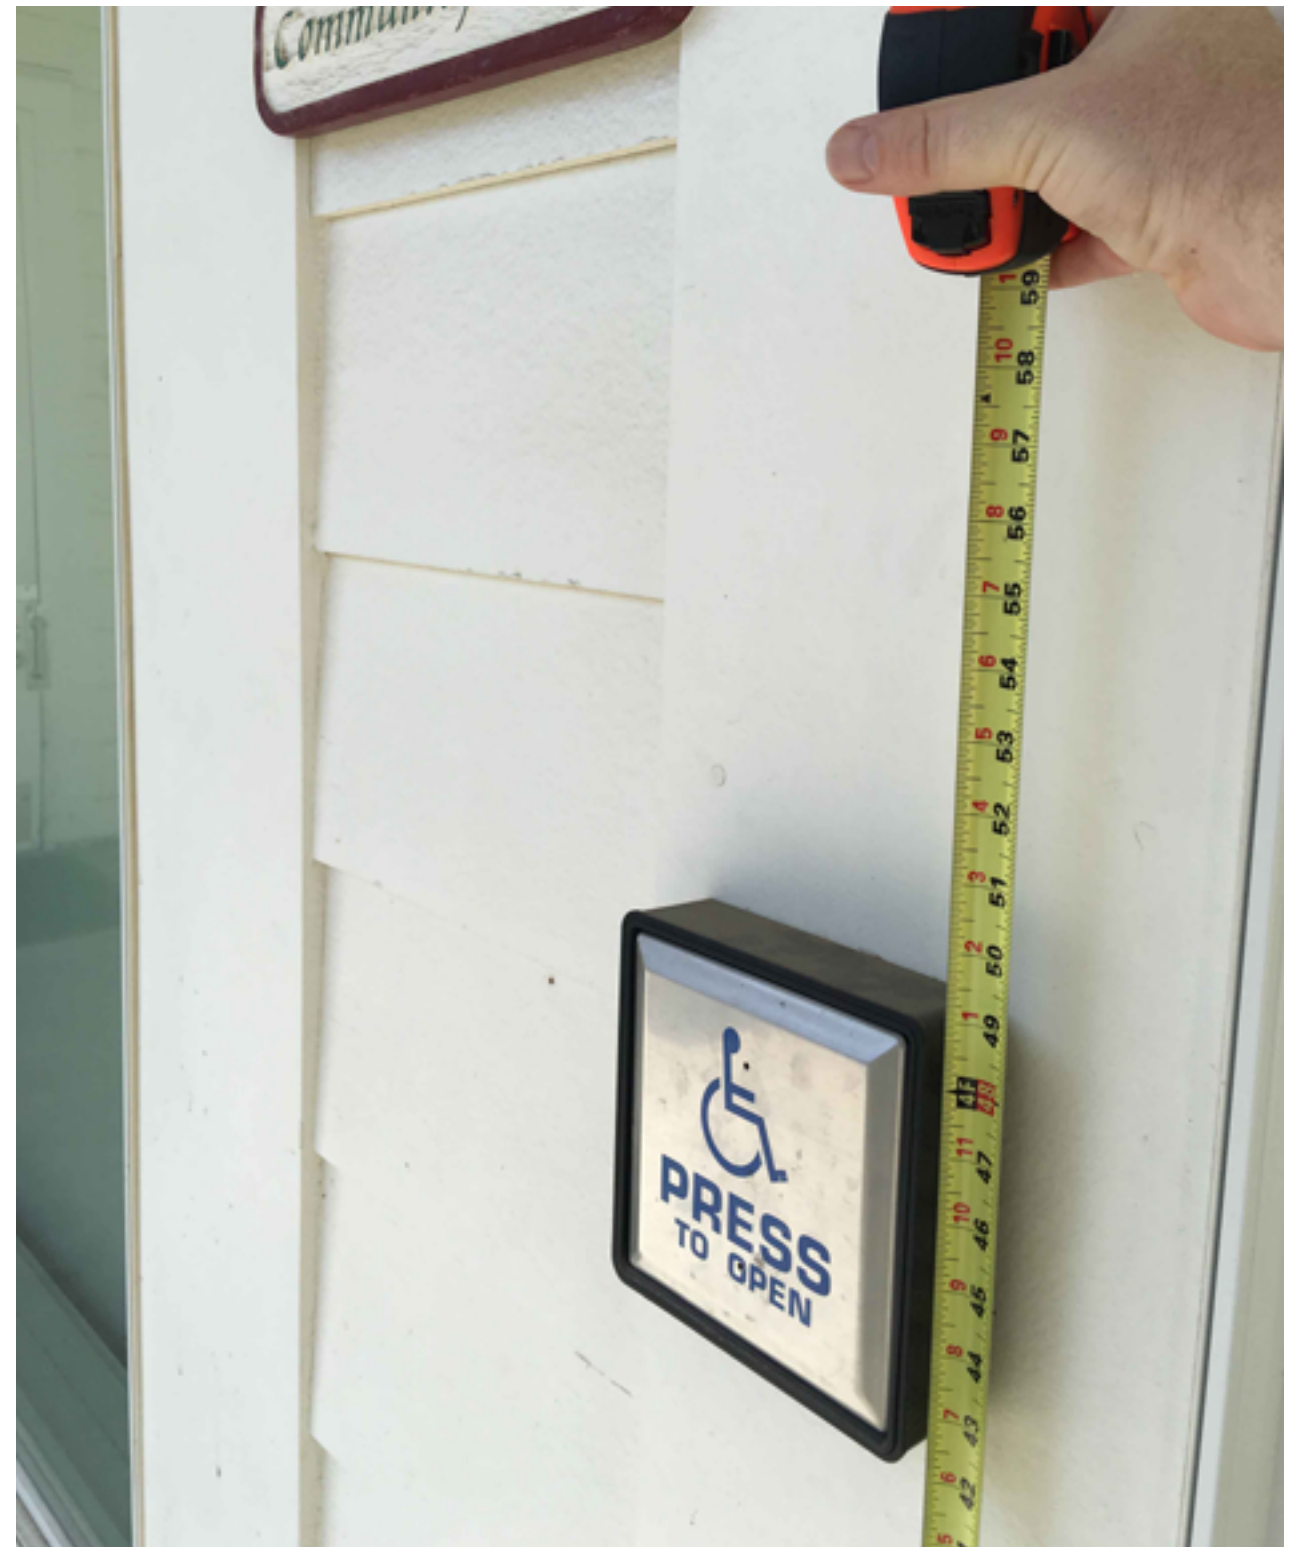
Press to continue.  
(This image shows a functional automatic door activation button within proper reach range; no corrections necessary)

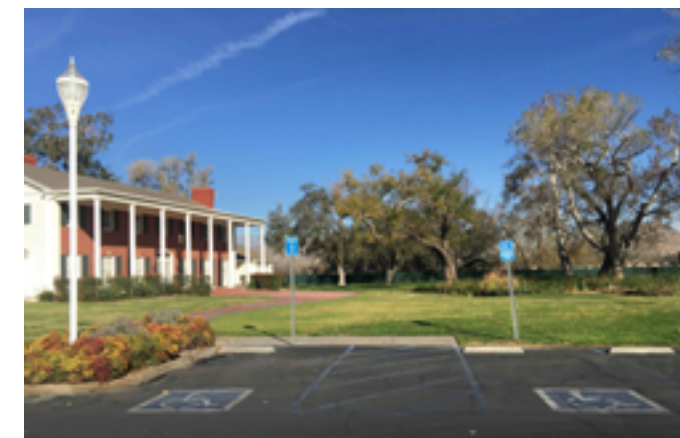
All Designated Accessible Parking Spaces observed generally met or exceeded the dimensions of 9' wide x 18' length. Two of the three Van Accessible space included an 8' wide access aisle/ loading zone, with the third measuring about 6" deficient in width. All parking signage appeared to be mounted at proper heights (80" clear when signage is placed within the accessible path/ 60" min. above finish floor to the bottom of the sign outside accessible paths). Loading zone diagonal striping was consistently observed at 3' on-center spacing. "NO PARKING" was NOT observed in 12" tall white painted letters at any of the loading areas. International Symbol of Accessibility was provided at each Designated Accessible Parking Space. All Designated Accessible Parking Spaces and adjacent access aisles were mostly found to be compliant in slope (1:48 maximum). Detectable warning (truncated domes) were NOT provided in Federal Yellow color, with proper contrasting surface resiliency, between accessible walkways and adjacent parking/ vehicular areas, where these walkways had a zero-curb condition (walkway and parking meeting flush in elevation to one another). A few action items are noted on the following page:

Designated Accessible Parking Spaces #1 (Left) and #2 (Right), located near the Manor House main entrance.

*ACTION ITEM 1.3.3: Provide "Minimum Fine: \$250" signage at ALL parking spaces as defined by CBC 11B-502.6.2; Recommendation is to replace all signage with the Caltrans R99 signage shown in the beginning of this report. Signage shall maintain 60" min. clearance where signs are located outside accessible routes, and 80" min. clear where located within accessible routes, as per CBC 11B-502.6.*

*ACTION ITEM 1.3.5: Grind and overlay asphalt paving to eliminate areas exceeding 1:48, as per CBC 11B-502.4, Exception #1. Excessive slope was noted at DAPS #1, 2, and the loading zone between 1 & 2.*

*ACTION ITEM 1.3.6: Restripe passenger loading zone between DAPS #1 and 2 to reflect full 8' width required for van parking spaces, in compliance with CBC 11B-502.2, Exception #1.*

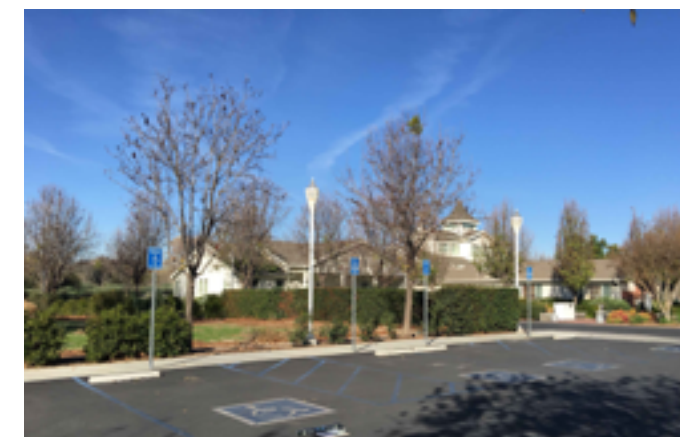
Designated Accessible Parking Spaces #3-6 (counted left to right), located at the western edge of the parking lot.

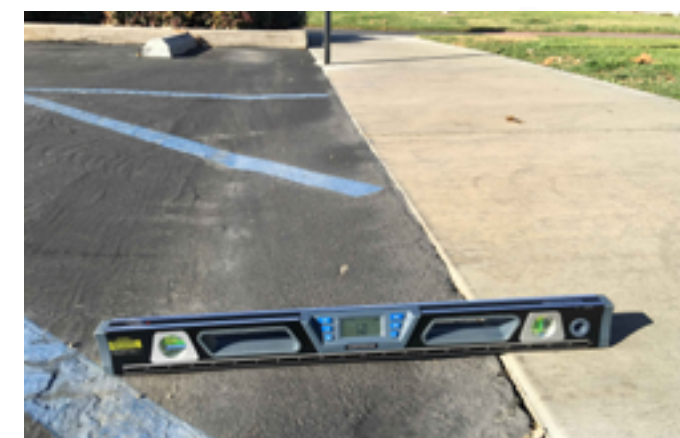
Example of excessive slope observed within the passenger loading zone between DAPS #1 and 2;

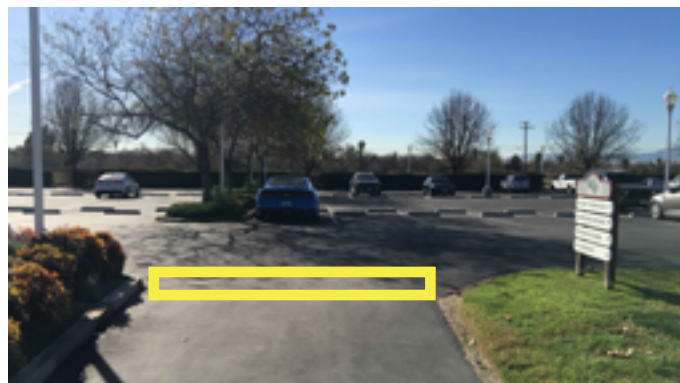
The existing walkway from the Designated Accessible Parking Spaces 1-2 to the Front Door of the Manor House alternates between asphalt, broom finish concrete, and brick. There is excessive cross slope immediately adjacent to the parking, gaps exceeding 1/2" width at expansion joints, and a two-riser stair set with no ramp present at the porch area. This walk also leads into the parking lot with no elevation change (zero-curb), without truncated domes to provide detectable warning of pedestrians entering a hazardous vehicular area.

Yellow rectangle indicates location of future truncated domes, as per Action Item 2.1.5.

*ACTION ITEM 2.1.5: Provide detectable warning along the entire walkway edge abutting the parking lot, in compliance with CBC 11B-247.*

2.1.5	Add truncated domes at walkway/ parking edge	\$2,500	with Conf Center project	
<b>2.2 WALK FROM PARKING TO CARRIAGE HOUSE &amp; COURTYARD</b>				
No immediate action recommended, as this is within the area designated for building and site renovation efforts				
<b>2.3 COURTYARD</b>

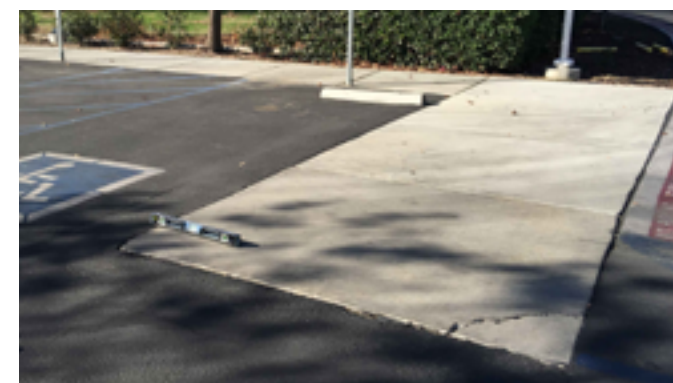
The pedestrian route from the remainder of the Designated Accessible Parking Spaces to the Carriage House and Courtyard crosses a vehicular drive at a zero-curb condition without the presence of detectable warnings. Cracked concrete and excessive gaps are present within the traveled path near the drive crossing. Cross slope readings at some brick areas well exceeded 1:48 at plaza areas, where turning movements are anticipated. However, portions of non-compliant paving areas appear to fall within the footprint of planned building renovation.

*ACTION ITEM 2.2.1: Modify concrete surface to eliminate gaps to comply with CBC 11B-302.3. Openings in floor or ground surfaces shall not allow passage of a sphere more than 1/2" diameter.*

*ACTION ITEM 2.2.2: Provide detectable warning along the entire zero-curb walkway edges abutting both sides of the designated crossing area, in compliance with CBC 11B-504.*

Replace uneven concrete, address paving gaps, and provide truncated domes where the walkway meets parking at a zero-curb condition.

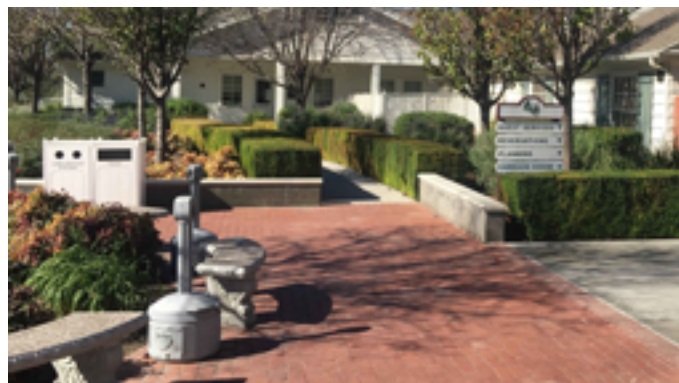
This walkway also appears to fall within the footprint of proposed upcoming construction. However, the existing benches are not accessible and should not be reused for accessible seating, as they are not 20" min. deep, nor 48" min. length, nor do they provide back support.

*ACTION ITEM 2.4.1: Remove and replace existing benches with furnishings that fully comply with CBC 11B-903.*

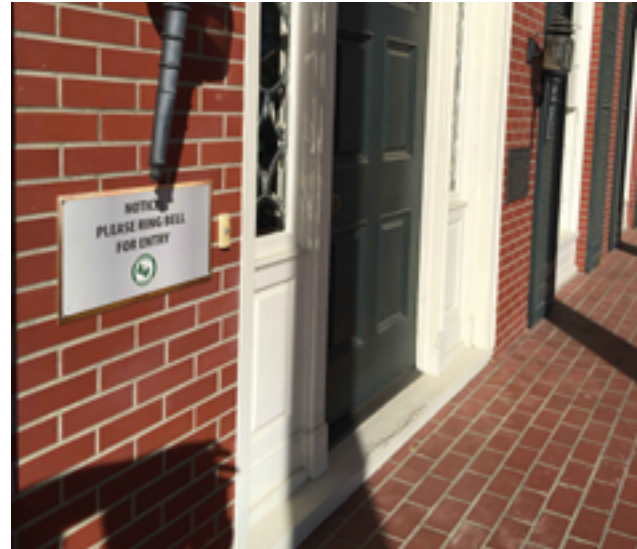
Access to the Front Door of the Manor House is impeded by a pronounced threshold. However, this door is not currently used as a primary entrance point into the building.

3.1.1 interim	Due to excessive cost of repair, recommend providing signage directing visitors to the currently accessible entrance	\$500	Immediate	
3.1.2	Provide adequate vertical clearance for passageway under stairs (potential structural constraints)	\$10,000	June 2021

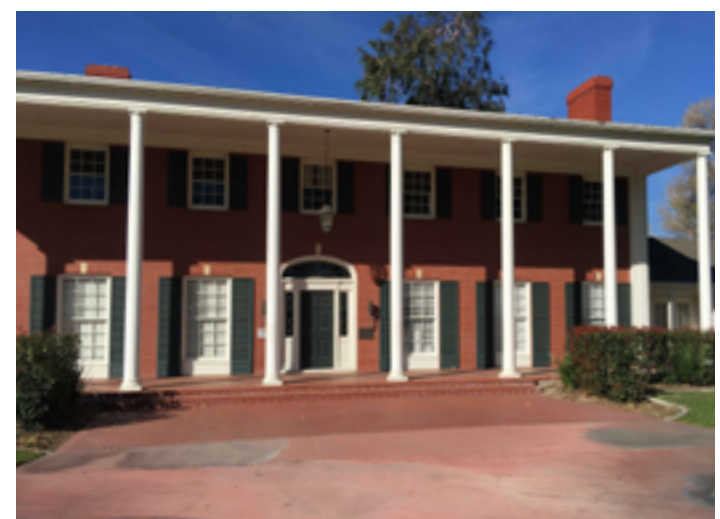
Handrails are not present anywhere along the two-step level change leading to the front door.

*ACTION ITEM 2.1.4: Provide handrails and contrasting tread stripes to at least one portion of the existing stairs, in compliance with CBC 11B-504.*

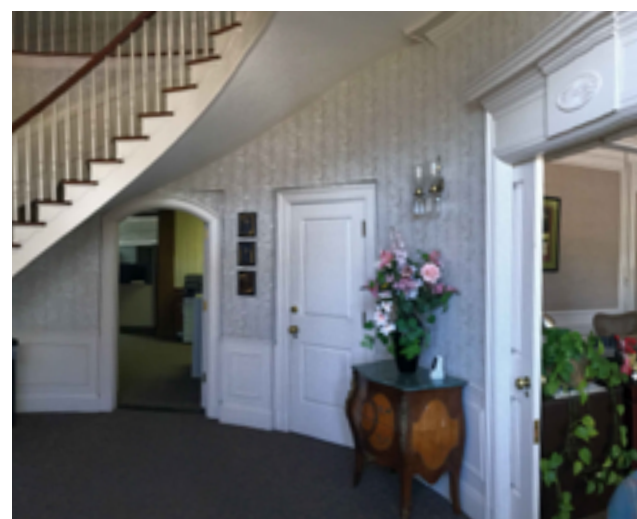
The underside of the curved portion of the staircase, as well as the arched doorway beneath, provide vertical obstructions without cane detection warning.

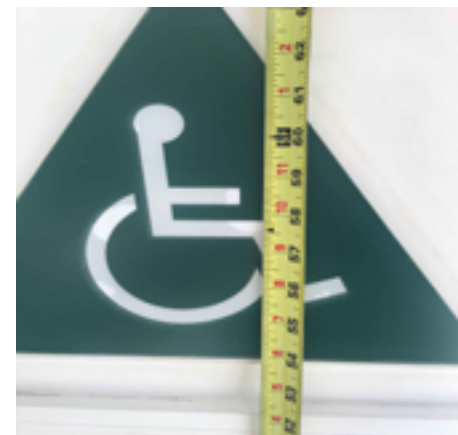
Center of geometric sign is required to be 60" AFF. Sign is currently 57" to 58".

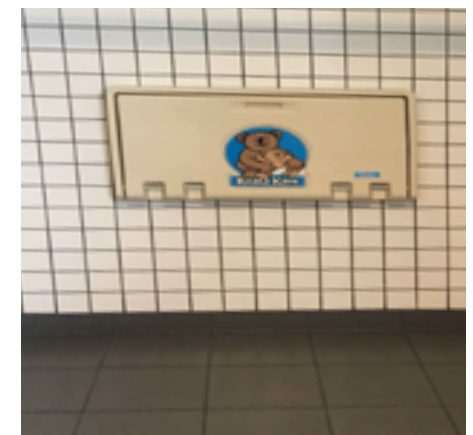
Baby Changing Stations cannot be located within Designated Accessible Toilet Compartments.

ITEM #	DESCRIPTION	APPROX. COST	EST. COMPLETION	COMPLETED
3.2.3	Adjust location of toilet paper dispensers	\$500	December 2018	
3.2.4	Relocate Baby Changing station to location outside accessible toilet compartments (no feasible alternate location identified within restrooms)	\$2,500	June 2019	
3.2.4 interim	Provide baby changing station in secured private room on-site, with signage directing users to this location	\$500	December 2018	
3.2.5	Bride room restroom - structural constraints present-recommend providing signage indicating restroom is not accessible, and directions to the accessible restroom directly adjacent to bride room	\$500	June 2018	
TOTAL OF INDIVIDUAL COSTS (will vary greatly depending on timing and grouping of repairs)		\$136,150

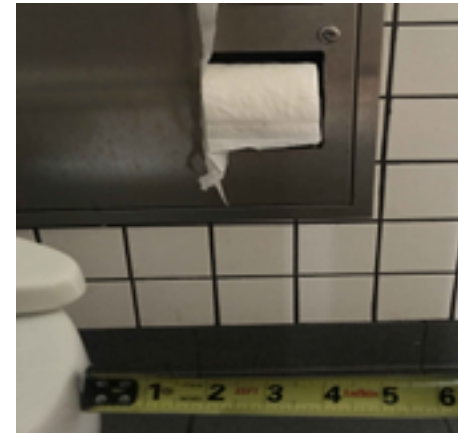
Centerline of Toilet Paper is required to be between 7" and 9" in front of toilet. Current location is approximately 3" in front of toilet.

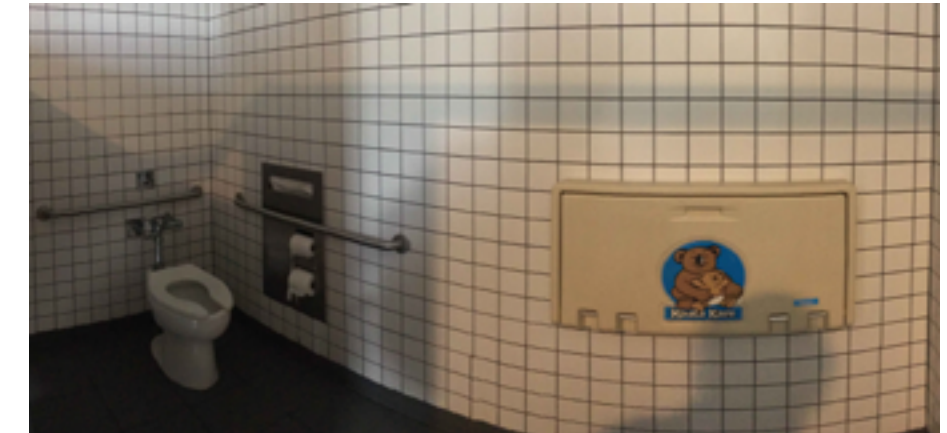
Overview of Men's Room Accessible Toilet Compartment; need to remove baby changing from toilet compartment.

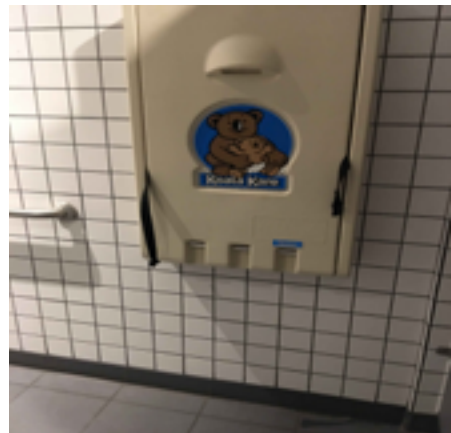
Baby Changing Stations cannot be located within Designated Accessible Toilet Compartments.

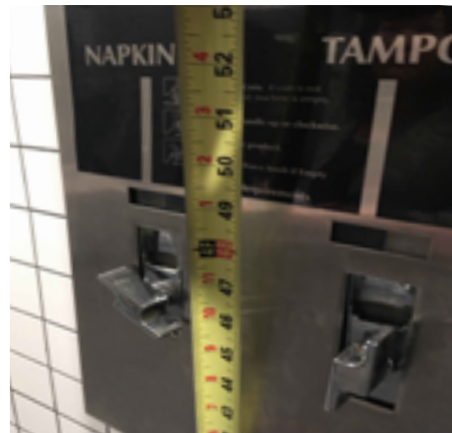
Operable parts of dispenser exceed 40" maximum AFF.

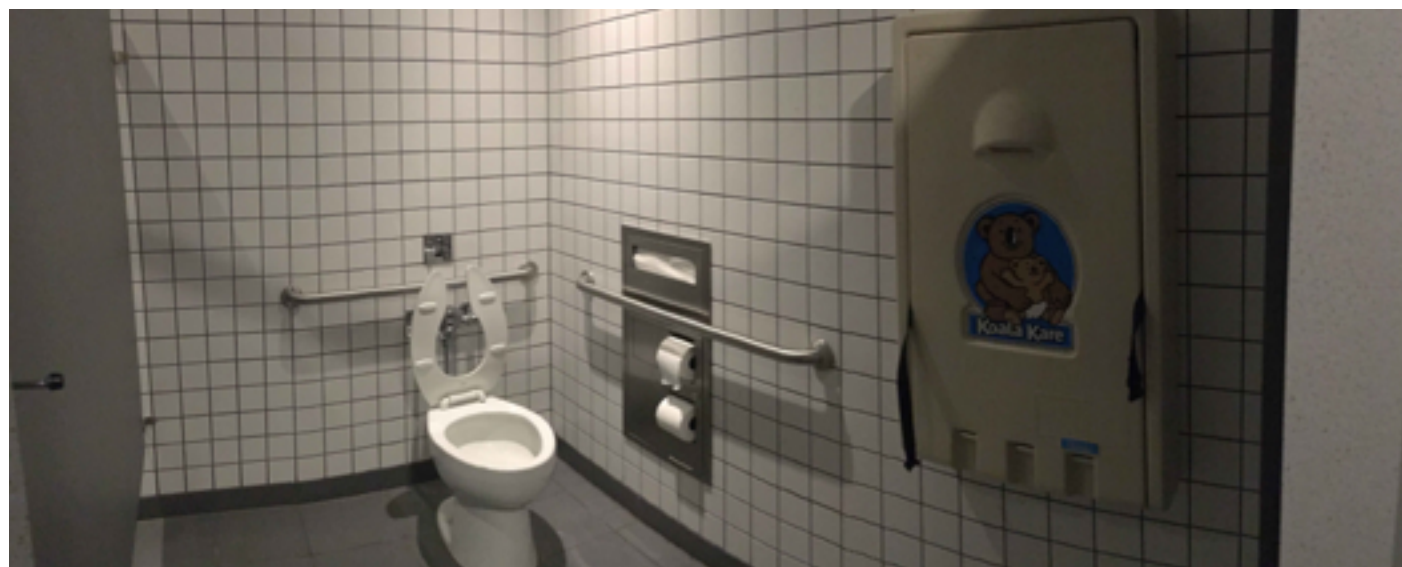
Overview of Women's Room Accessible Toilet Compartment. The Baby Changing Station will need to be relocated out of Accessible Toilet Compartment.

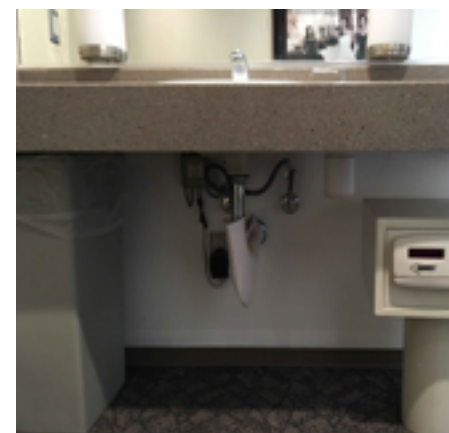
Waste container and property safe obstruct the wheelchair approach to the sink.

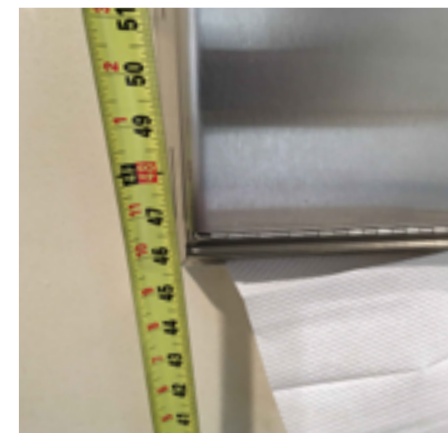
Paper Towel dispenser exceeds 40" AFF maximum at the towel exit point.

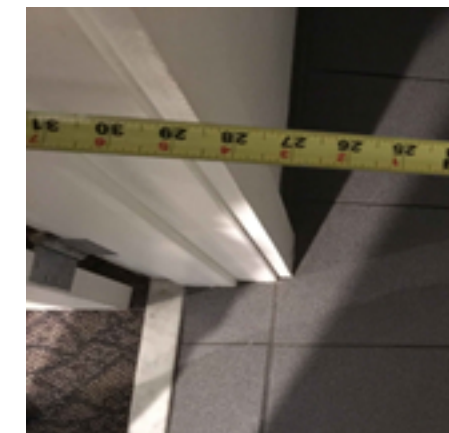
Toilet compartment entrance is only 28" wide.

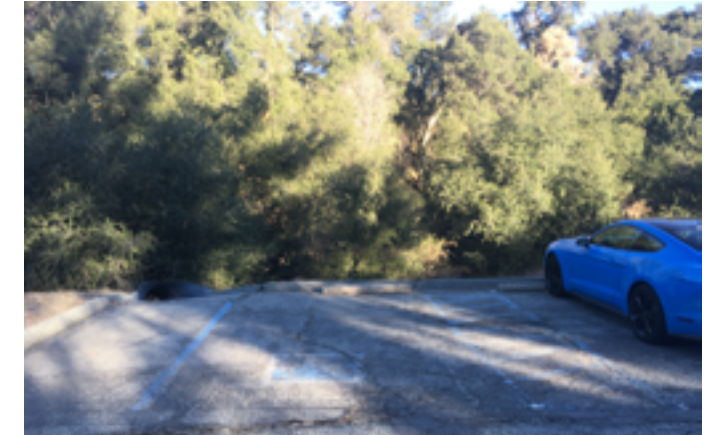
Typical condition of Designated Accessible Parking Spaces located throughout Bogart Park: deteriorated striping, missing or faded signage, excessive slope, etc. Pictured above: Pine Lot

*ACTION ITEM 1.3: In addition to providing Designated Accessible Parking Spaces (DAPS) mentioned in Action Items 1.1.1 through 1.1.3, the four (4) DAPS within Meadow Lot shall be brought to full compliance with CBC 11B-502.*

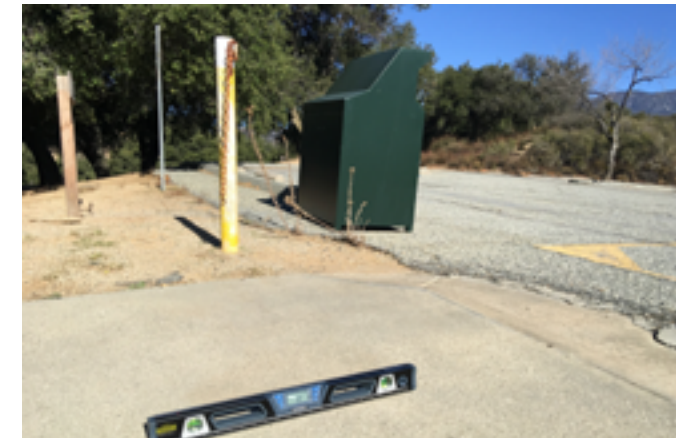
None of the DAPS observed at Bogart Park made accessible connections to intended park amenities. Pictured above: excessive slope and waste container obstructing access in Meadow Parking Lot.

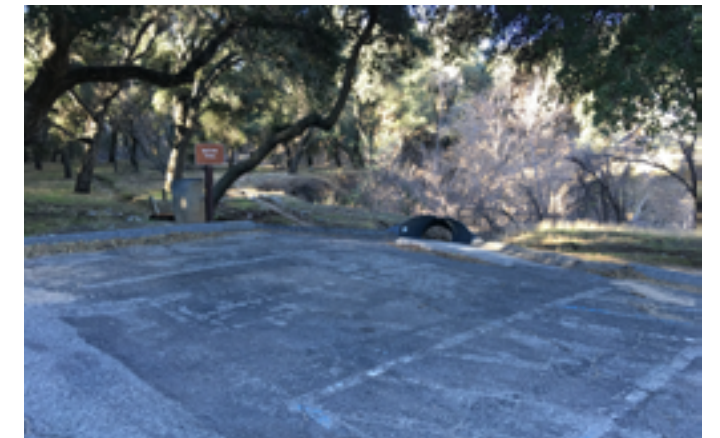
Existing DAPS at Oak Parking Lot. Signage is absent, markings are not clear. Loading zone does not connect to any accessible site amenities.

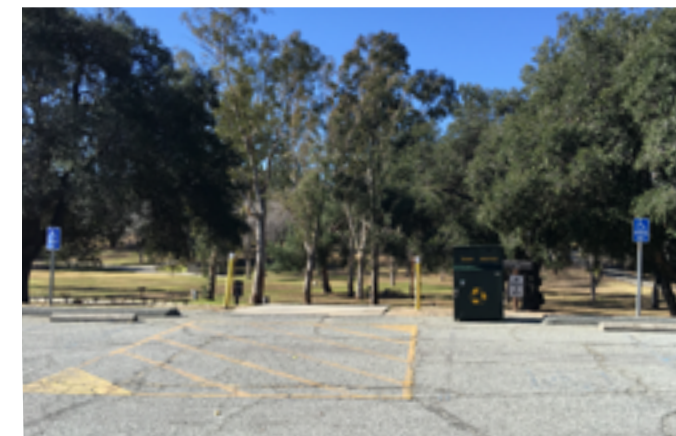
While signage was present at the DAPS within Meadow Parking Lot, most other accessibility components (striping, slope, loading zones) were severely deficient.

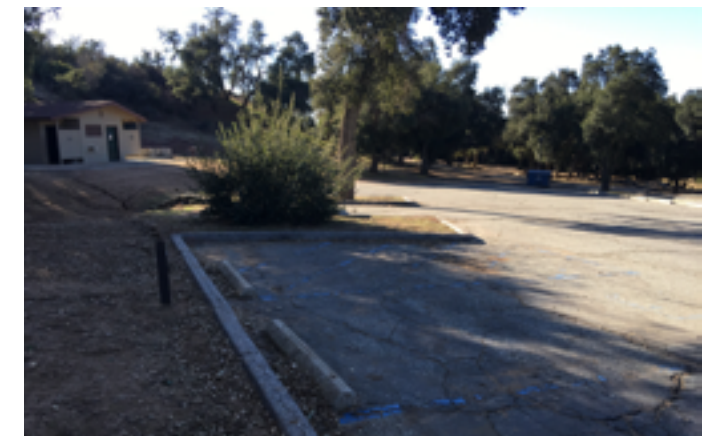
The DAPS within Manzanita Parking Lot also were observed to be severely out of compliance with current accessibility requirements.

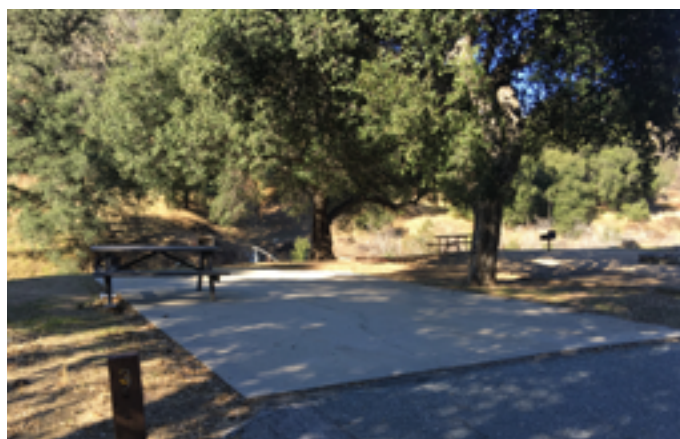
Campsite #3 is currently designated as the accessible site, but does not provide the required connection to sanitary facilities.

*ACTION ITEM 2.1.1: Remove any accessibility designations from Campsite #3 and renovate two campsites near the restroom facility to meet the requirements of CBC 11B-246.2.*

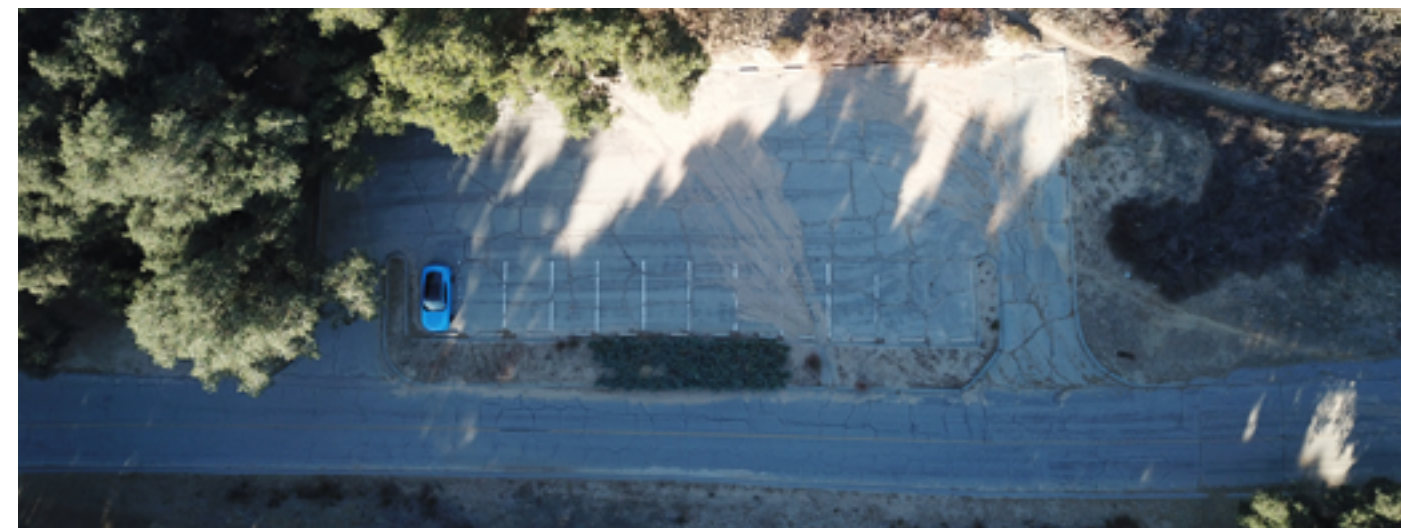
Top Left: Aerial view of Pine Parking Lot  
Top Right: Trail connection from remnants of Designated Accessible Parking Space  
Bottom: Aerial view of Oak Parking Lot

*ACTION: Beyond parking-related items listed in Action Items 1.1.1 through 1.1.3, no action is recommended at this time. Plan shall be revisited if and when amenities are proposed near Pine and/or Oak Parking Lot.*

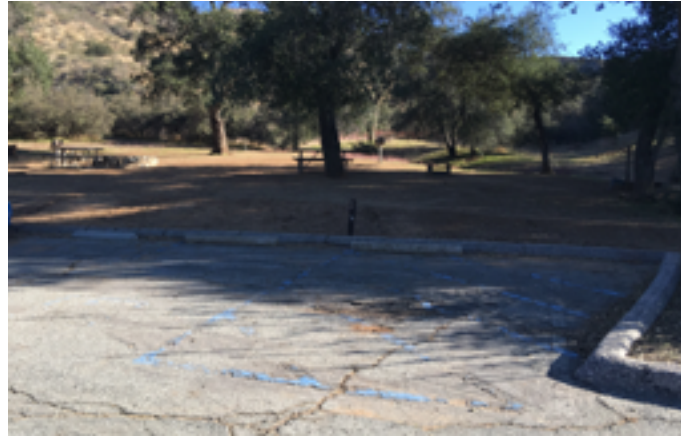
There is no accessible walkway connecting the Designated Accessible Parking Spaces with the Manzanita restroom nor to any of the picnic tables. Per CBC 11B-246.5, where picnic tables are provided, at least one picnic table, and one additional table for each 20 tables or fraction thereof, shall be accessible and comply with CBC 11B-902.

*ACTION ITEM 2.4.1: Provide an accessible path from the parking lot to at least one picnic table, barbecue and fire pit, as per CBC 11B-246.5 and CBC 11B-246.6*

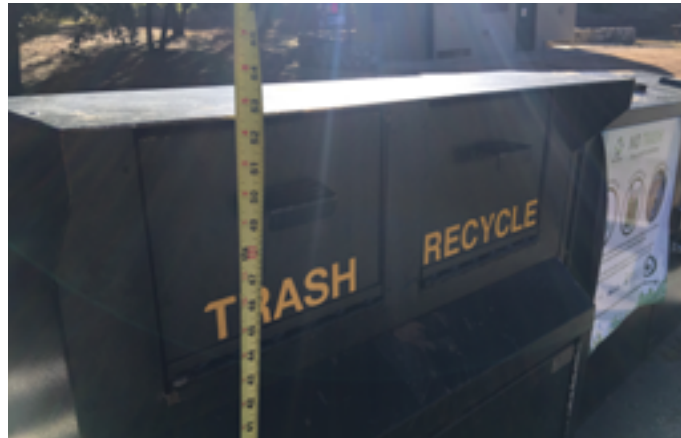
Both of the waste and recycling receptacles require movements above the maximum reach range for operable parts of 48" maximum as defined in CBC 11B-308.3.1 (see Unobstructed Side Reach)

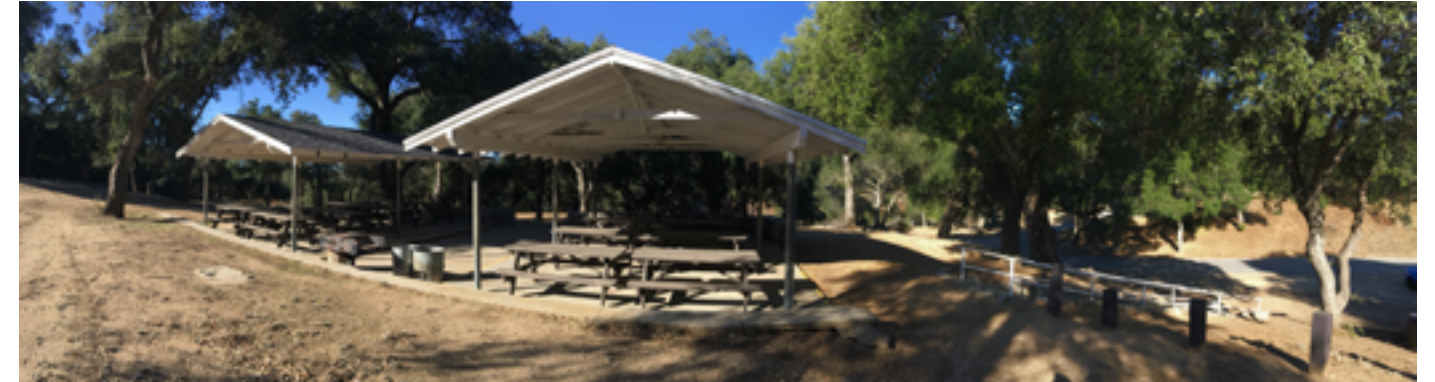
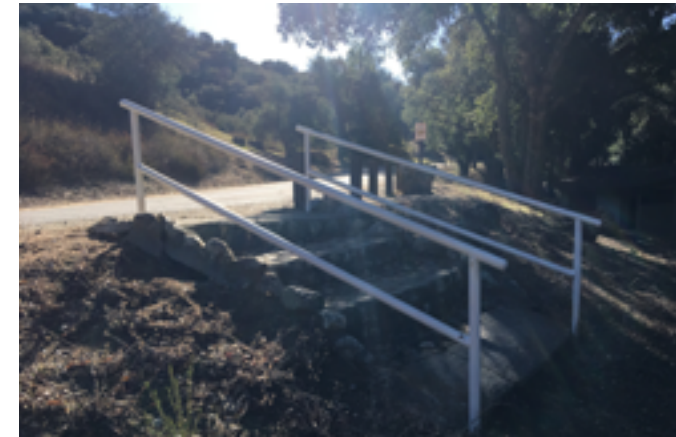
These stairs would require a complete renovation to meet accessibility standards.

*ACTION ITEM 2.6.1: Provide an accessible path from Designated Accessible Parking Space(s) to the activity level.*

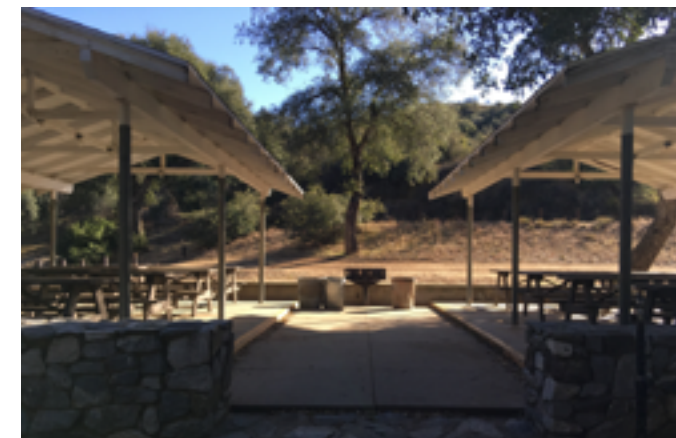
Steps between the shelters and barbecue area prevent accessible circulation.

*ACTION ITEM 2.6.3: Renovate shelter area to have a contiguous concrete surface unimpeded by steps.*

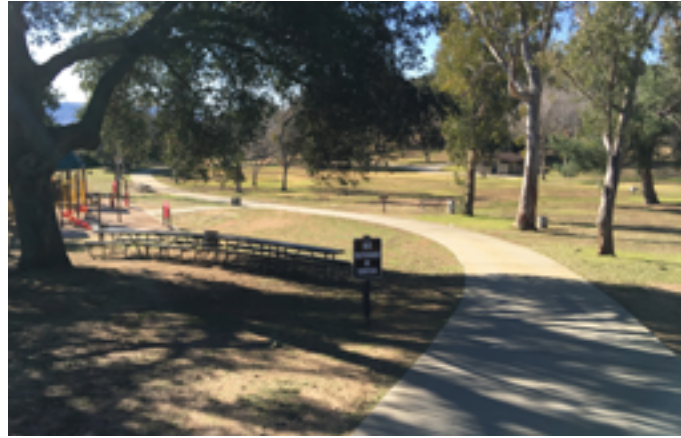
The majority of the Meadow concrete walkway exceeds maximum allowable slope requirements. There are also no picnic tables that meet the requirements of CBC 11B-246.5 and 11B-902.

2.7.1 interim	Provide signage warning wheelchair users of excessive slope; provide interim means of transport to key amenities	\$10,000	Immediate	
2.7.2	Provide accessible picnic tables (recommend 10 accessible tables spread amongst various areas); provide accessible trash receptacles	\$2,500	June 2025

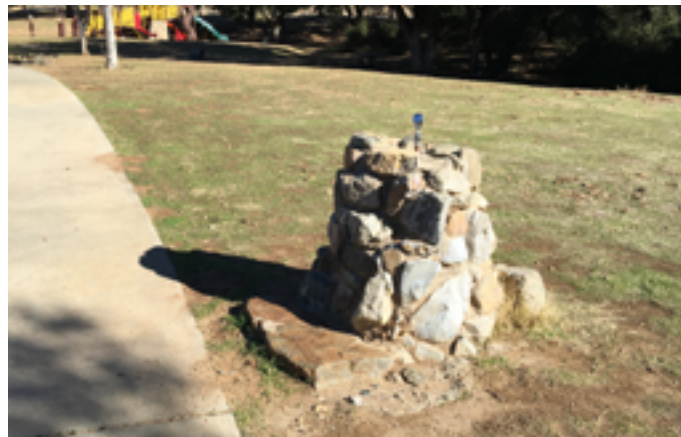
This historic drinking fountain should be supplemented with an accessible high-low fountain at a level location in close proximity.

*ACTION ITEM 2.7.3: Where drinking fountains are provided, a fountain meeting the full accessibility requirements of CBC 11B-602 shall be provided.*

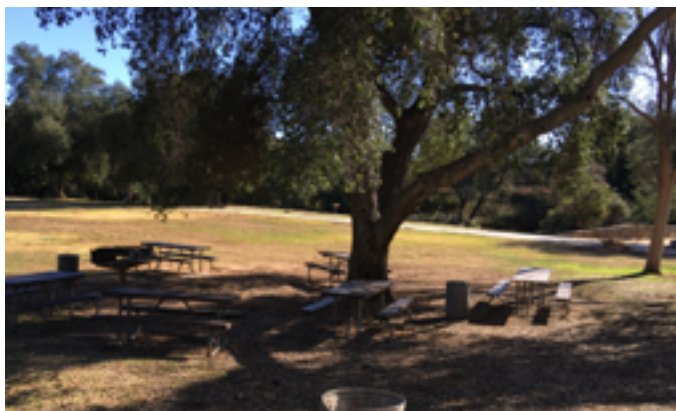
Typical shot of several groupings of picnic tables under shade trees within the Meadow area, but no provisions exist for accessible use.

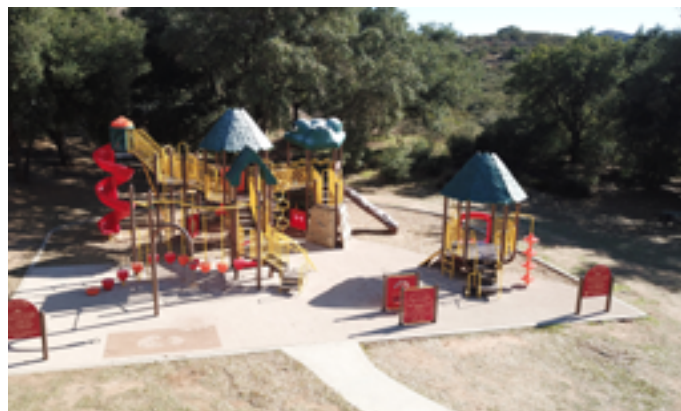
The playground construction is fairly recent, and generally meets the current accessibility requirements. Ongoing maintenance is necessary to stay in accessibility compliance.

*ACTION ITEM 2.7.4: Provide contrasting stripe at each transfer step on the playground, as per CBC 11B-1008.3.2.4*

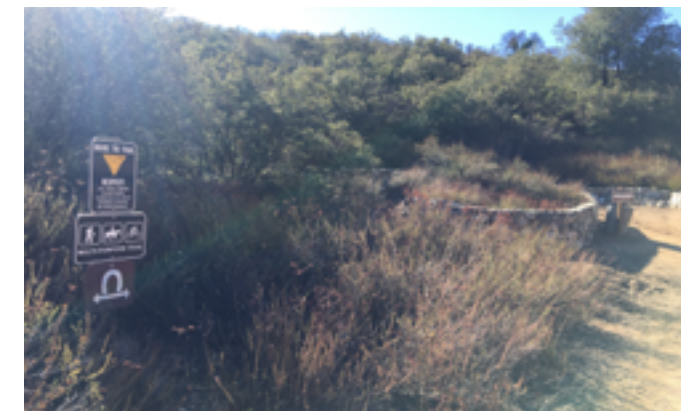
Existing signage indicates the trail is intended for pedestrian hiking. Per CBC 11B-246.7, at least portions of the trail shall be constructed with gradients allowing for at least partial use by wheelchairs.

*ACTION ITEM 2.8.1: Supplement existing lookout amenities at the top of the Candlelight Trail to permit the ability for wheelchair occupants a comparable educational experience, in compliance with CBC 11B-246.7 and 11B-246.8.*

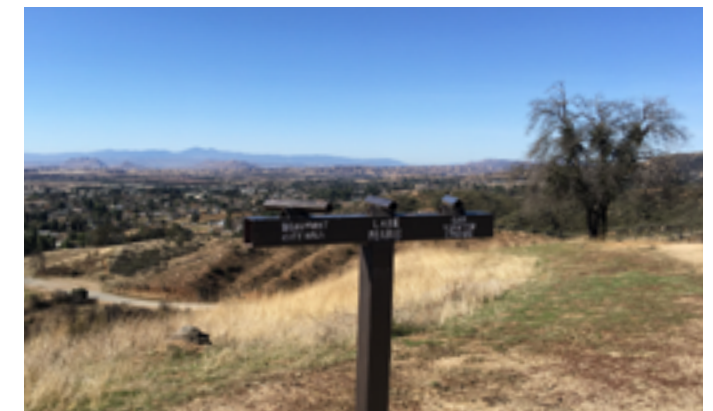
The lookout scopes at the top of the Candlelight trail are mounted too high to be used by wheelchair occupants.

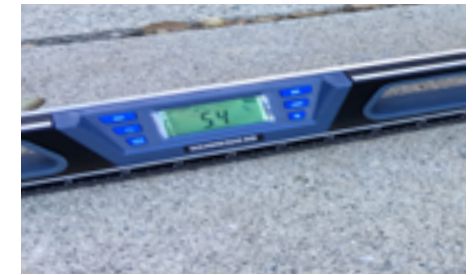
*Excessive slope in perimeter concrete slabs.*

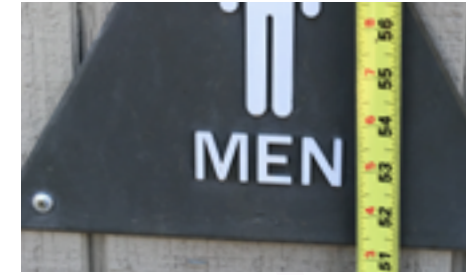
*Center of Geometric signage too low.*

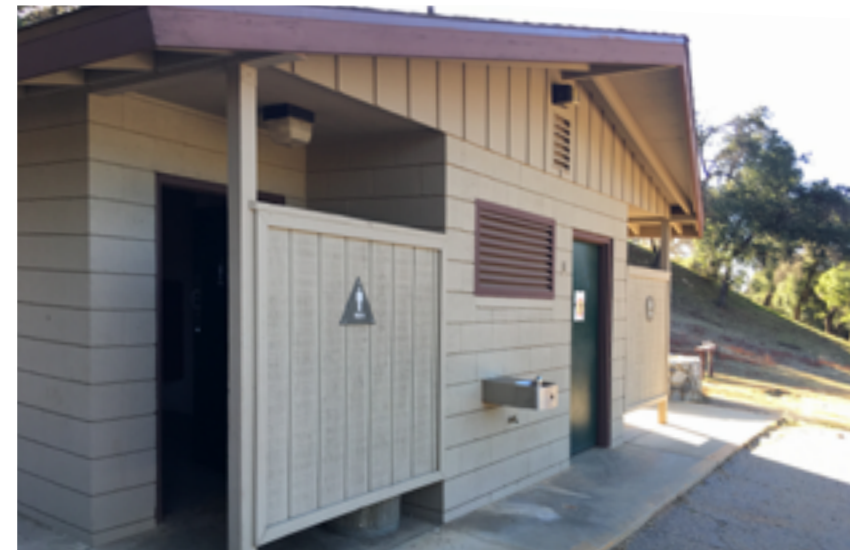
*Drinking fountain does not have cane detection barriers from side approach, which are required if the fountain is not located within an alcove.*

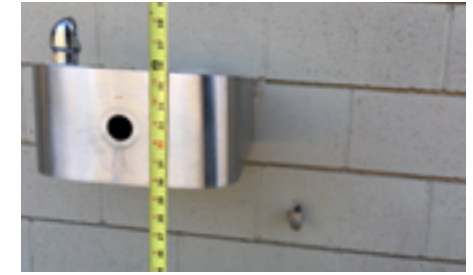
*Second (High) drinking fountain not provided; Low drinking fountain not functional.*

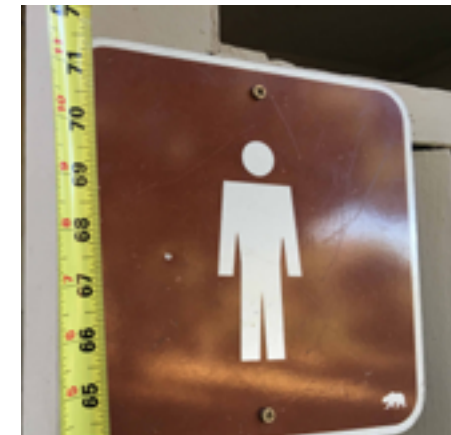
No geometric signage provided.

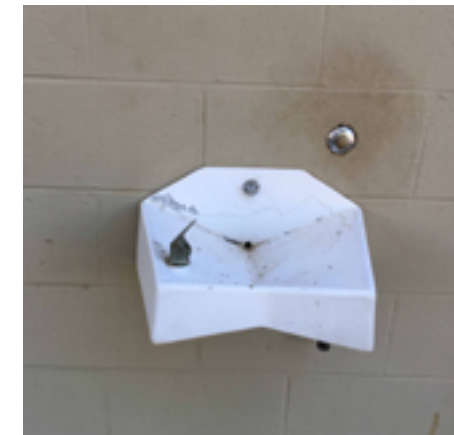
Non-compliant drinking fountain.

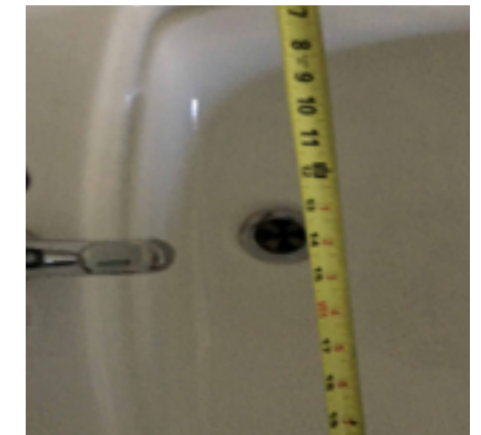
Sink too close to wall.

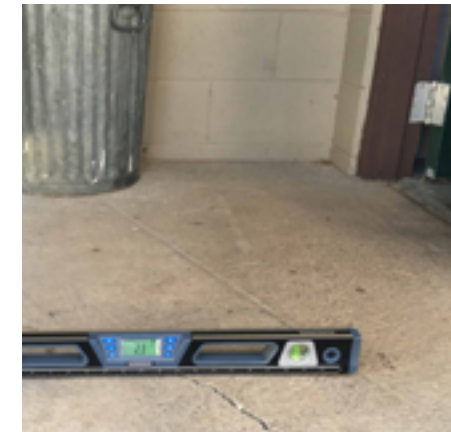
Excessive slope at restroom entry.

3.3.1 interim	Provide Accessible Portable Restroom and hand washing station near activity area	\$1,000	December 2018	
<b>3.4 MEADOWS RESTROOM</b>				
3.3.1	Remove/ replace concrete surrounding building where slope exceeds 1:48 (anticipate 500 SF); coordinate with item 2.7.1	\$3,500	June 2019

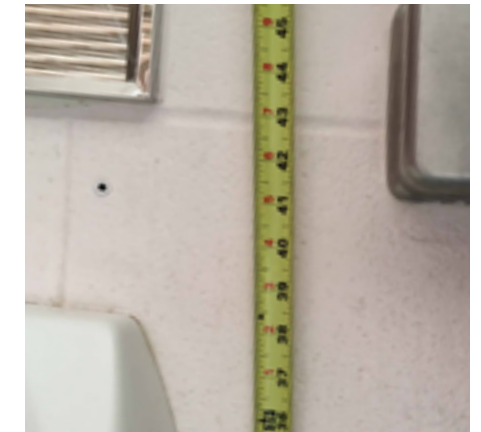
Men's room soap dispenser and mirror mounted too high.

3.3.2	Adjust mens restroom mirror and soap dispenser	\$500	December 2018	
	TOTAL OF INDIVIDUAL COSTS (will vary greatly depending on timing and grouping of repairs)	\$551,750

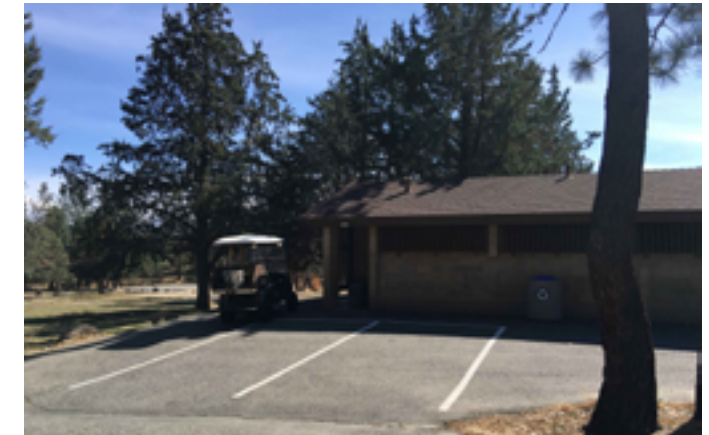
No Designated Accessible Parking is currently provided at the Indian Hill Restroom.

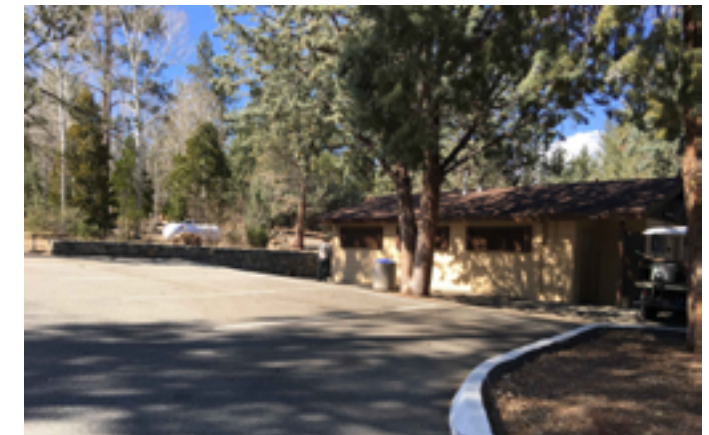
No Designated Accessible Parking is currently provided at either side of the Central Restroom. Additionally, excessive sloping in both directions is present, as well as between parking and restroom.

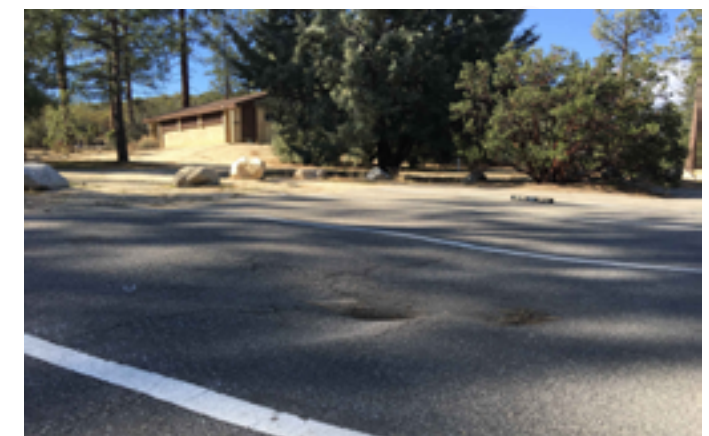
No Designated Accessible Parking is currently provided near Coyote Run Restroom.
