RIVERSIDE COUNTY REGIONAL PARK AND OPEN SPACE DISTRICT

# ACCESSIBILITY COMPLIANCE REPORT- 2018 UPDATE

MAY 31, 2018

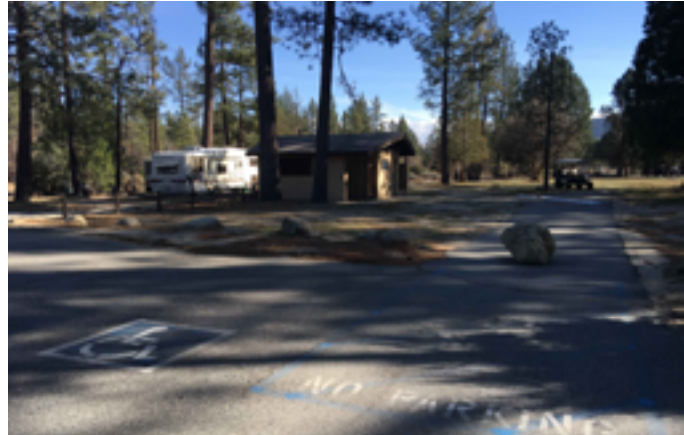
One Designated Accessible Parking is currently provided near the Day Use Restroom. However, the required signage is not present.

*ACTION ITEM 1.3.3: Provide "Minimum Fine: \$250" signage at ALL parking spaces as defined by CBC 11B-502.6.2; Recommendation is to replace all existing signage with the Caltrans R99 signage shown in the beginning of this report. Signage shall maintain 60" min. clearance where signs are located outside accessible routes, and 80" min. clear where located within accessible routes, as per CBC 11B-502.6.*

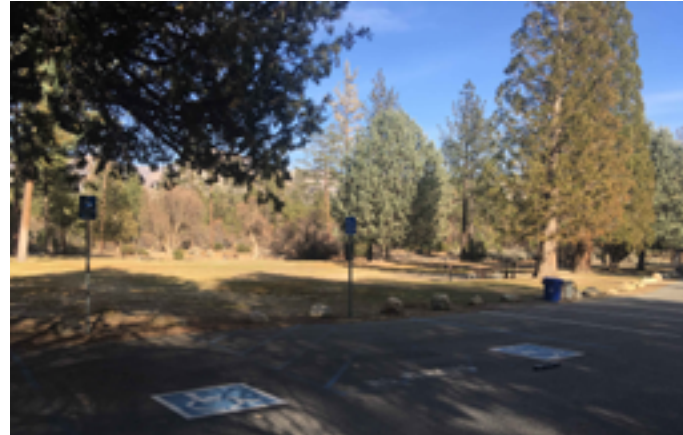
Parking at the south edge of the Meadow area is missing "Van Accessible" and "MINIMUM FINE \$250" signage; Loading zone does not connect with any accessible site features nor buildings.

*ACTION ITEM 1.3.5: Where applicable, restripe passenger loading zones to reflect full 8' width required for van parking spaces, in compliance with CBC 11B-502.2, Exception #1*

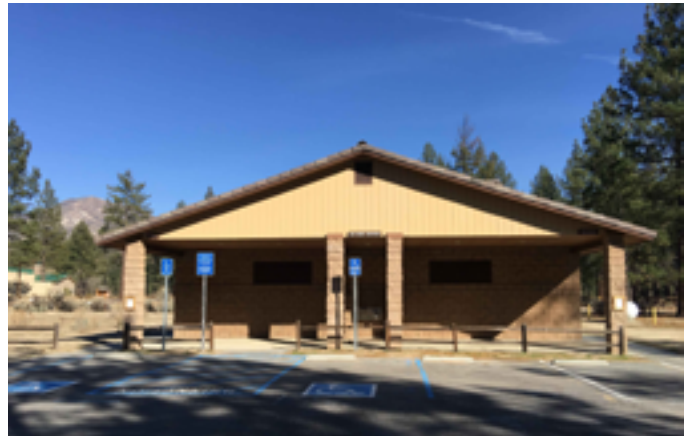
Designated Accessible Parking Spaces outside the New Group Restroom appear to be a fairly recent installation. These spaces are generally compliant, except the "MINIMUM FINE \$250" sign is not present.

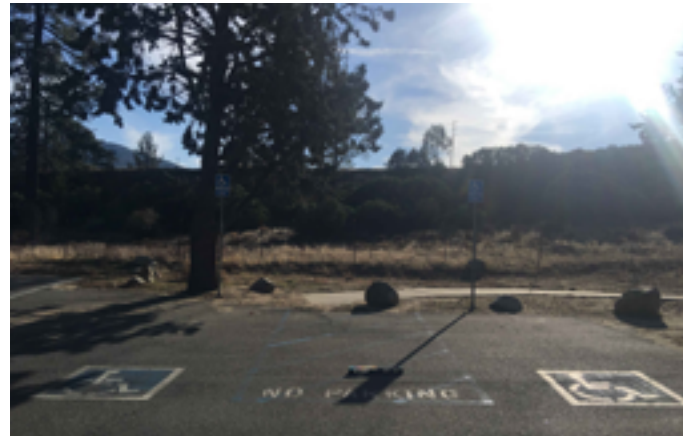
Similar barriers to the Meadow parking mentioned above are also present at the Designated Accessible Parking Spaces near the playground.

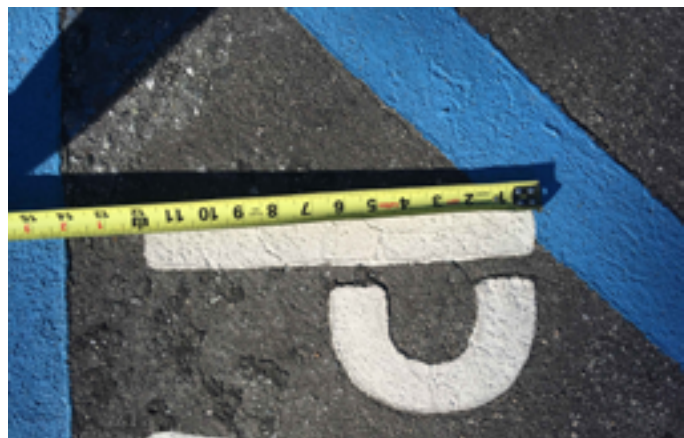
Pavement outside the New Group Restroom is currently in good shape; All painted stripes have good contrast. "NO PARKING" lettering is at proper size and location.

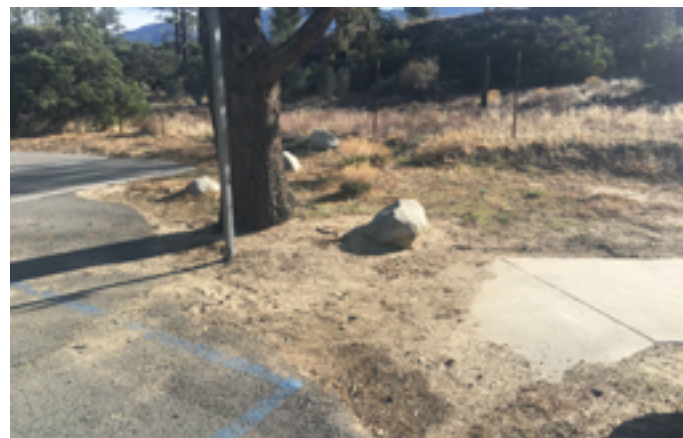
Excessive slope, debris on walkway surfaces, and subsiding asphalt all hinder the accessibility of the playground-adjacent parking.

*ACTION ITEM 1.3.4: Grind and overlay asphalt paving to eliminate areas exceeding 1:48, as per CBC 11B-502.4, Exception #1. Excessive slope was noted at several locations throughout the parking areas at the various restroom (except New Group).*

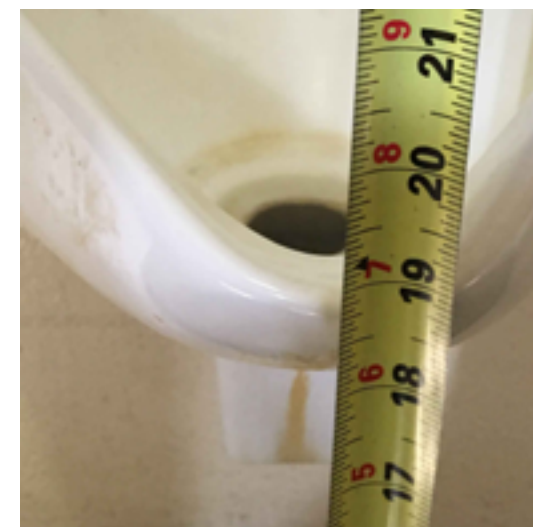
Urinal rim too high (17" AFF maximum allowed)

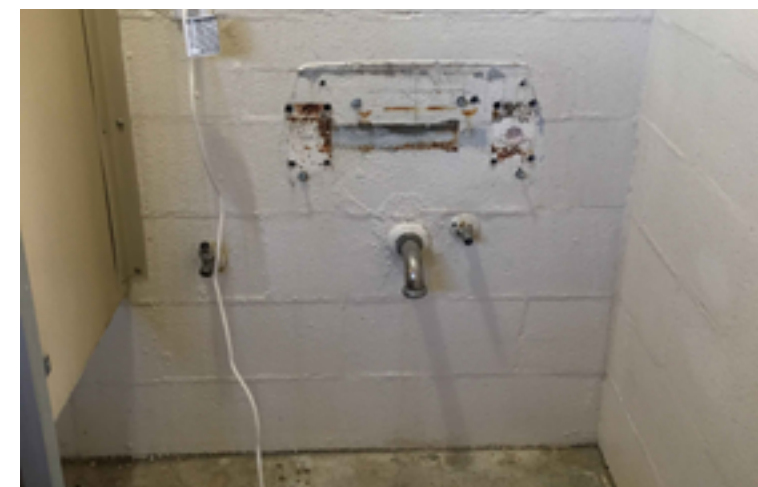
Renovations underway during inspection.

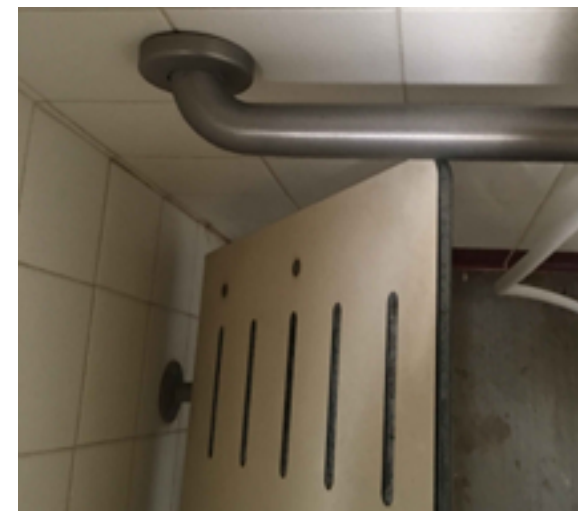
Shower seat obscured from folding upright by grab bar mounted in conflict.

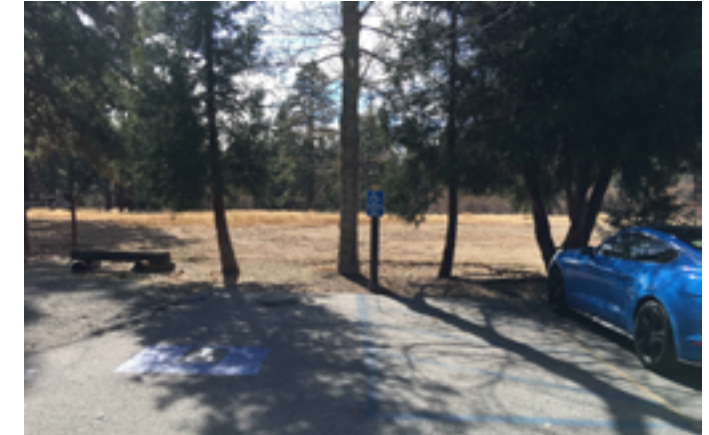
*The sole Designated Accessible Parking Space is present on uneven asphalt with improper ISA markings, missing/ low signage, and has no accessible route between the loading zone and the adjacent restroom building.*

*ACTION ITEM 1.3.4: Grind and overlay asphalt paving to eliminate areas exceeding 1:48, as per CBC 11B-502.4, Exception #1. Excessive slope was noted at several locations throughout the parking areas at the various restroom (except New Group).*

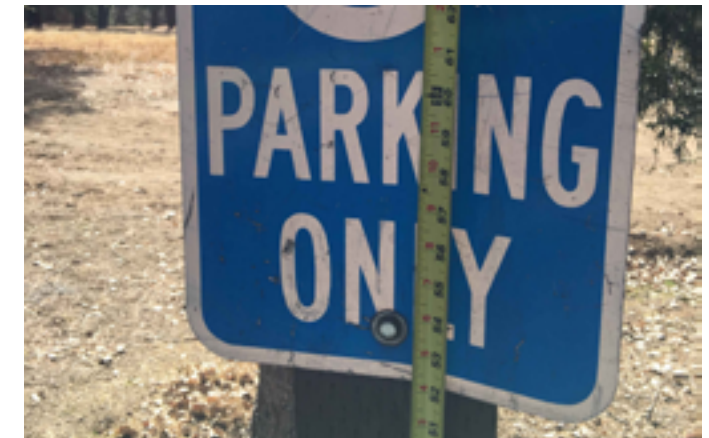
*Signage shall be remounted with proper height clearance, as well as Van designation and "MINIMUM FINE \$250" signage.*

*ACTION ITEM 1.3.3: Provide "Minimum Fine: \$250" signage at ALL parking spaces as defined by CBC 11B-502.6.2; Recommendation is to replace all existing signage with the Caltrans R99 signage shown in the beginning of this report.*

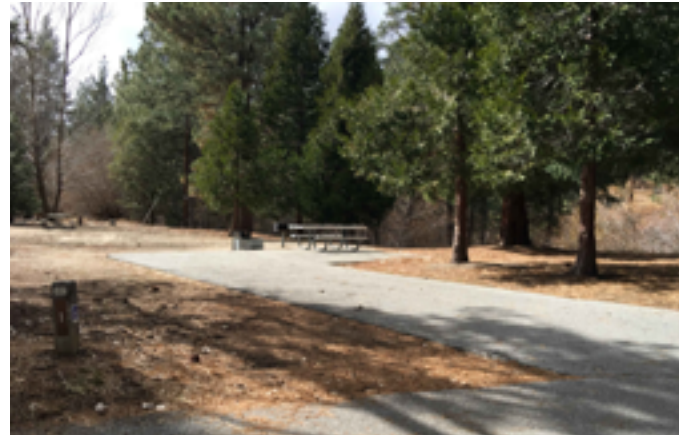
Campsite #1 is marked with an International Symbol of Accessibility, but does not provide an accessible route to the nearest sanitary facilities.

*ACTION ITEM 2.1.1: Renovate Campsite #1 and one additional campsite in a location near restroom/ shower facilities to meet the full requirements of CBC 11B-246.2.*

*ACTION ITEM 2.1.2: Provide an accessible route between designated accessible campsites and the closest adjacent sanitary facilities, as required by CBC-246.2.*

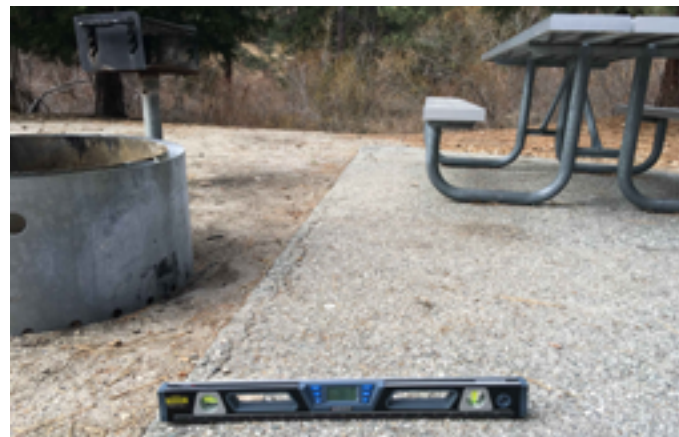
Amenities currently provided in the Designated Accessible Campsite are on an asphalt surface with excessive slope.

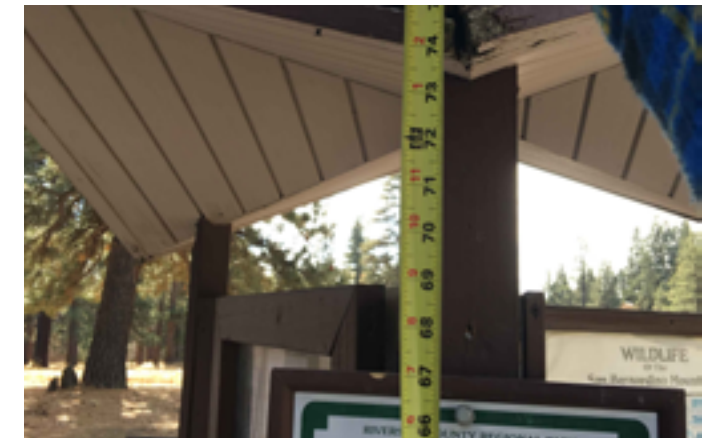
There is an information kiosk near the restroom/ shower building that has a low roof eave, causing an overhead obstruction within an area intended to be accessible.

This information kiosk has three eaves that cause vertical clearance obstructions at approximately 74" above finish grade.

*ACTION ITEM 2.2.2: Modify kiosk to provide consistent vertical clearance of at least 80 inches above finish grade, or provide a cane warning rail in full compliance with CBC 11B-307.4*

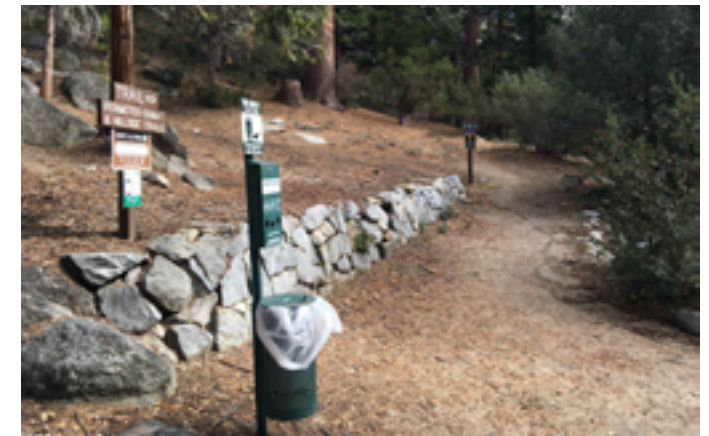
Trails shall be evaluated for alignment opportunities that will accommodate wheelchair use. This particular trail is fairly steep and not a likely candidate for modification.

*ACTION ITEM 2.3.1: Supplement existing trails to permit the ability for wheelchair occupants to use, in compliance with CBC 11B-246.7.*

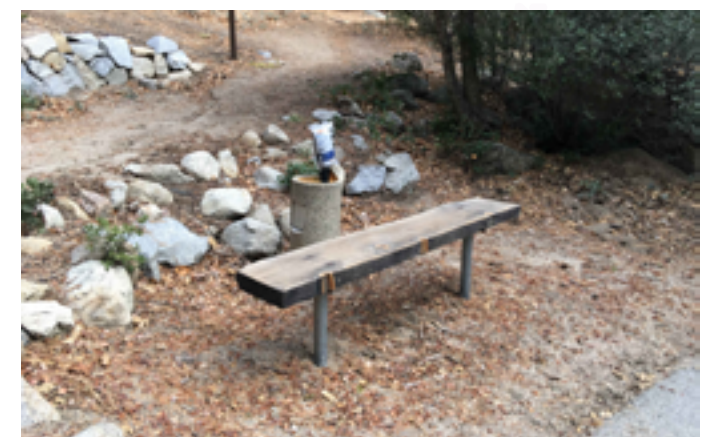
Existing benches do not provide the proper depth nor back support required by CBC 11B-903.

*ACTION ITEM 2.3.2: Remove and replace existing benches with furnishings that fully comply with CBC 11B-903.*

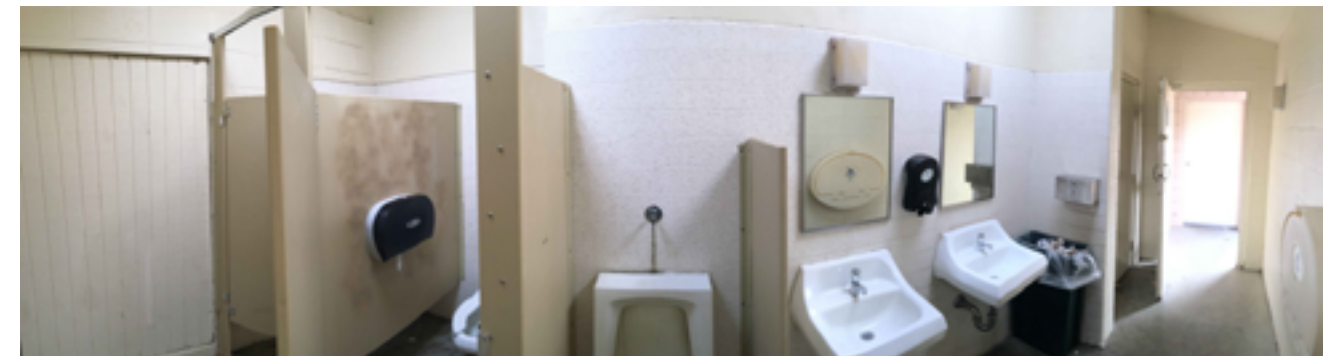
- Perimeter walkway has excessive slope, vertical displacement
- Grab bars provided at 32" wide stall only
- Toilet paper too high

Panoramic shot of men's restroom interior.

- Partition screens impede forward approach to urinal
- Sinks too close to wall
- Mirror and soap dispenser too high
- Sink plumbing not wrapped
- Geometric signage too high
- Baby changing table impedes wheelchair turning space
- Shower approach too narrow, requires 3" step

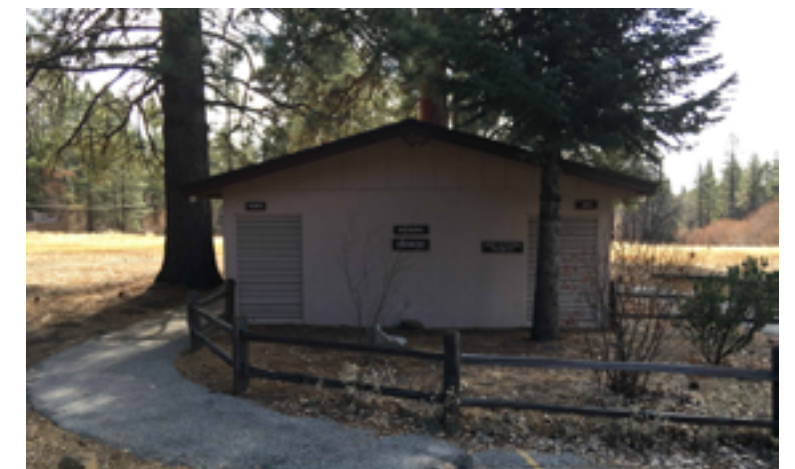
Walkway leading to restroom from parking.

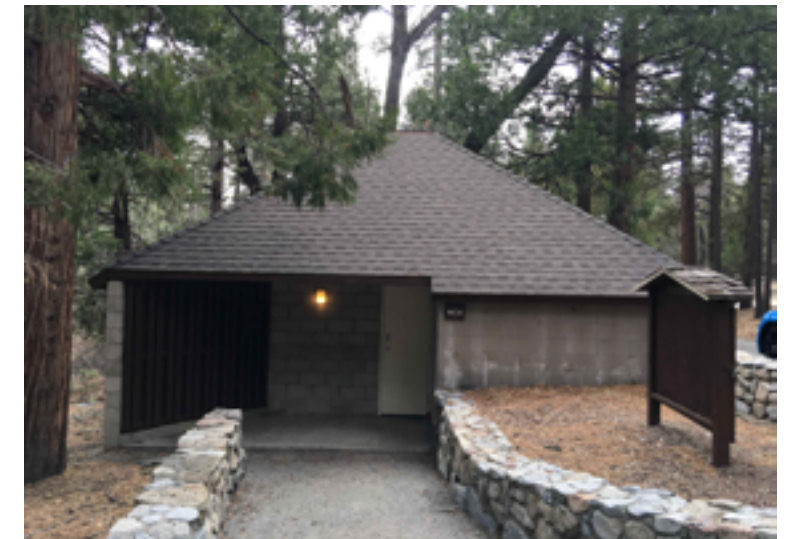
- Very steep slope heading into men's room
- Missing geometric signage
- Grab bars provided at 32" wide stall only
- Toilet paper too high
- Partition screens impede forward approach to urinal
- Sinks too close to wall
- Mirror and soap dispenser too high
- Sink plumbing not wrapped
- Coat hook too high
- Shower approach too narrow, requires 3" step

Very steep walk approach to men's room.

3.3.2	Remove steep walkways leading to building and reroute with accessible walks / ramps	\$50,000	June 2025	
3.3.3	Provide high-low drinking fountain to existing building	\$4,000	June 2025	
<b>3.4 CAMPGROUND RESTROOM #2</b>				
Not inspected during site visit				
TOTAL OF INDIVIDUAL COSTS (will vary greatly depending on timing and grouping of repairs)		\$666,500

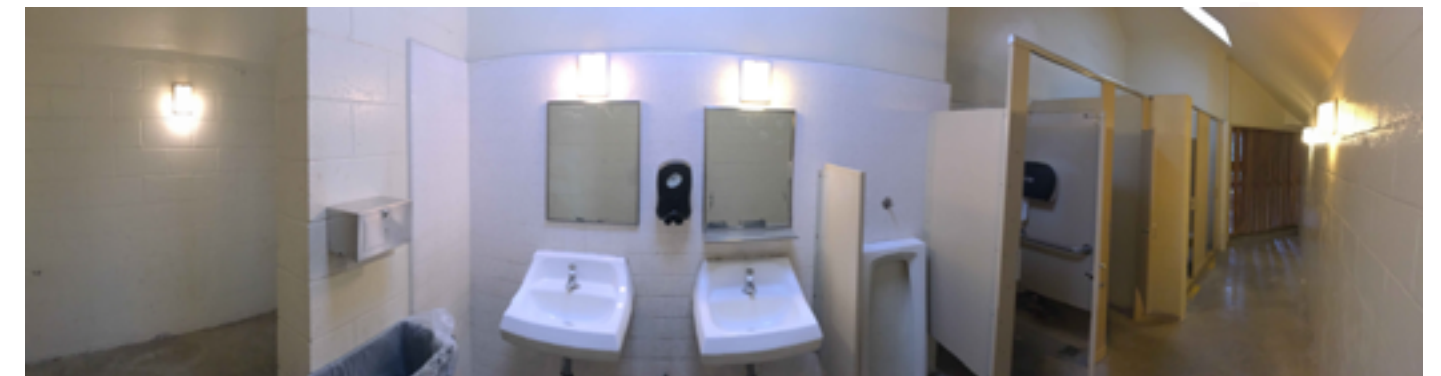
Panoramic shot of men's restroom interior.

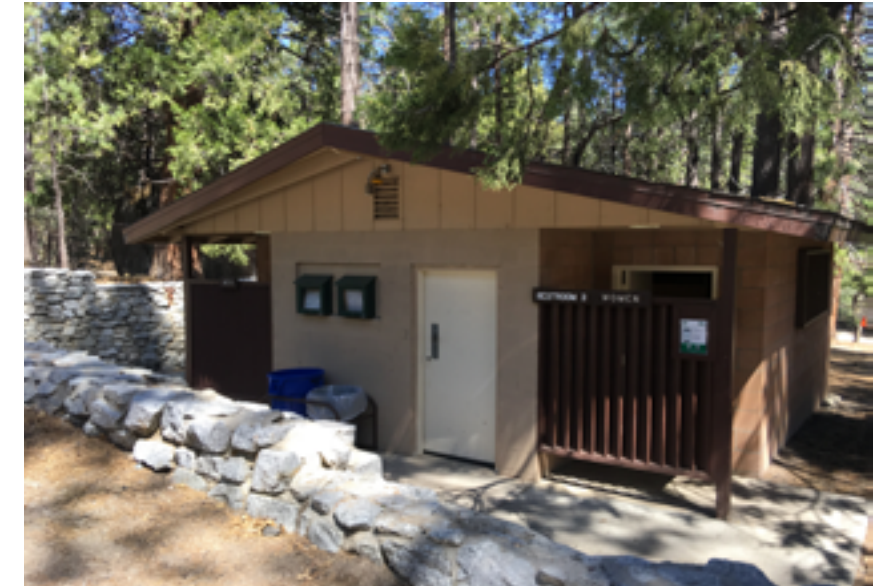
- No accessible connection to accessible campsite nor parking
- No geometric signage
- No accessible toilet compartments provided

Restroom Entrance

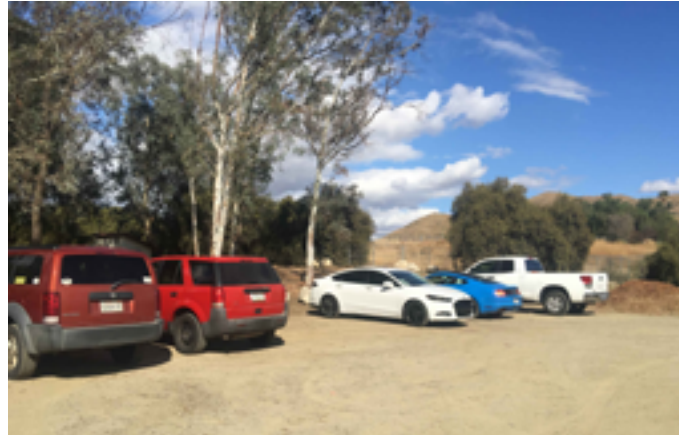
There are currently no Designated Accessible Parking Spaces at Kabian Park.

*ACTION ITEM 1.1: Provide at least one Designated Van-Accessible Parking Space and one standard Designated Accessible Parking Space on a firm, stable and slip resistant surface, conforming to the full requirements of CBC 11B-502.*

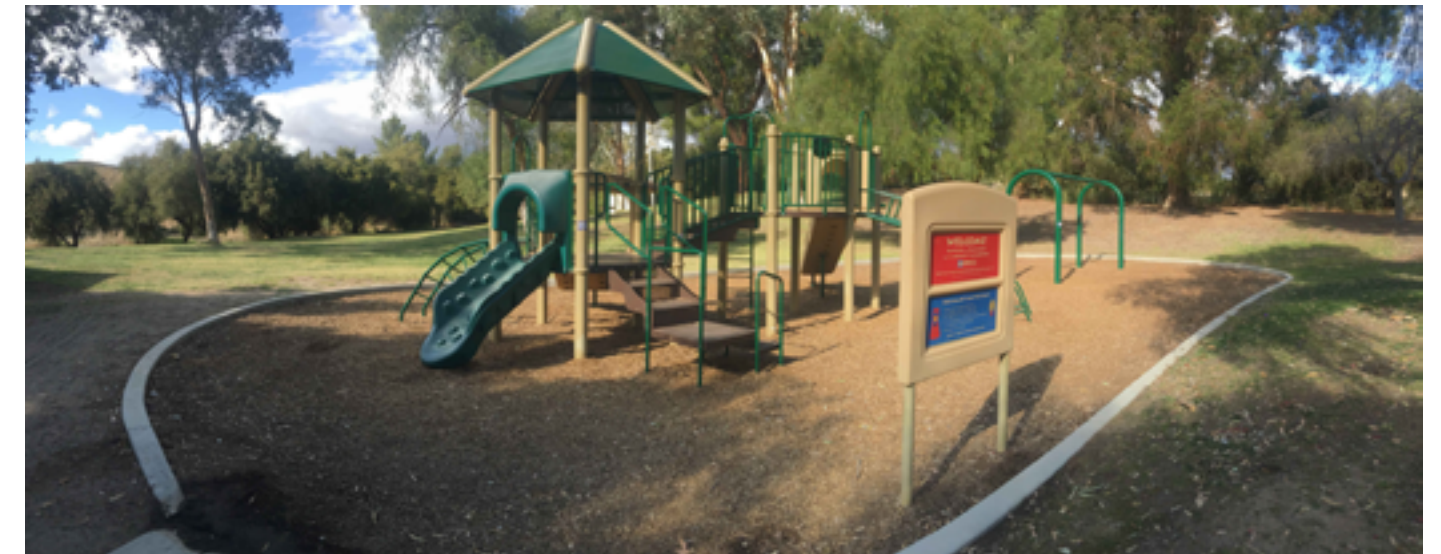
The playground itself is fairly recent in construction. However, the entire playground is on loose engineered wood fiber, observed to be variable in height at key accessible areas, such as the ramp leading into the play area as well as the slide exits and transfer stations.

*ACTION ITEM 2.2.1: Maintain wood playground mulch at heights and surface continuity to allow accessible connectivity between play components, and at proper heights for transfer points and slide exits, in full compliance with CBC 11B-1008.2; Since frequent maintenance of playground surface is required by CBC 11B-1008.2.6.1, the installation of rubber safety surfacing to provide an accessible path to all accessible ground level play features and transfer stations is recommended.*

*ACTION ITEM 2.2.2: Provide contrasting stripe at each transfer step on the playground, as per CBC 11B-1008.3.2.4*

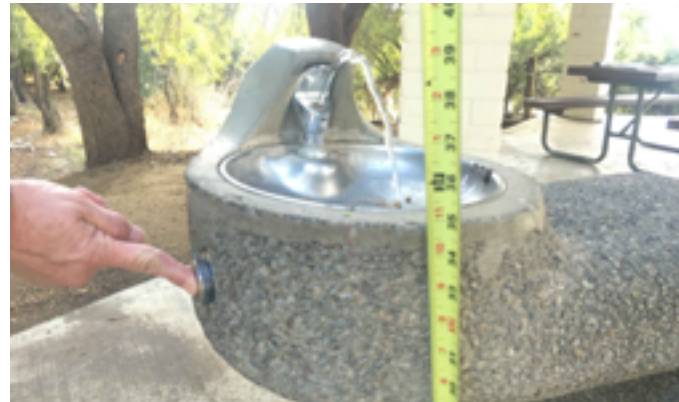
*The drinking fountain does not meet the height requirements for either of the two height ranges: wheelchair accessible spout at 36" max, or standing person spout outlet between 38"-43".*

*ACTION ITEM 2.3.2: Remove existing drinking fountain and replace with a high/low unit, in compliance with the full requirements of CBC 11B-602.*

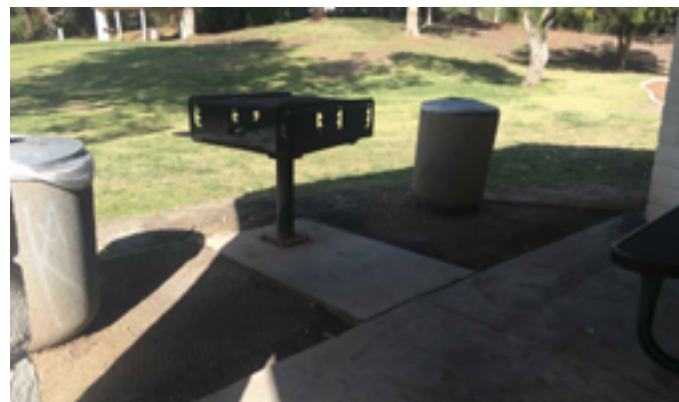
*The orientation of the barbecue is not conducive to use by wheelchair occupants.*

2.3.1	Provide (1) Accessible Picnic Table	\$1,500	June 2019	
2.3.2	Replace drinking fountain with high/low model	\$4,000	June 2019	
2.3.3	Provide side approach to barbecue	\$500	June 2019

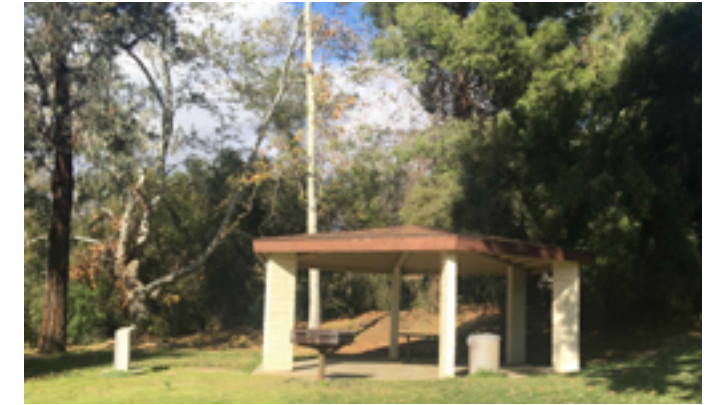
*Picnic Shelter #2 is not connected to any other accessible amenities within Kabian Park.*

*ACTION ITEM 2.4.1: Provide an accessible connection to Shelter #2 from the park entrance and other park amenities, in compliance with CBC 11B-206 and 11B-246.5.*

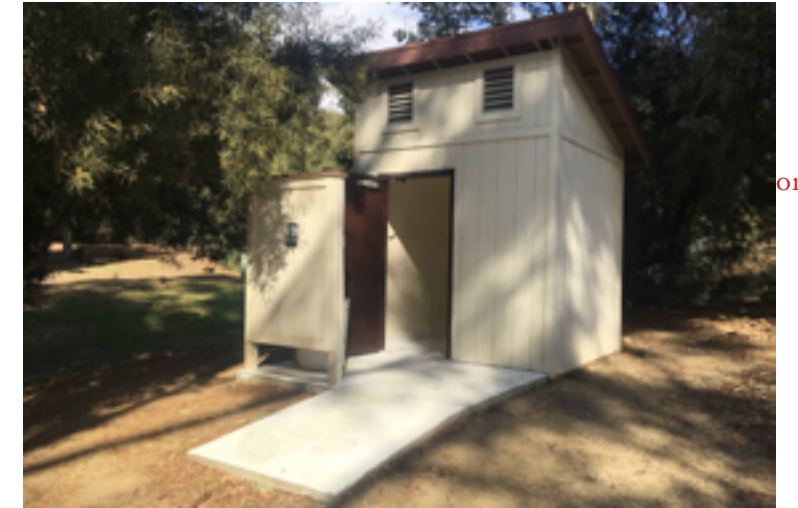
- No accessible approach to building (excessive running slope, no edge protection handrails)
- Missing geometric signage
- Excessive interior floor slope
- Side grab bar does not extend 54" min. from head wall

Excessive slope to restroom entry.

2.5	Provide partial wheelchair access	\$10,000	June 2023	
<b>3.1 RESTROOM</b>				
3.1.1	Remove concrete walk approach and replace with accessible walkway (coordinate with 2.1.1)	\$5,000	June 2019

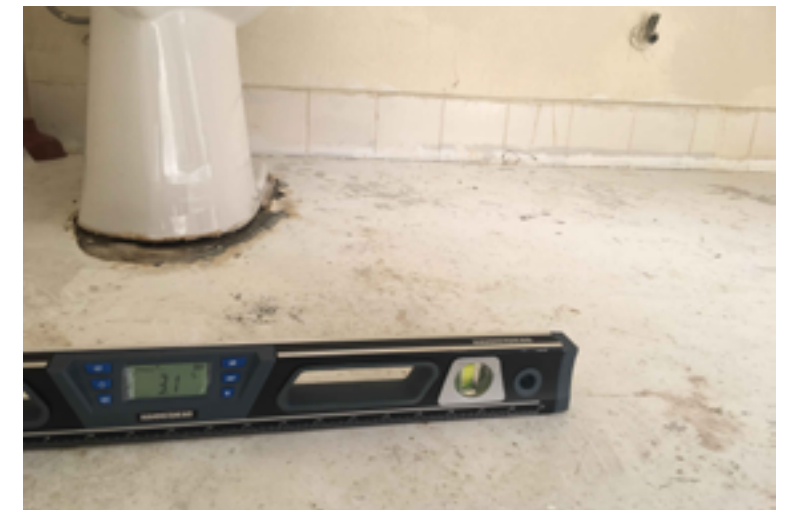
Excessive slope at restroom floor.

3.1.2	Provide gender neutral geometric sign at door	\$100	Immediate	
3.1.3	Add topping surface to reduce floor slope	\$500	December 2018	
	TOTAL OF INDIVIDUAL COSTS (will vary greatly depending on timing and grouping of repairs)	\$94,500

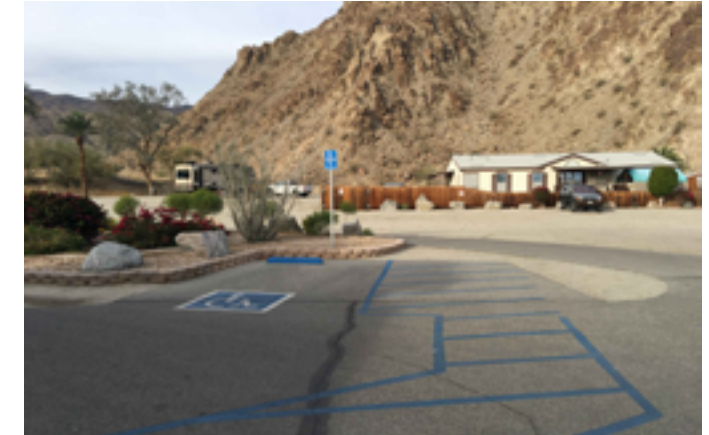
The Designated Accessible Parking Space near the Guard House at the Park entry is missing the “MINIMUM FINE \$250” sign, and does not have detectable warning where the loading zone crosses into a hazardous vehicle area.

*ACTION ITEM 1.3.2: Provide “Minimum Fine: \$250” signage at each Designated Accessible Parking Space as defined by CBC 11B-502.6.2; Recommendation is to replace all existing signage with the Caltrans R99 signage shown in the beginning of this report. Signage shall maintain 60” min. clearance where signs are located outside accessible routes, and 80” min. clear where located within accessible routes, as per CBC 11B-502.6.*

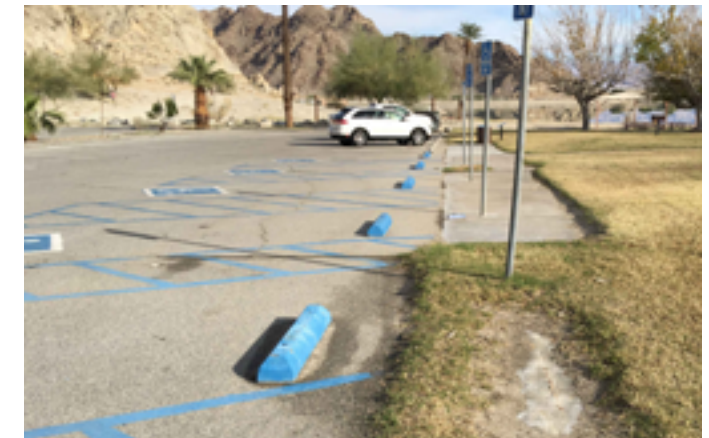
Designated Accessible Parking Spaces west of the Day Use area have a mix of compliant and non-compliant features. See action items.

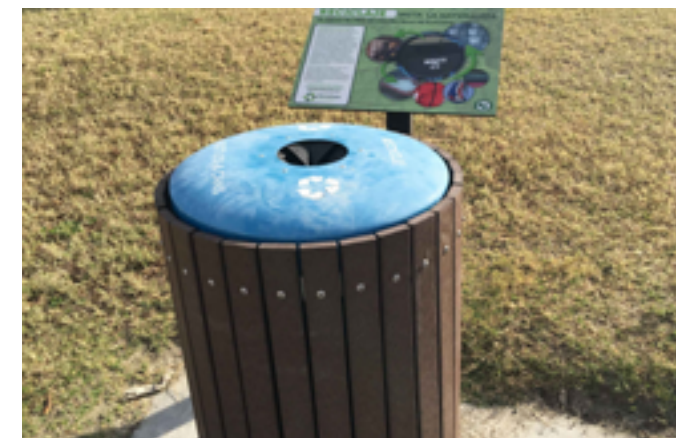
An informational sign about the importance of recycling, is impeded by the recycling receptacle itself.

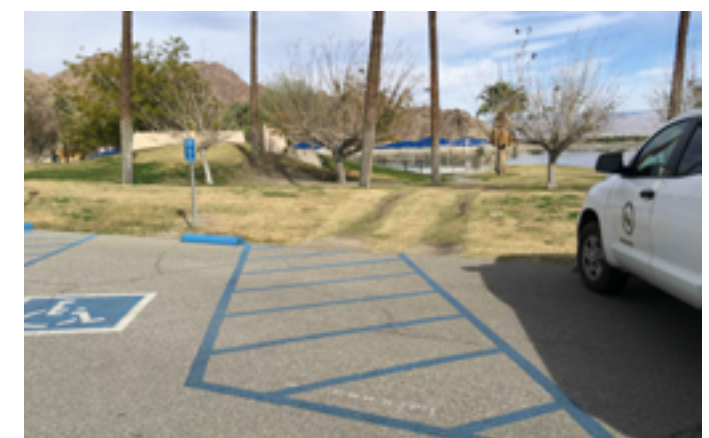
At the parking lot due south of the Day Use area, the loading zones do not connect to accessible routes heading to park amenities.

*ACTION ITEM 1.3.5: At the southernmost Designated Accessible Parking Spaces at the parking lot west of the Day Use area, as well as all of the Designated Accessible Parking Spaces located south of the lagoon, provide an accessible connection to park amenities. Currently, there is no accessible path beyond the loading zones. Per CBC 11B-502.7.1, parking spaces and access aisles/ loading zones shall be designed so that persons using them are not required to travel behind parking spaces other than to pass behind the parking space in which they parked.*

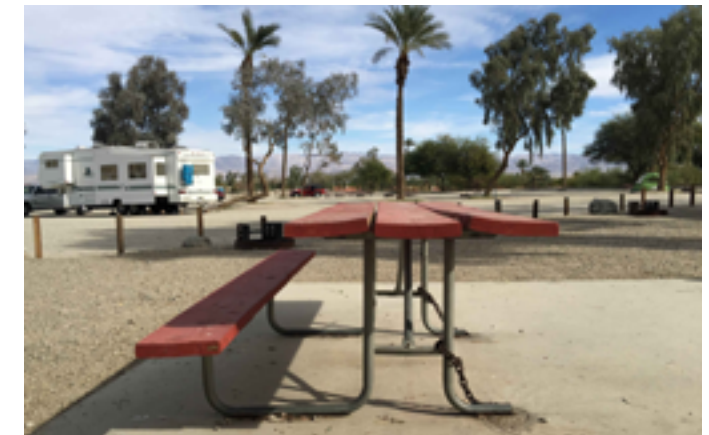
Existing picnic table within the Designated Accessible Campsite has a severely warped table top.

*ACTION ITEM 2.2.3: Replace the picnic table within the Designated Accessible Campsite to meet full compliance with the requirements of CBC 11B-902.*

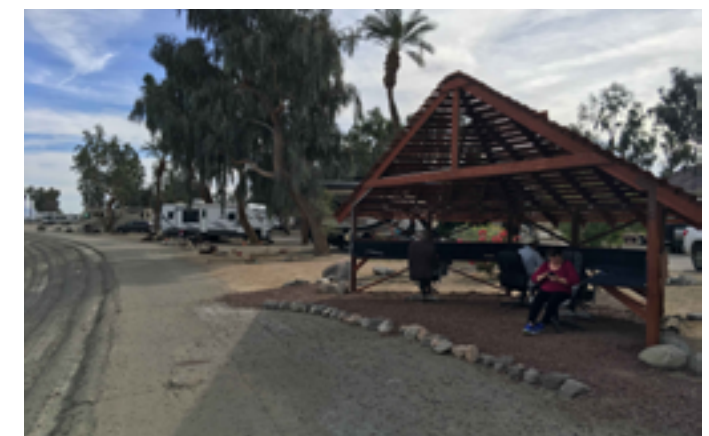
WiFi Hut within the RV portion of Lake Cahuilla does not currently provide an accessible path to the facility.

*ACTION ITEM 2.2.2: Provide an accessible route between designated accessible campsites and the closest adjacent sanitary facilities, as required by CBC-246.2. Extend accessible route to connect to the WiFi hut.*

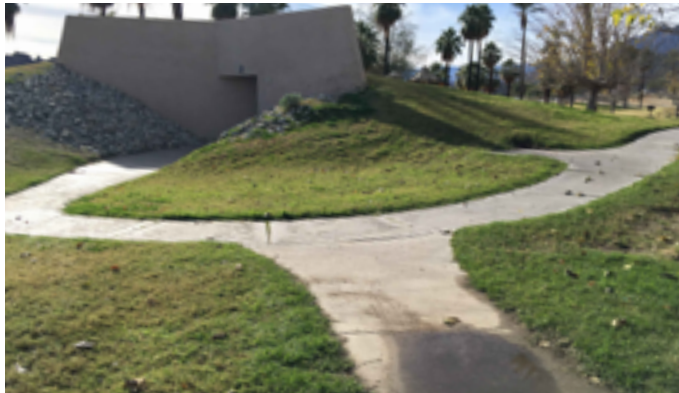
Steep, undulating walkway to restrooms. Standing water also present within walkway areas.

*ACTION ITEM 2.3.1: Provide a realigned circulation walkway to connect the Designated Accessible Parking Spaces with all provided amenities, including but not limited to playground, picnic table groupings, restrooms and lagoon. This will likely require a substantially different walkway location in order to accommodate accessibility requirements, given the existing sloped topography.*

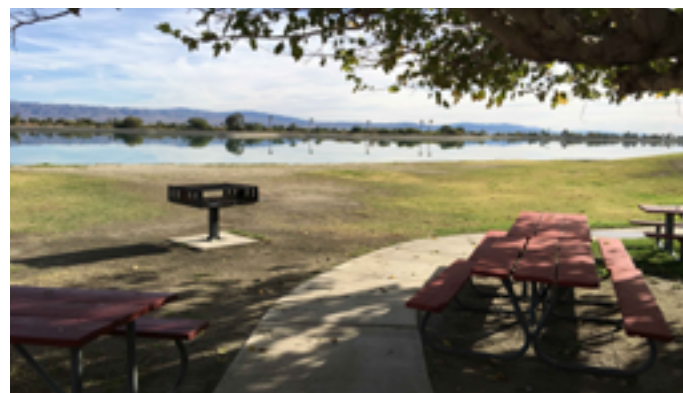
Non-accessible picnic tables and barbecues in shaded areas adjacent to walkways.

*ACTION ITEM 2.4.1: Provide at least one accessible picnic table in each grouping of tables, in compliance with CBC 11B-246.5 and CBC 11B-902.*

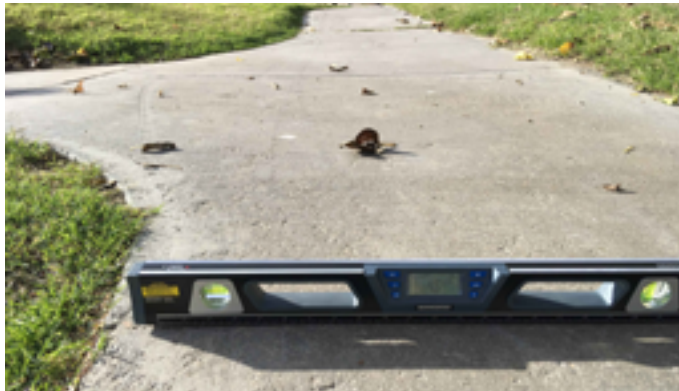
Typical example of excessive cross slope and running slope at walkway intersections.

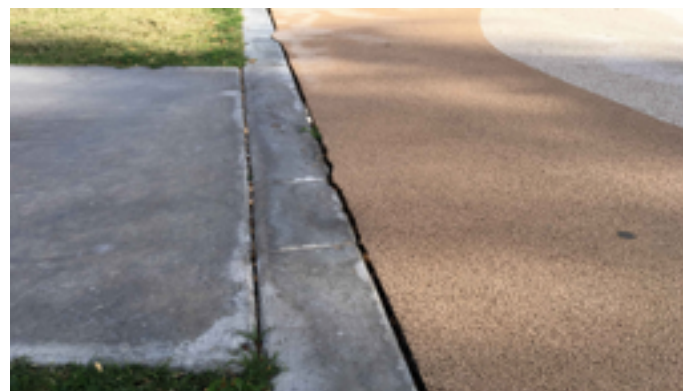
Playground surfacing is separating from perimeter curb, creating a gap larger than the maximum 1/2" allowable by accessibility codes.

*ACTION ITEM 2.3.5: Repair playground surfacing to eliminate gaps at accessible routes, as per CBC 11B-1008.2.6.1.*

2.3.4	Provide contrasting stripe at transfer steps	\$150	Immediate	
2.3.5	Repair playground surfacing where gaps are present adjacent to curbing	\$2,500	June 2018

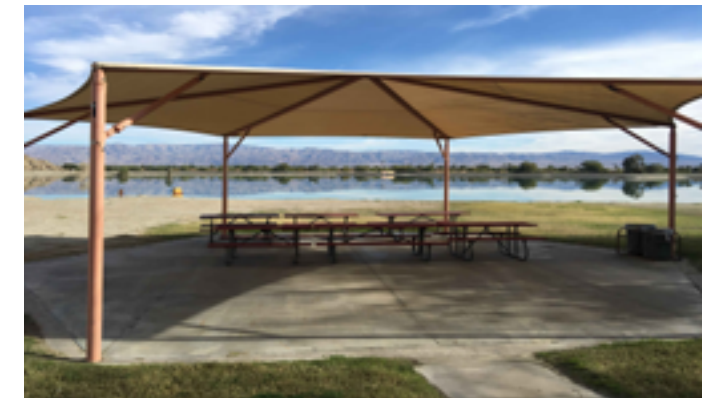
Non-accessible picnic tables are pushed together, with insufficient circulation clearances, at each of the four fabric covered picnic shelters near the waterfront.

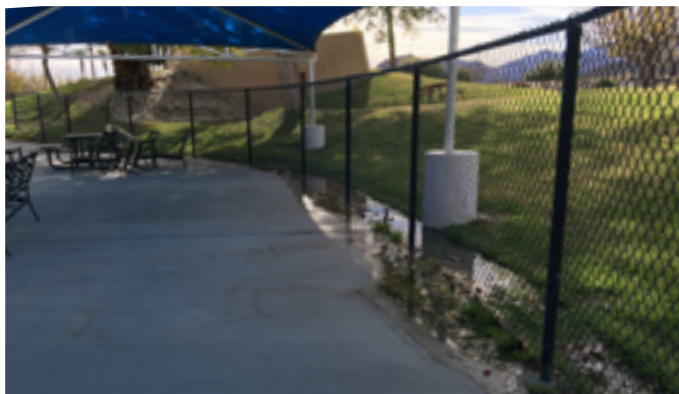
Non-recreational standing water is present within the circulation area.

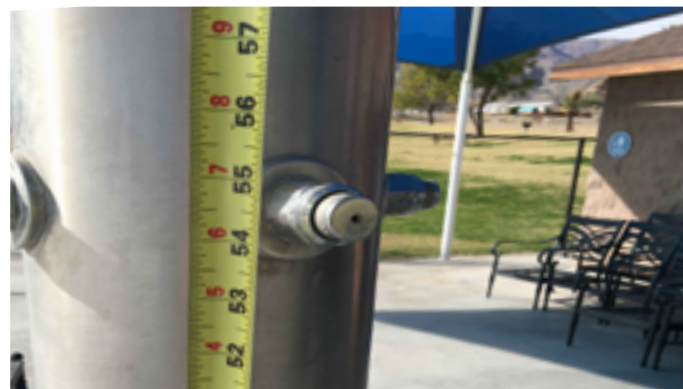
Shower actuation buttons are located outside of reach range for wheelchair users.

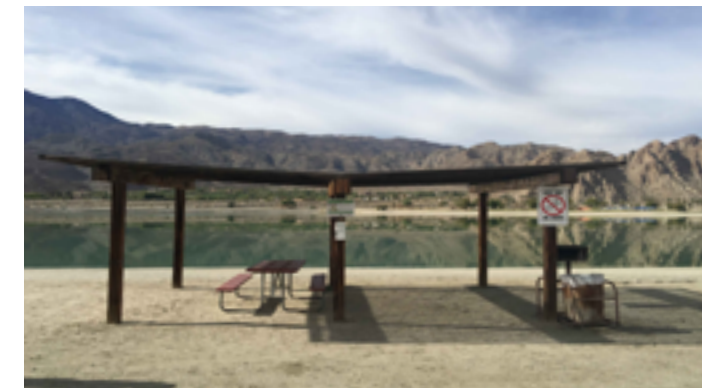
Example of one fishing shelter location with insufficient overhead clearance.

*ACTION ITEM 2.6.4: Reconstruct fishing shelter(s) to provide a consistent minimum vertical clearance of at least 80 inches above finish grade, or provide a cane warning rail in full compliance with CBC 11B-307.4*

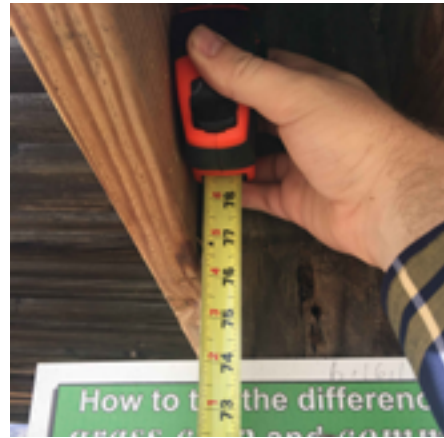
Low beam height at one shelter, as noted in Action Item 2.6.4

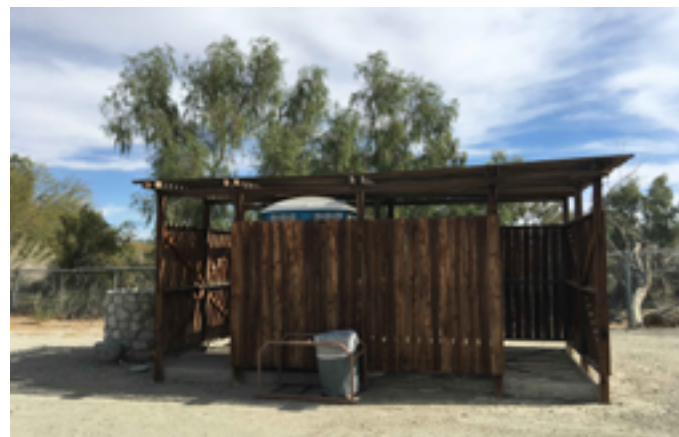
Typical example of portable restroom enclosure with no wheelchair-accessible portable toilet.

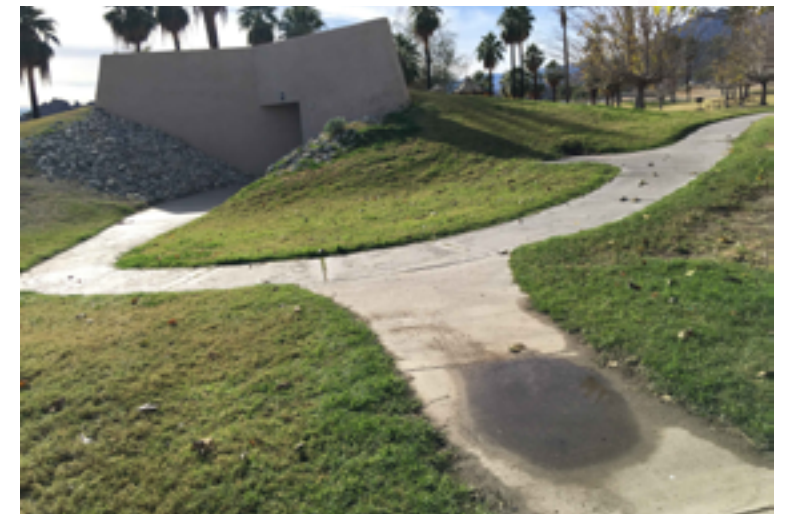
*Non-accessible walks leading to restroom.*

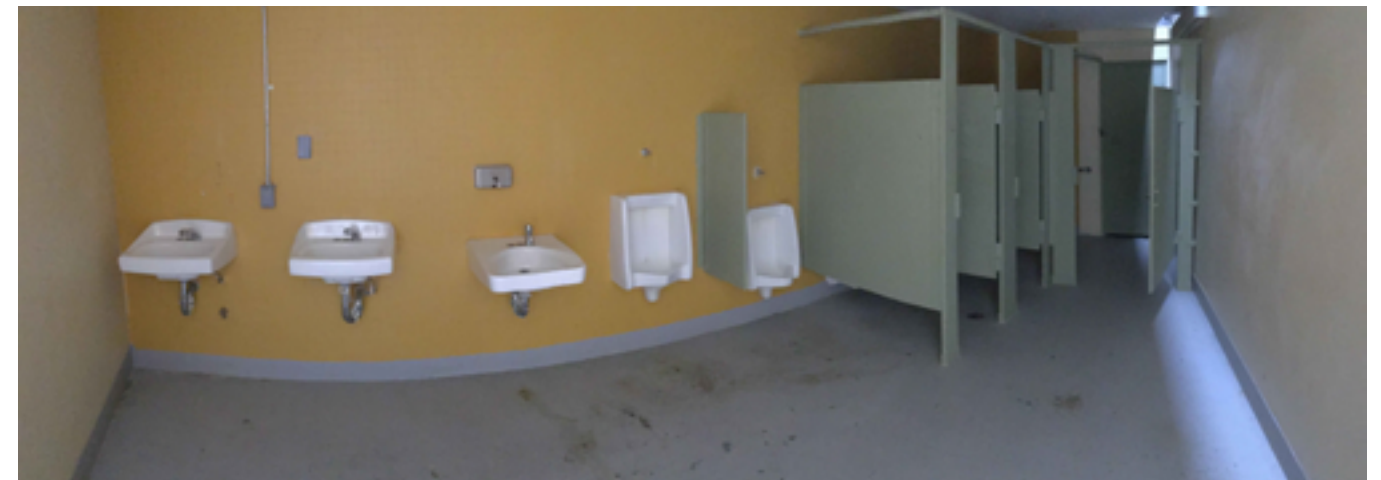
Panoramic view of inside men's restroom. Notable difference from previous restroom: no divider present between urinal and sink.

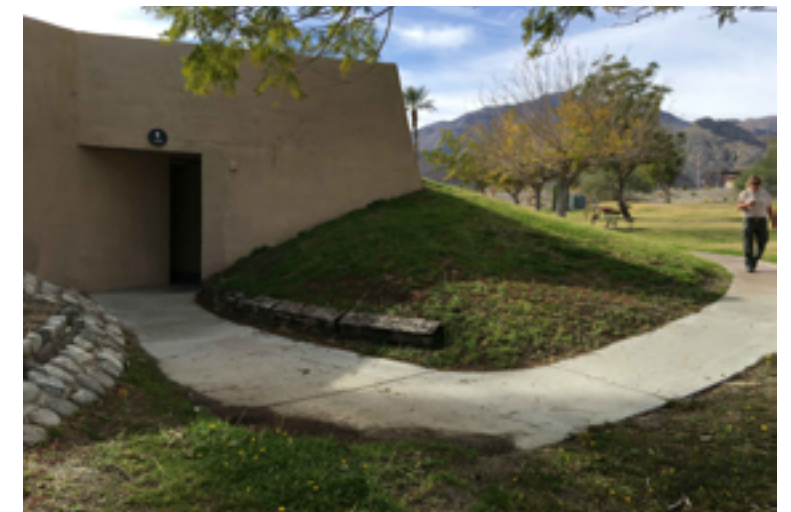
Non-accessible walks leading to restroom.

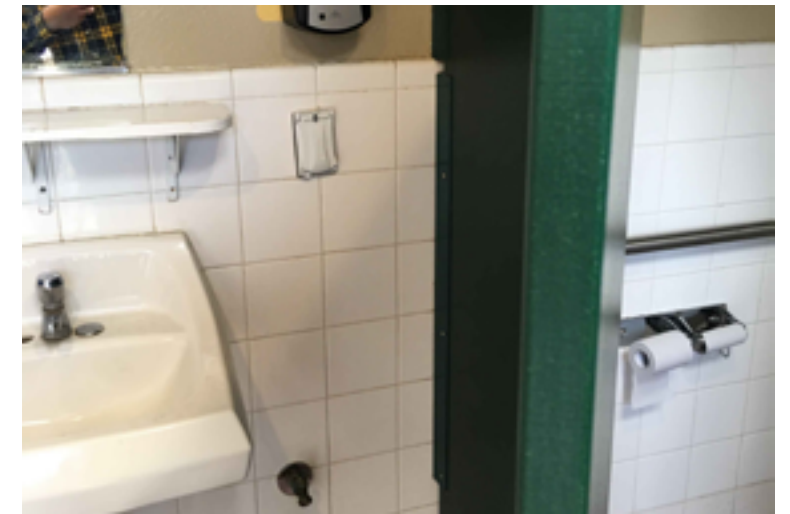
- Perimeter walkway does not provide accessible connection to adjacent amenities
- Toilet too close to side wall
- Side grab bar too short
- Mirror too high over sink
- Sink too close to wall
- Soap dispenser too high
- Shower head too high
- Excessive slope to floor drain

*Interior view.*

This restroom/ shower facility is generally not compliant and should be replaced when feasible.

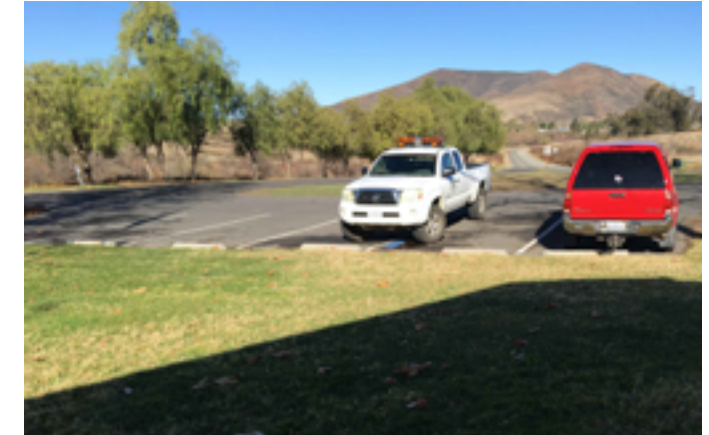
*There is no Designated Accessible Parking Space within the parking lot near the Guard House.*

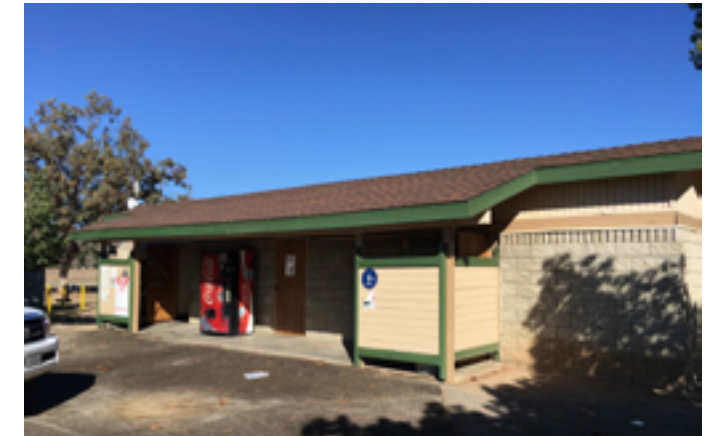
*There is no Designated Accessible Parking Space within the parking lot near the Campground C Restroom.*

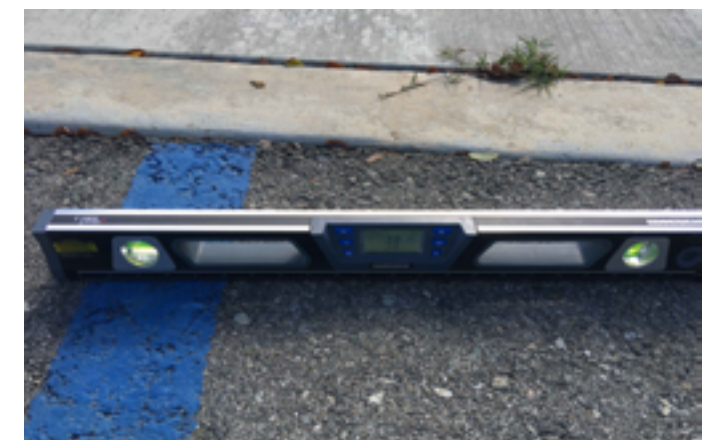
*Example of excessive slope observed within the passenger loading zone near the Splash Pad;*

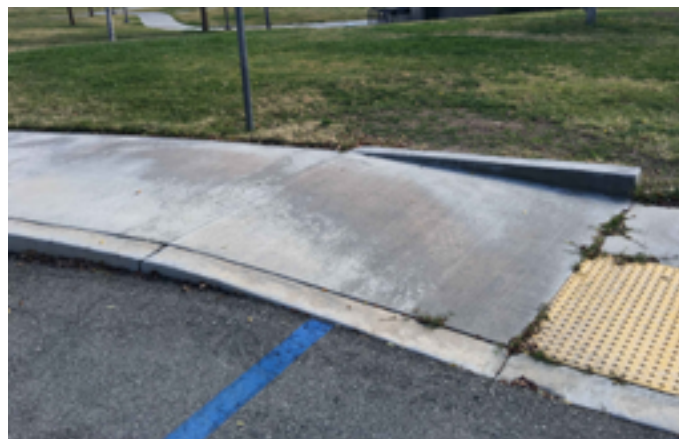
Asphalt near the zero-curb/ detectable warning area is built up, causing slope to exceed the 1:48 maximum within the loading zone of this parking space near the Splash Pad.

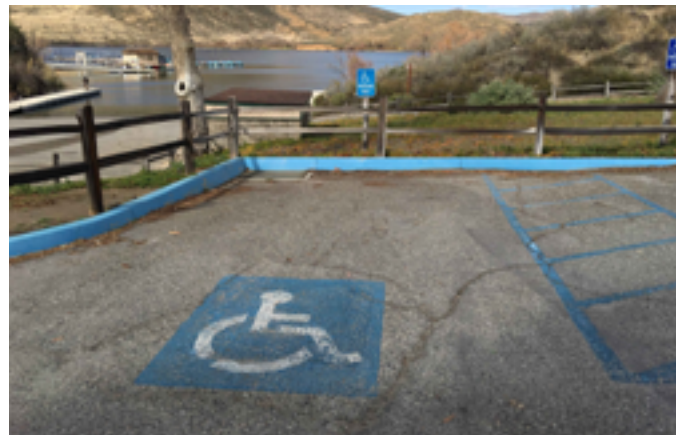
Provide access aisle at van width, and an accessible connection between designated accessible parking spaces and the amenities they are intended to serve.

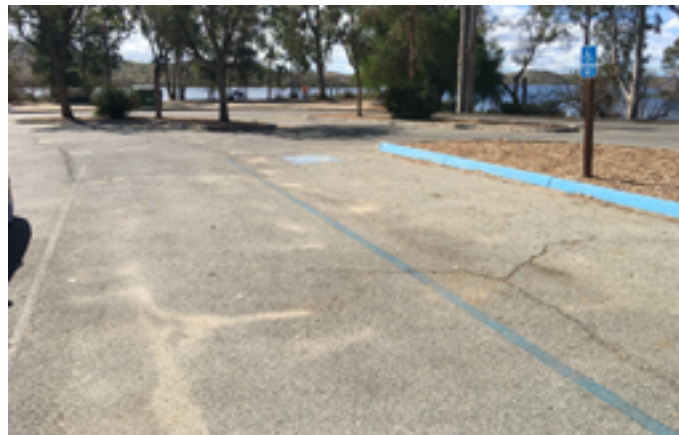
Provide an access aisle/ loading zone adjacent to Designated Accessible parking at Boat Launch areas.
