RIVERSIDE COUNTY REGIONAL PARK AND OPEN SPACE DISTRICT

# ACCESSIBILITY COMPLIANCE REPORT- 2018 UPDATE

MAY 31, 2018

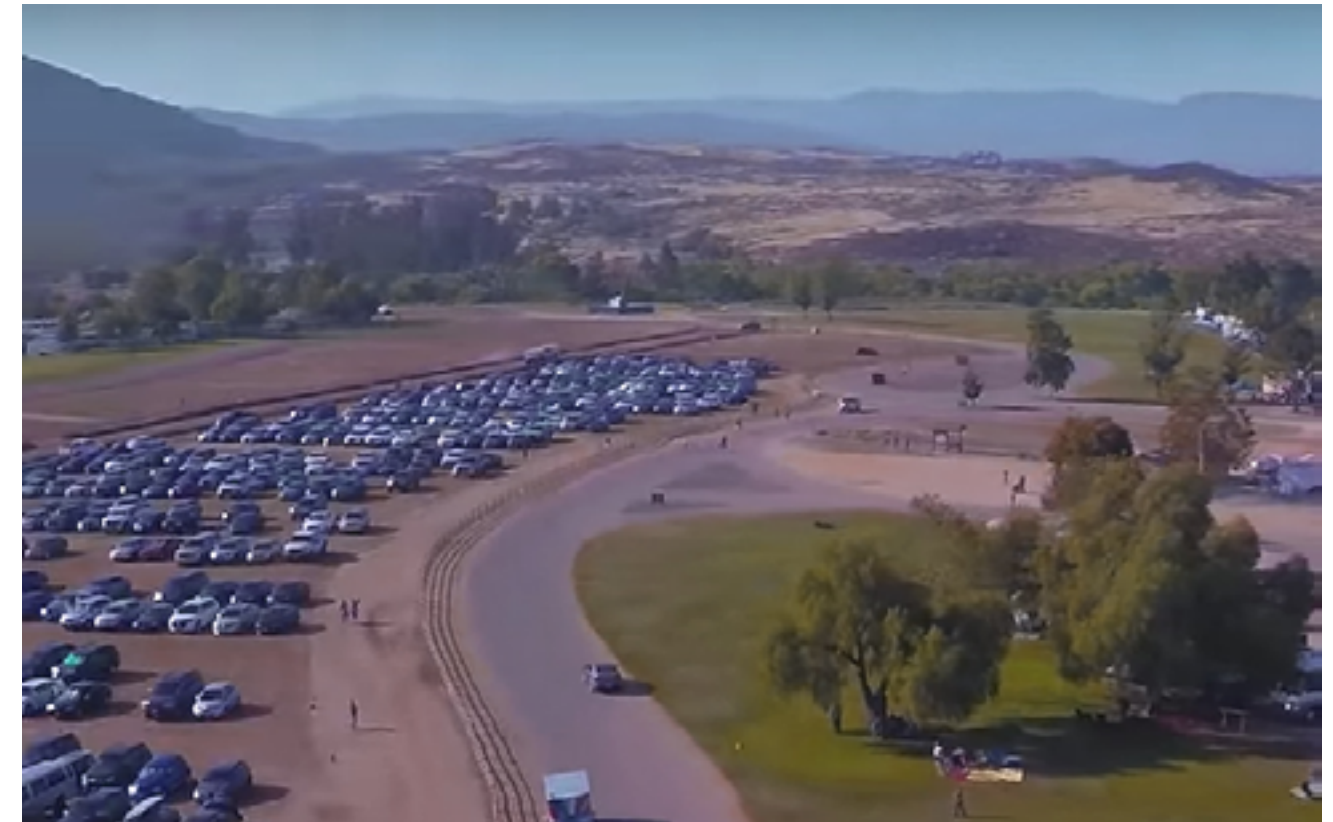
Screen shot from a YouTube video, showing overflow parking for the 2015 Temecula Valley Balloon & Wine Festival. Source: <https://www.youtube.com/watch?v=emn7KFy2vfA>

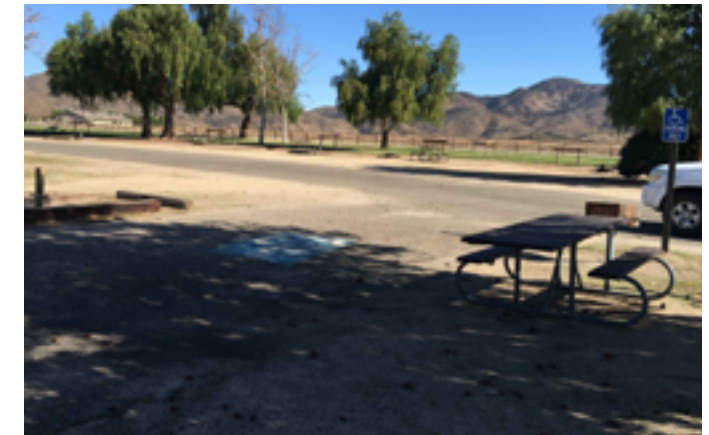
Existing Designated Accessible Campsite in Campground A.

*ACTION ITEM 2.1.3: Remove “Parking Only” signage and replace with an International Symbol of Accessibility sign, reflecting that the Designated Accessible Campsite as a whole is reserved for campers with disabilities.*

*ACTION ITEM 2.1.4: Replace the picnic table within the Designated Accessible Campsite to meet full compliance with the requirements of CBC 11B-902.*

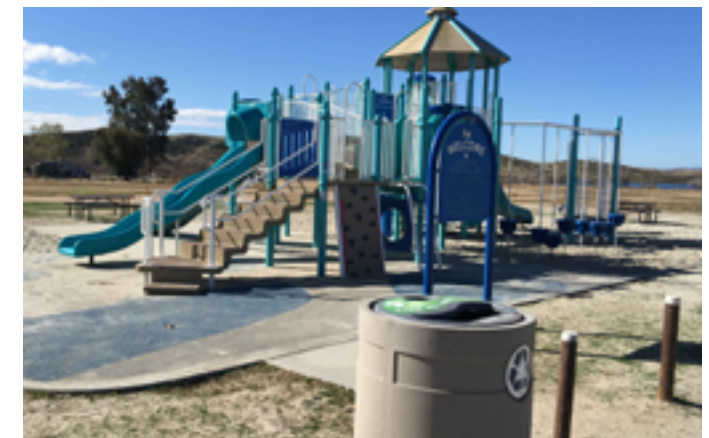
Existing Playground near Campground A.

*ACTION ITEM 2.1.6: Provide contrasting stripe at each transfer step on the playground, as per CBC 11B-1008.3.2.4*

*ACTION ITEM 2.1.7: Remove sand from rubber play surfacing to keep rubber surface slip resistant.*

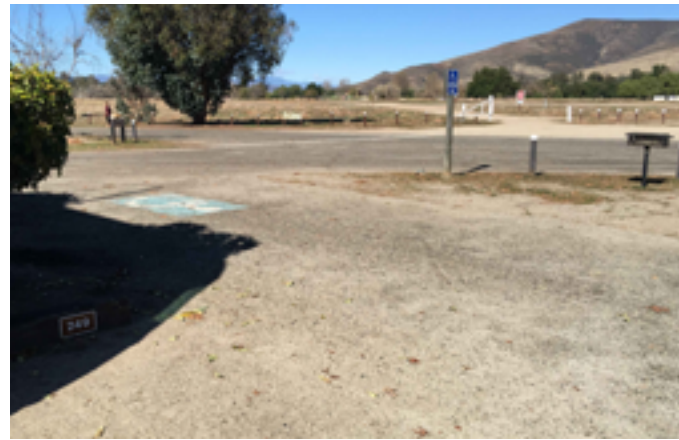
Designated Accessible Campsite within Campground B (249).

*ACTION ITEM 2.2.3: Remove "Parking Only" signage and replace with an International Symbol of Accessibility sign, reflecting that the Designated Accessible Campsite as a whole is reserved for campers with disabilities.*

*ACTION ITEM 2.2.4: Replace the picnic table within the Designated Accessible Campsite to meet full compliance with the requirements of CBC 11B-902.*

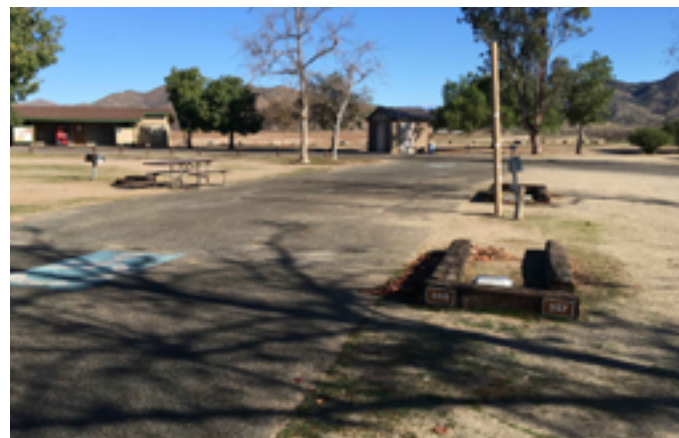
Designated Accessible Campsite within Campground C (356).

*ACTION ITEM 2.3.3: Remove "Parking Only" signage and replace with an International Symbol of Accessibility sign, reflecting that the Designated Accessible Campsite as a whole is reserved for campers with disabilities.*

*ACTION ITEM 2.3.4: Replace the picnic table within the Designated Accessible Campsite to meet full compliance with the requirements of CBC 11B-902.*

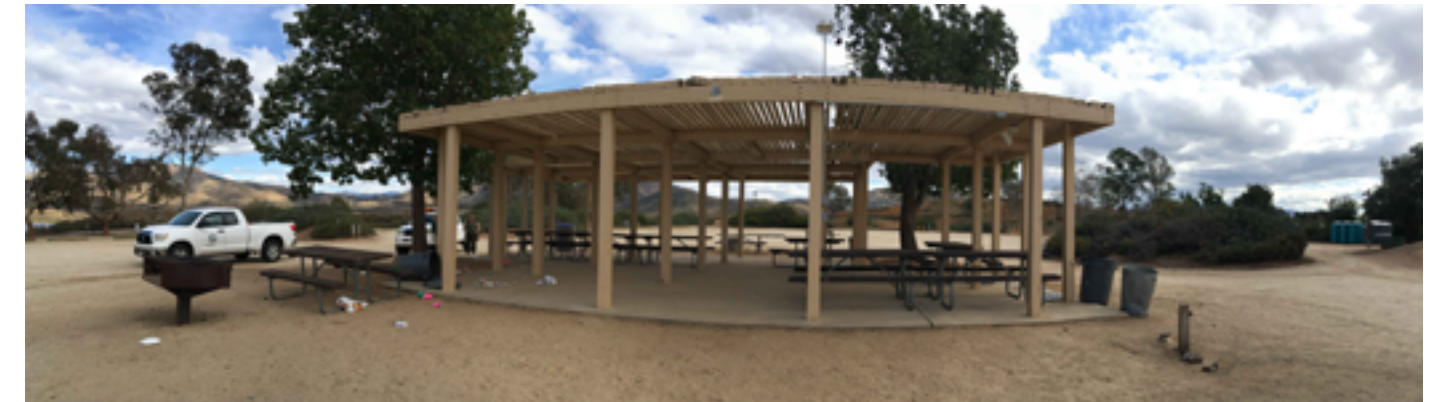
The Primitive Group Campground at Lake Skinner contains a large picnic shelter with adjacent barbecues. Portable toilets are provided, including one wheelchair accessible model.

*ACTION ITEM 2.4.1: Provide at least one accessible picnic table in each grouping of tables, in compliance with CBC 11B-246.5 and CBC 11B-902.*

*ACTION ITEM 2.4.2: Provide wheelchair access for side approach at the barbecue, within the reach range requirements of CBC 11B-308.3*

*ACTION ITEM 2.4.3: Renovate concrete slab to eliminate changes in level, wide cracks, etc., in full compliance with CBC 11B-302.*

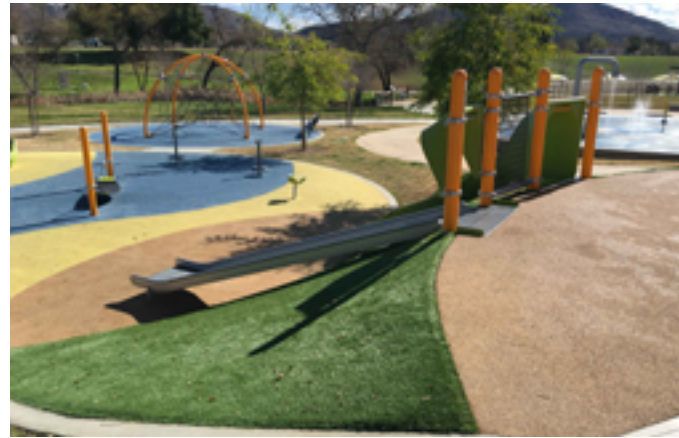
*Play surface transitions to a steep incline with no provision for edge protection, to prevent wheelchairs from accidentally overtaking the top of slope.*

*ACTION ITEM 2.5.2: Provide edge protection where playground surfacing transitions to steep downward slopes adjacent to level areas. Provide signage to warn visitors of steep slopes.*

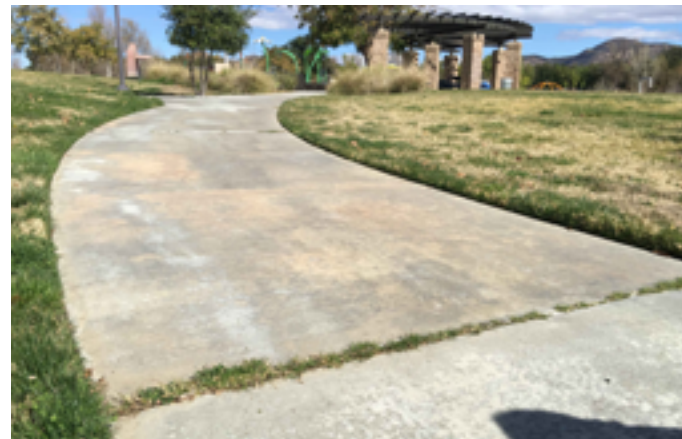
*Another view of non-compliant sloped walkway. Also, some joints appear to exceed gap tolerances, but gaps are currently being filled with lawn.*

*ACTION ITEM 2.5.3: Provide a realigned circulation walkway to connect the Designated Accessible Parking Spaces with all provided amenities, where slope exceeds 1:48 at wheelchair turning zones.*

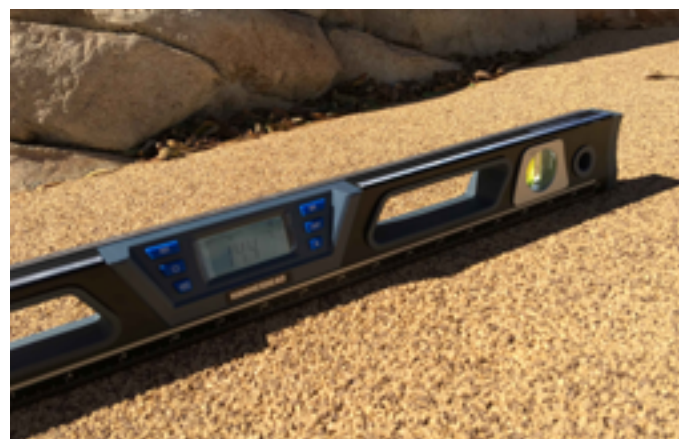
*Another portion of play surfacing located parallel to an access ramp far exceeds allowable ramp slope.*

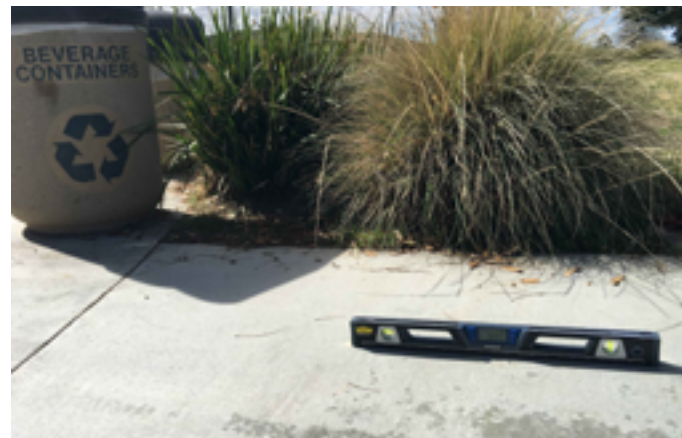
*Portions of the pedestrian route exceed 1:20 without the presence of handrails nor landings. Adjacent path intersections also exceed maximum slope for wheelchair turning.*

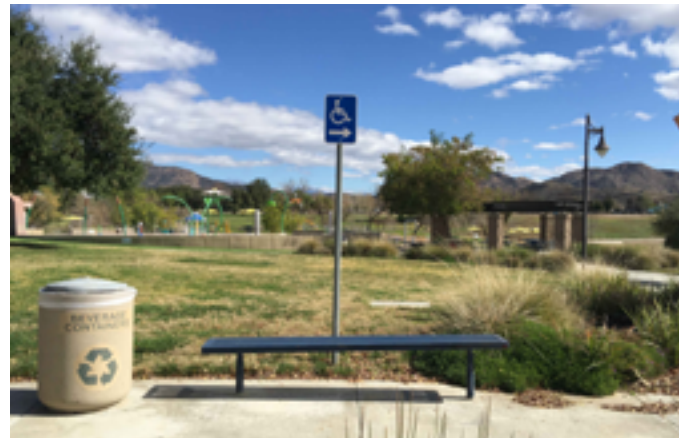
*Replace benches with models providing back support, adjacent wheelchair companion seating, and mounted on a level surface so that the entire bench falls within the acceptable height range.*

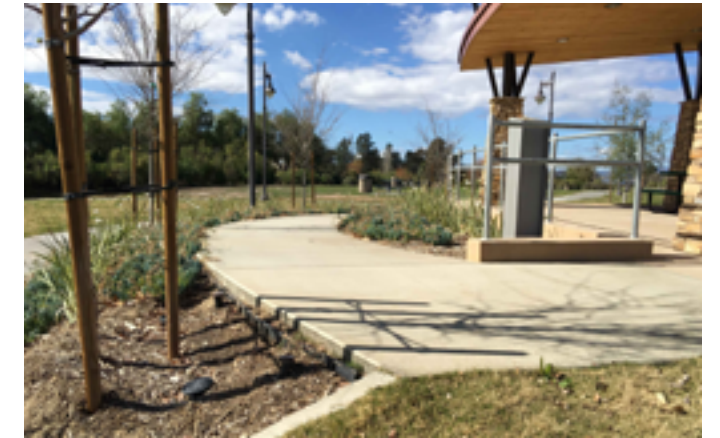
*Edge protection is needed at walkway leading up to amphitheater picnic shelter.*

*ACTION ITEM 2.6.2: Provide edge protection where walkway falls off toward adjacent planter.*

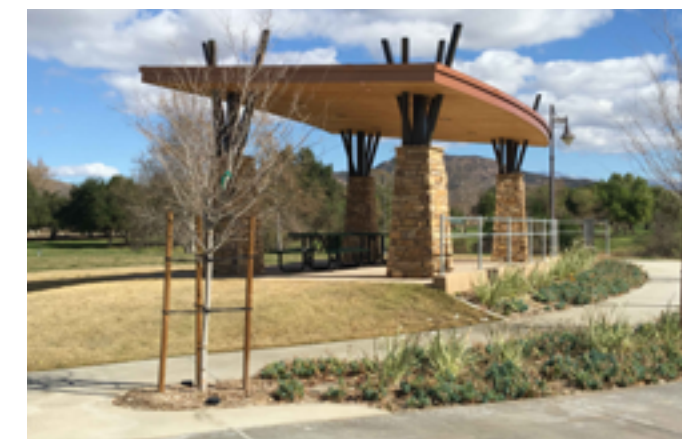
*Where sloped walkway meets adjacent path, the turning space is somewhat ambiguous and potentially exceeds maximum allowable cross slope for wheelchair turning space.*

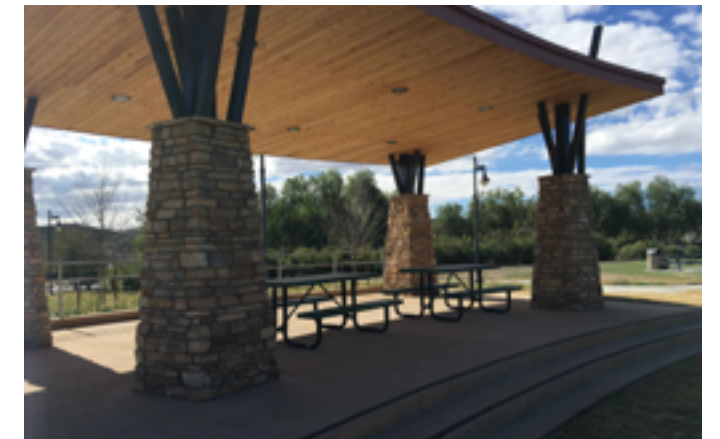
*Stairs at amphitheater picnic shelter are absent of handrails.*

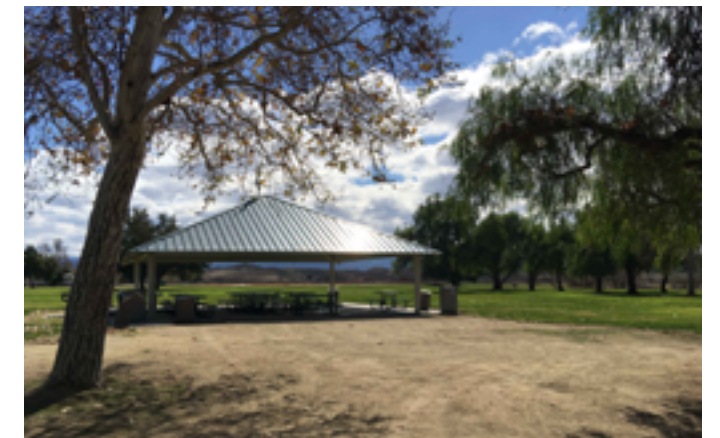
*Large group picnic shelter with no accessible path leading to it.*

*ACTION ITEM 2.7.1: Provide an accessible connection to Shelter #2 from the closest designated accessible parking spaces and other park amenities, in compliance with CBC 11B-206 and 11B-246.5.*

*ACTION ITEM 2.7.2: Provide at least one accessible picnic table in each grouping of tables, in compliance with CBC 11B-246.5 and CBC 11B-902.*

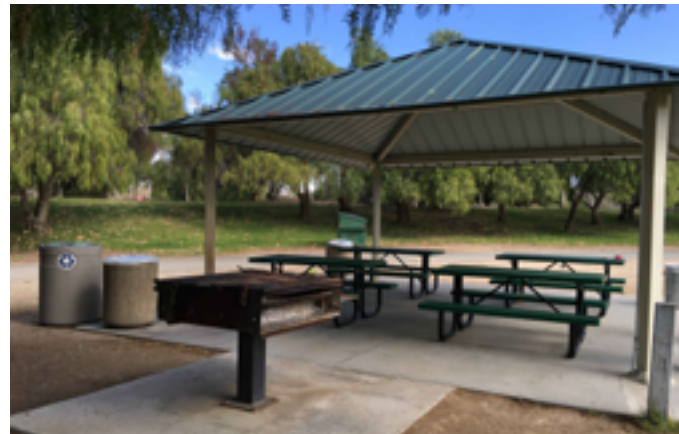
*Group picnic shelter at Day Use Area #2 with no accessible path leading to it.*

*ACTION ITEM 2.8: See all Action Items from 2.7 above.*

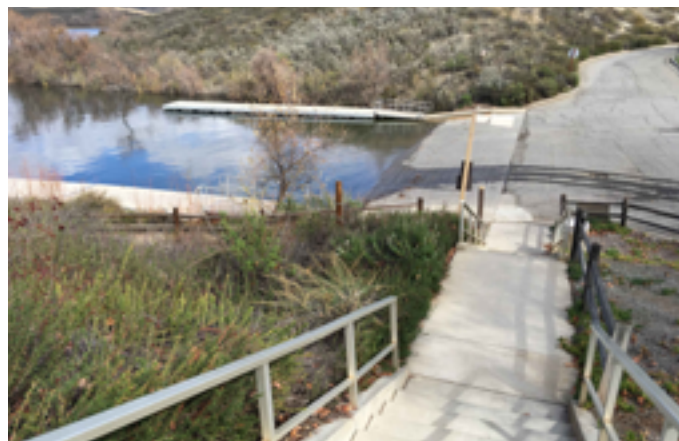
*This portion of the park contains extreme elevation changes, making the accommodation of accessible features very difficult.*

*ACTION ITEM 2.9.1: Develop a long term plan to completely renovate this area to remove major access barriers. Provide interim signage indicating that this area is generally not accessible.*

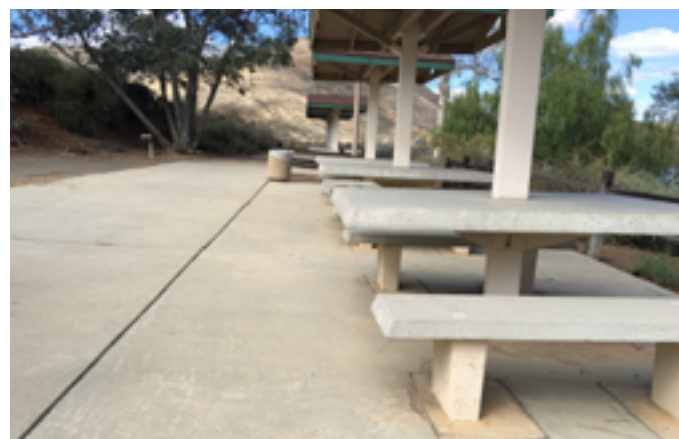
*The entire area contains excessive running and cross slopes.*

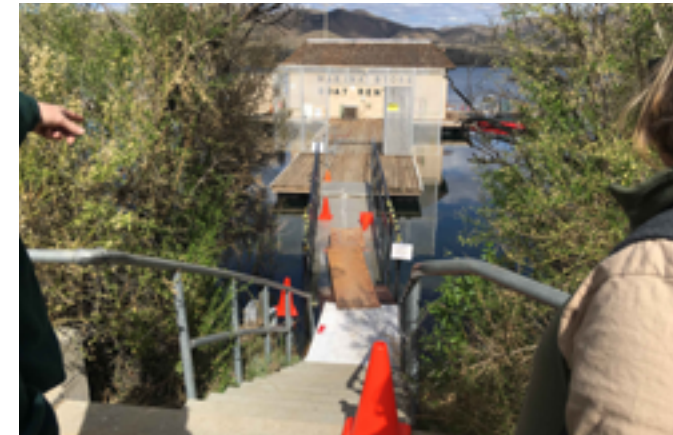
*The only way to currently access the marina building is by stairs.*

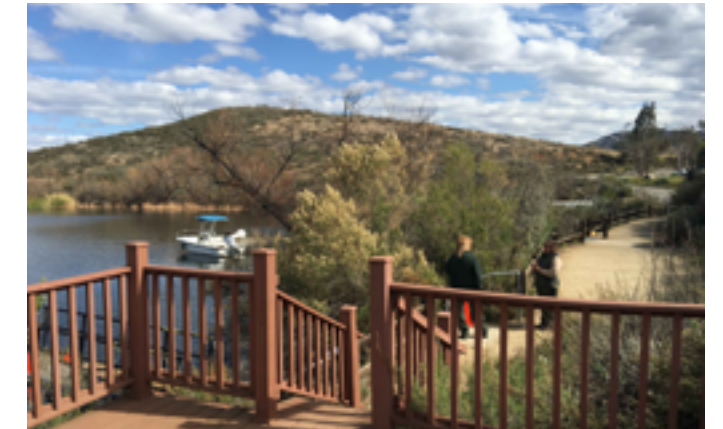
*More examples of non-accessible features at or near Boat Launch #1.*

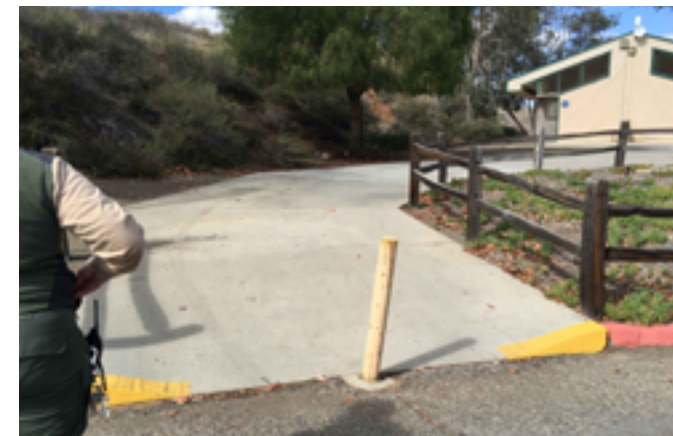
*Major topographic hurdles stand in the way of accessibility improvements.*

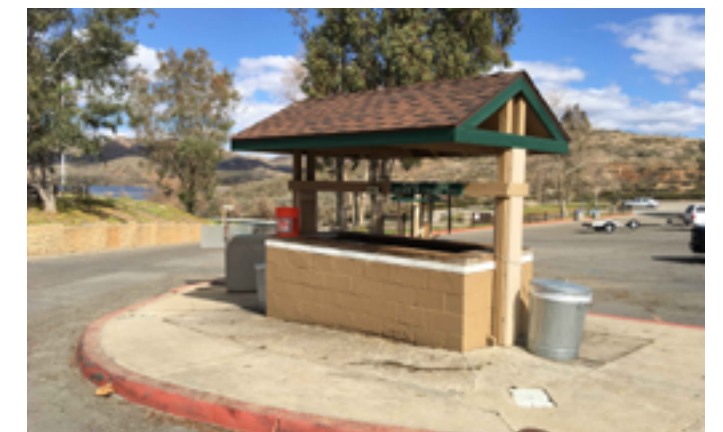
*This fish cleaning station cannot be made accessible until the parking lot in which it is placed receives major renovations, likely including terracing.*

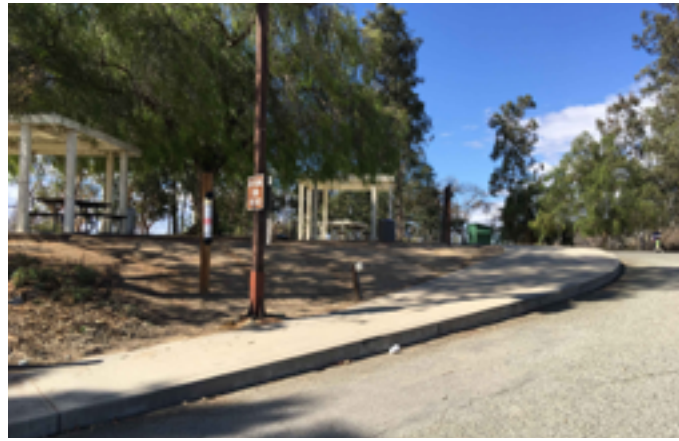
The walkway leading to the boat launch is in excess of allowable ramp steepness.

*ACTION ITEM 2.10.1: Develop a long term plan to completely renovate this area to remove major access barriers. Provide interim signage indicating that this area is generally not accessible.*

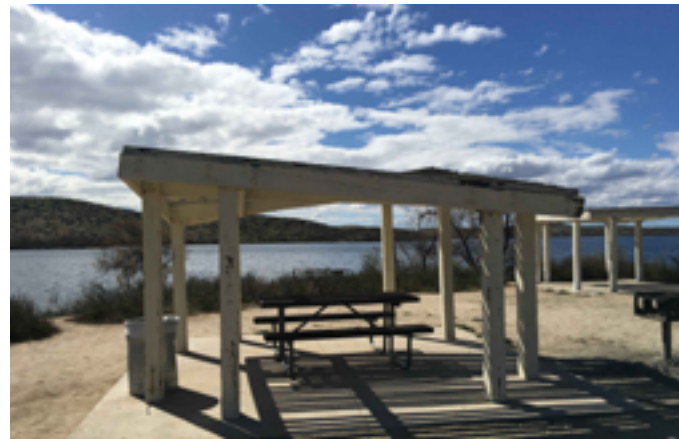
Many shelters have beams as low as 63" above finish grade, and would need to be removed and replaced to eliminate vertical clearance issues.

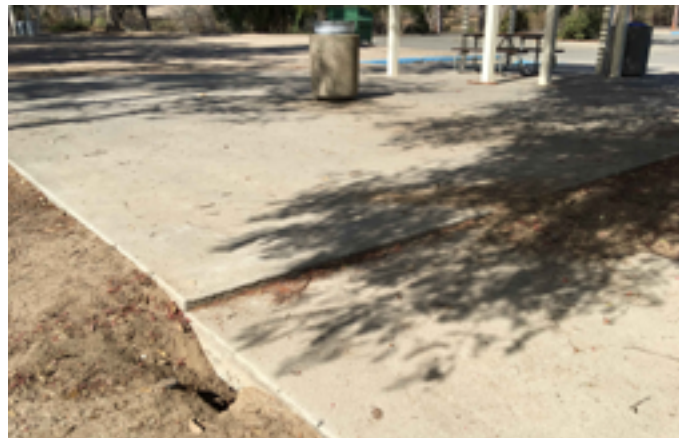
Walk surfaces include major vertical "steps" requiring removal and replacement.

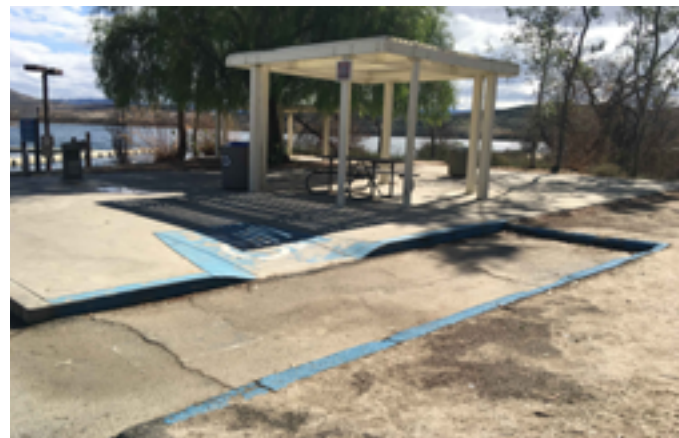
This non-compliant curb ramp leads wheelchair users directly to and from a hazardous vehicle zone.

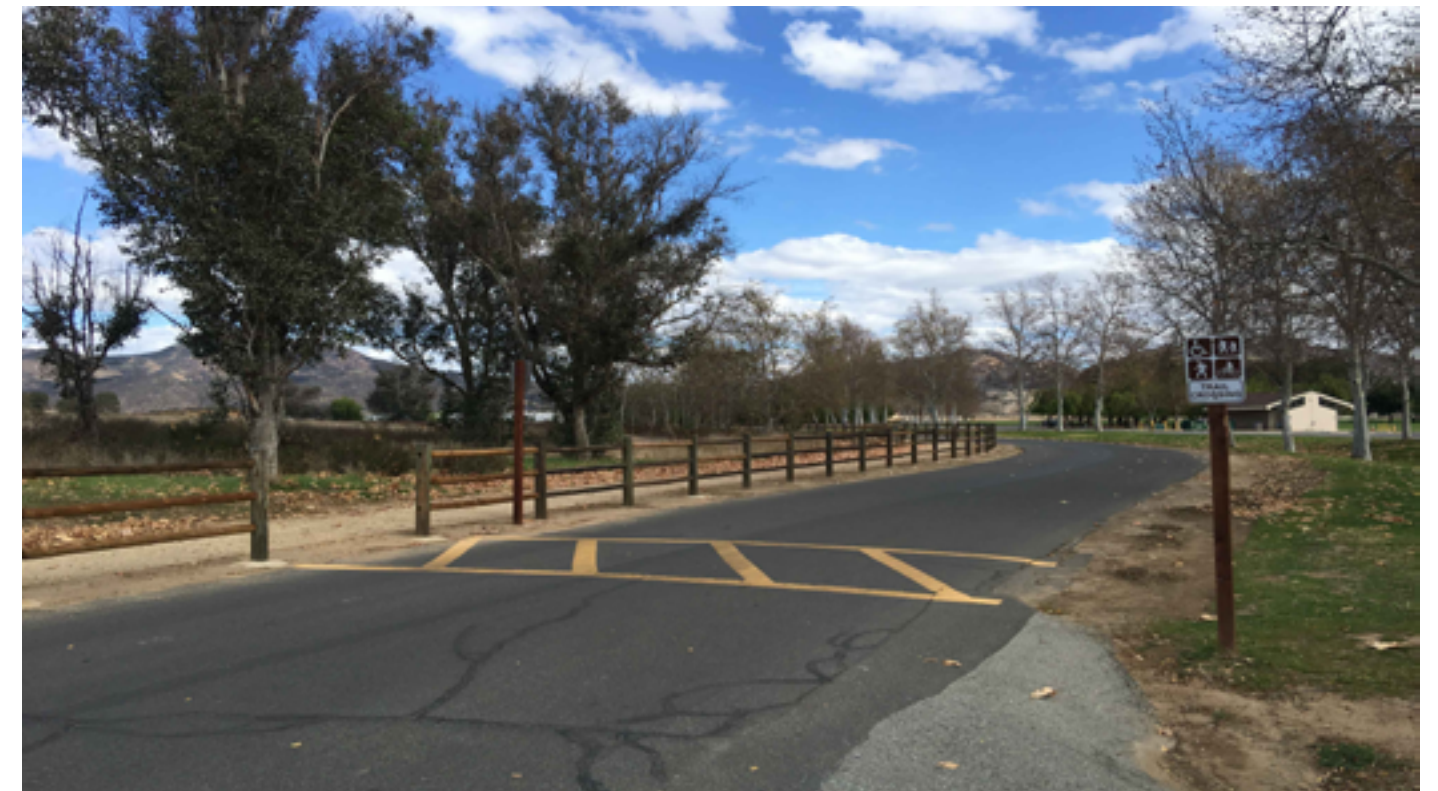
## 2.11 TRAILS

The California Building Code currently states that trails, paths, and nature walk areas, or portions of them, shall be constructed with gradients permitting at least partial use by wheelchair occupants. (CBC 11B-246.7) Currently, Lake Skinner has crossings, like the one pictured above, that indicate accessible trail crossing. However, these crossings do not provide the detectable warnings required at hazardous vehicle areas.

*ACTION ITEM 2.11.1: Provide detectable warnings as per CBC 11B-247.1.2.5, complying with Sections 11B-705.1.1 and 11B-705.1.2.5.*

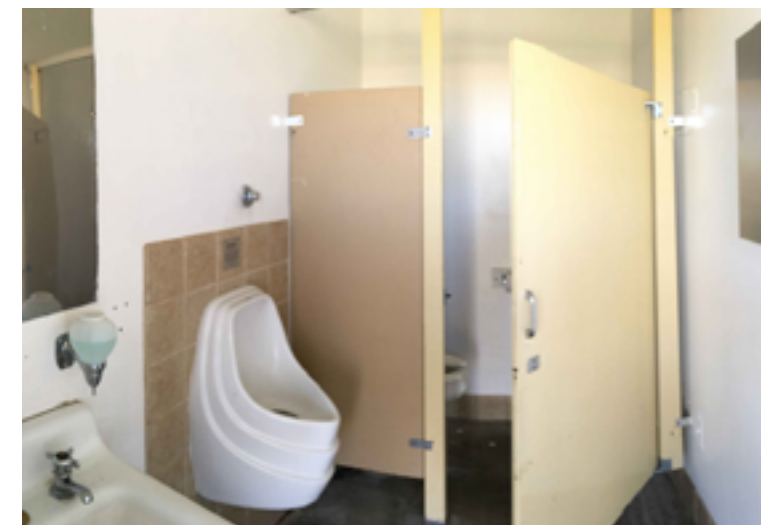
- Perimeter walkway has excessive slope, threshold, not connected to parking
- Geometric signage mounted too high
- Sink plumbing not wrapped
- Soap dispenser and mirror too high
- Interior floor dimensions not suitable for wheelchair circulation
- Recommend adding "STAFF ONLY" sign at left room

Interior view of restroom.

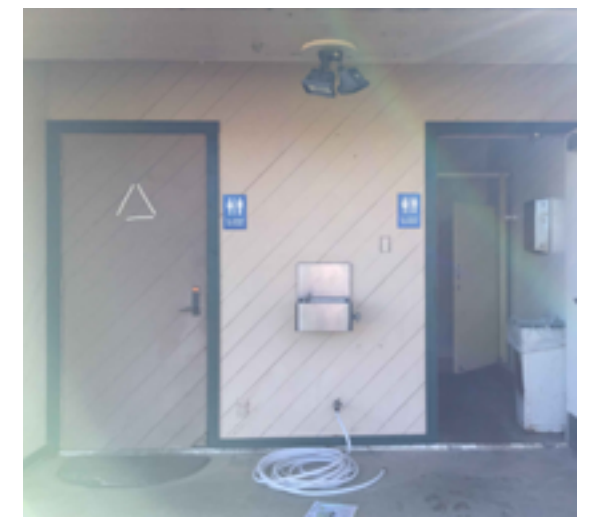
Exterior view of restroom entry.

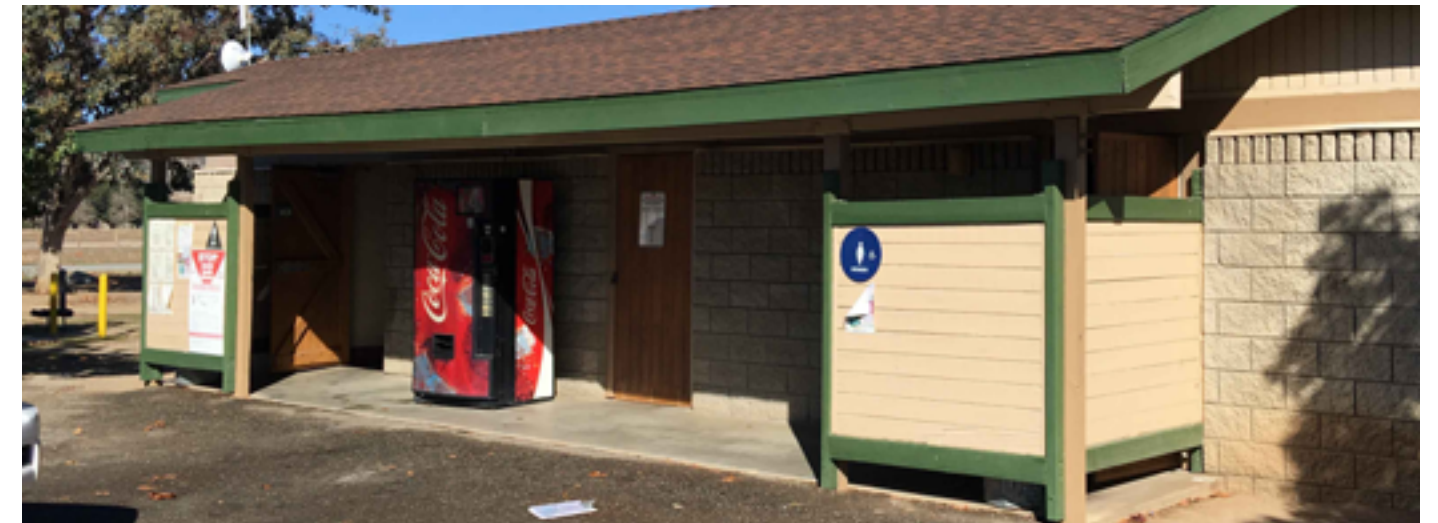
Exterior view of restroom.

- Side grab bar too short
- Paper towels dispensed too high
- Sink unit does not allow forward wheelchair approach
- Shower seat too high (19" max allowed)
- Shower grab bar should not be mounted above seat
- Excessive slope to floor drains
- Urinal rim too high
- Geometric sign too low
- Drinking Fountain not high-low

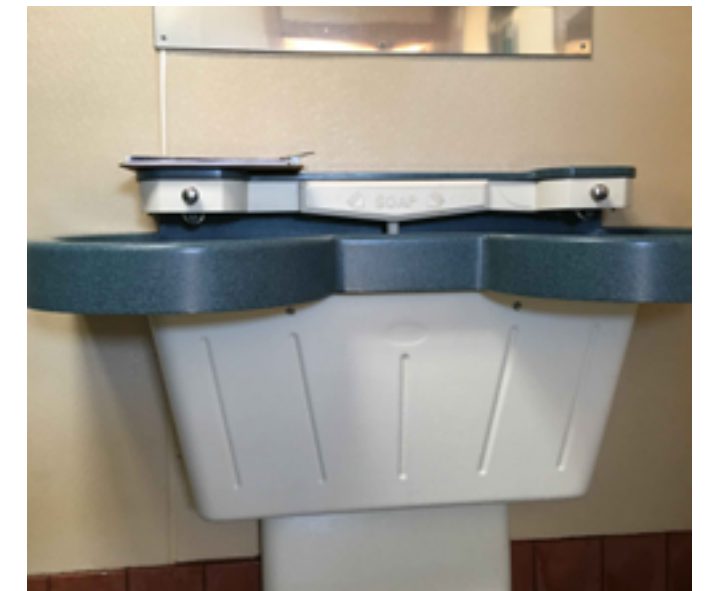
Non-standard, non-accessible sink within restrooms.

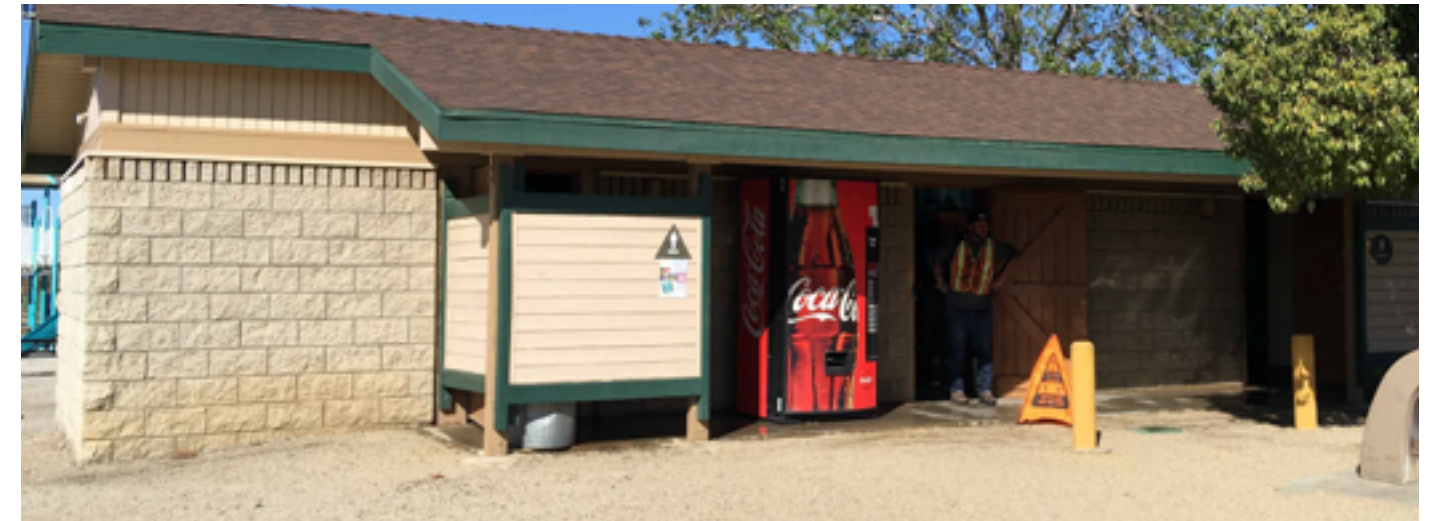
Exterior view of restroom.

- Toilet paper mounted too far from toilet (16" observed/ 9" max allowed)
- Side grab bar too short
- Paper towels dispensed too high
- Sink unit does not allow forward wheelchair approach
- Shower seat too high (19" max allowed)
- Grab bar mounted above shower seat (not allowed per CBC 11B-608.3.2)
- Bench too narrow (20" min required)
- Excessive slope to floor drains
- Urinal rim too high
- Geometric sign too low
- Drinking Fountain not high-low

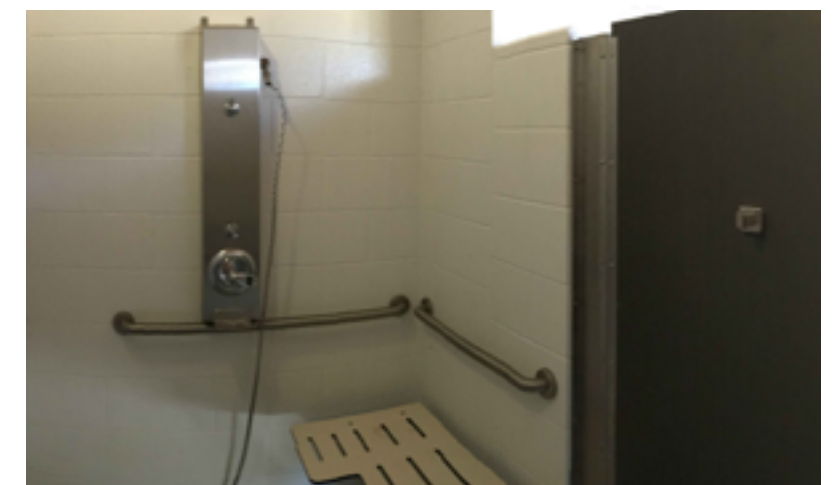
Grab bar above improperly mounted shower seat.

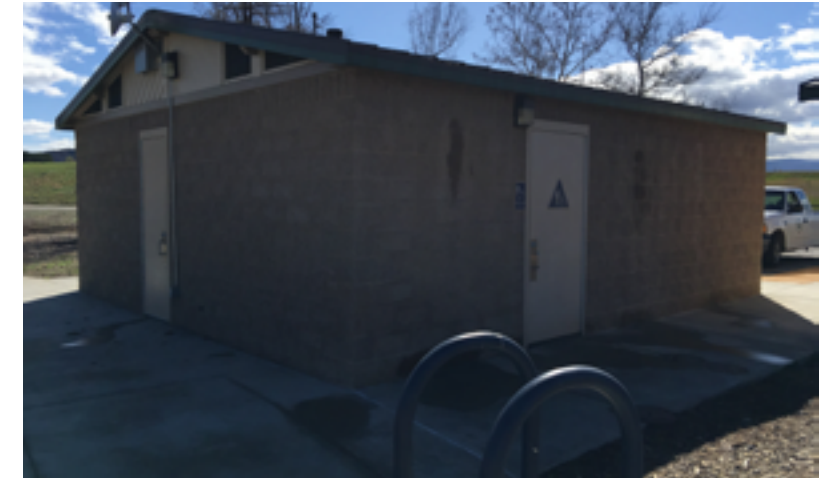
- Grab bar should not be above the shower seat as per CBC 11B-608.3.2

Exterior view of restroom.

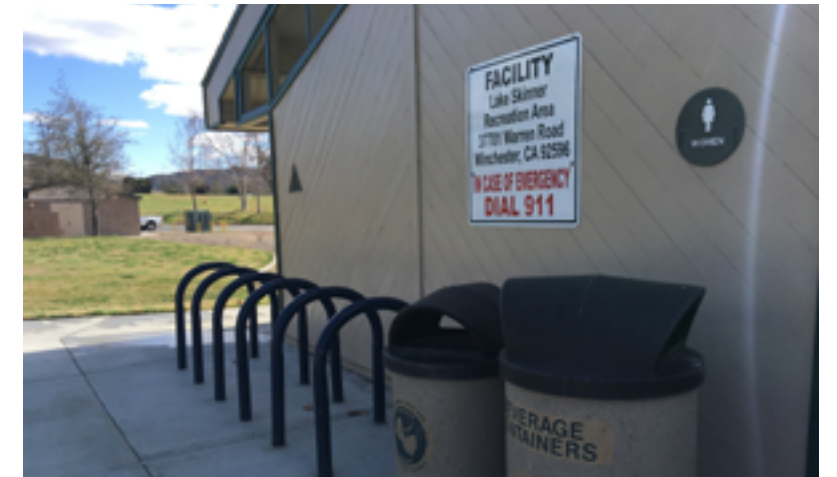
- Geometric Signage mounted too high.
- No accessible toilet compartment provided
- Soap dispensers and mirrors mounted too high above sink
- Sink plumbing not wrapped
- Urinal rim too high

Directional signage shall be mounted near all entry points to this restroom, directing park users to the adjacent "New Splash Pad" restroom, where accessible features are located.

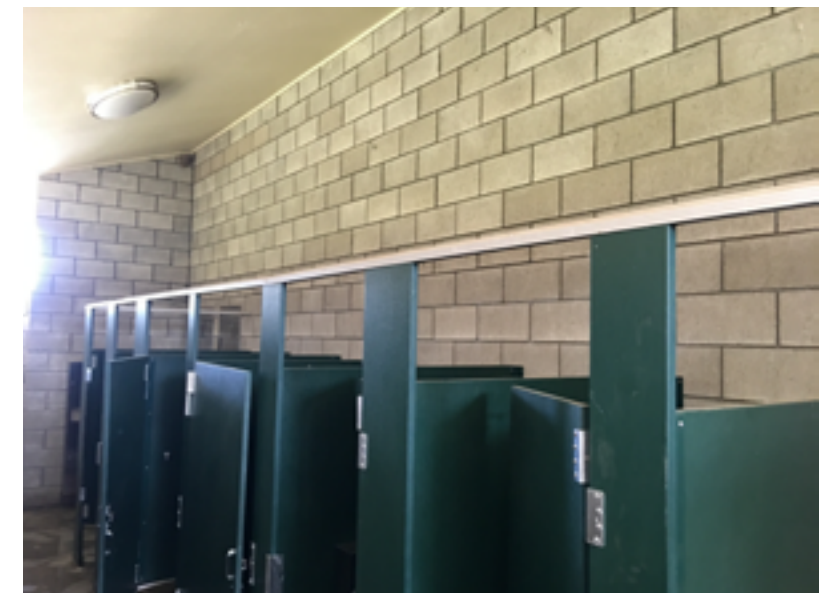
Interior view of building.

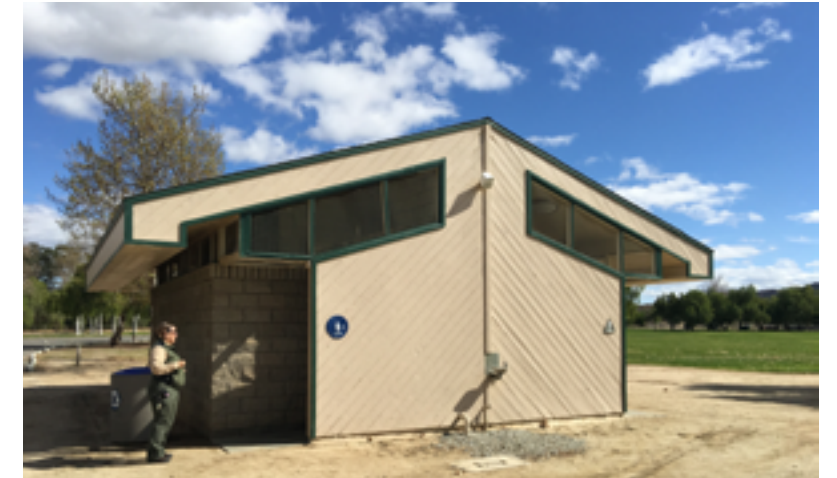
- No accessible toilet compartment provided
- Excessive slope in restroom floor
- Soap dispensers and mirrors mounted too high above sink
- Sink plumbing not wrapped
- Urinal rim too high
- Urinal/sink partition obstructs forward wheelchair approach
- Exterior drinking fountain not high/low model

Exterior view of restroom.

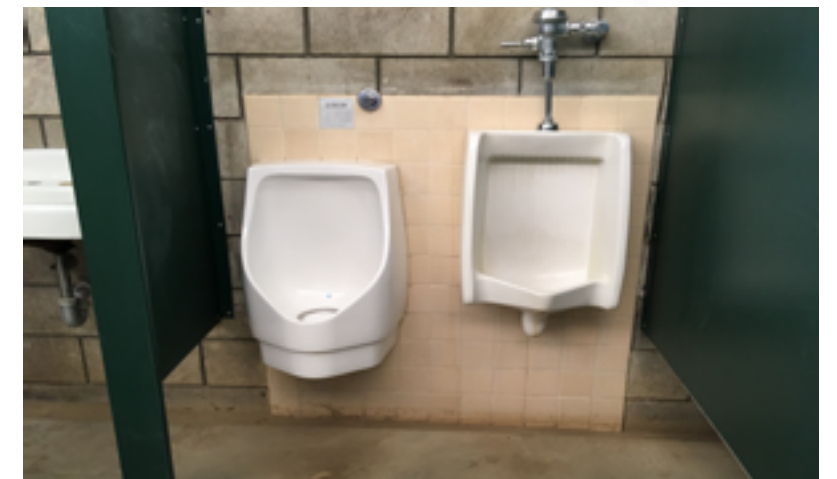
The absence of a splash guard/modesty partition between urinals allows for forward wheelchair approach.

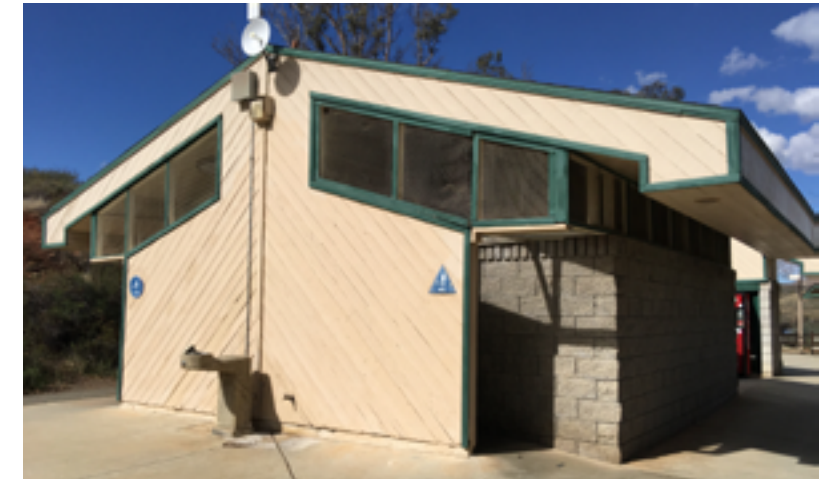
- Geometric signage mounted too high
- Sink plumbing not wrapped
- Entry walkway slope too steep
- Drinking fountain not high/low

Exterior view of restroom.

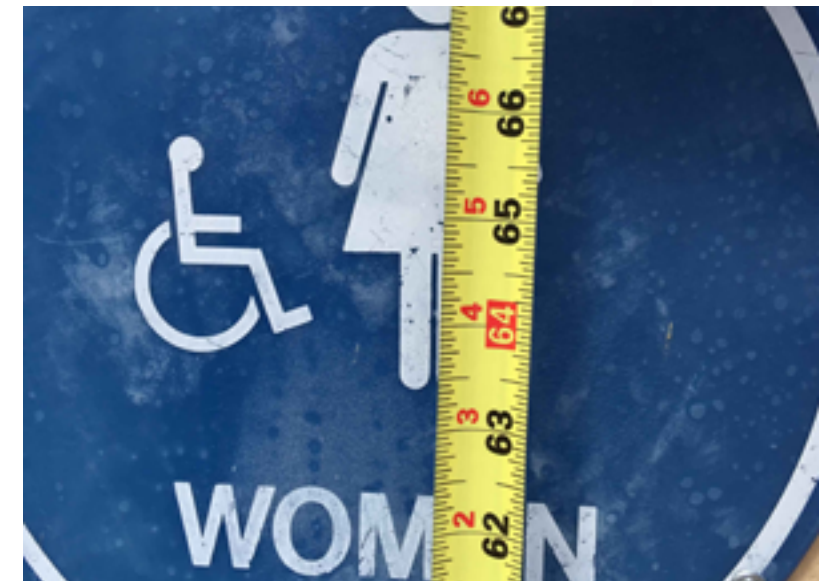
Geometric signage mounted too high.

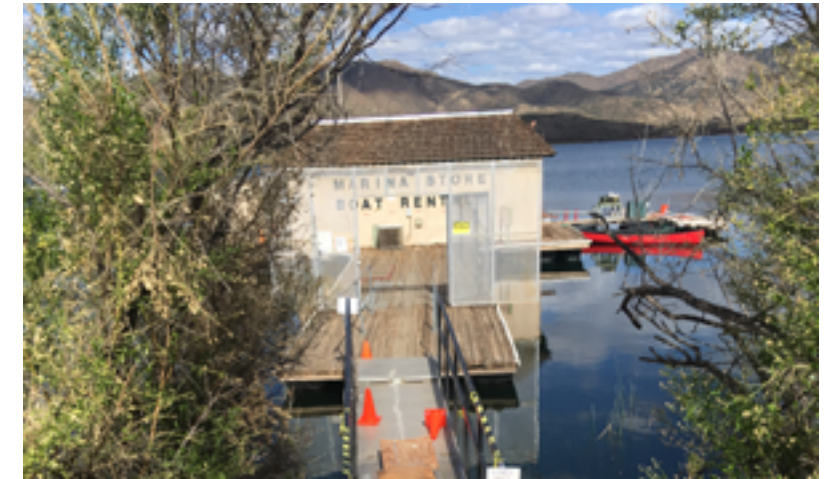
- No ramp to dock level (stairs only)
- Dock has large gaps, far exceeding 1/2"
- Dock has uneven surfaces

Marina and associated docks are completely wheelchair inaccessible.

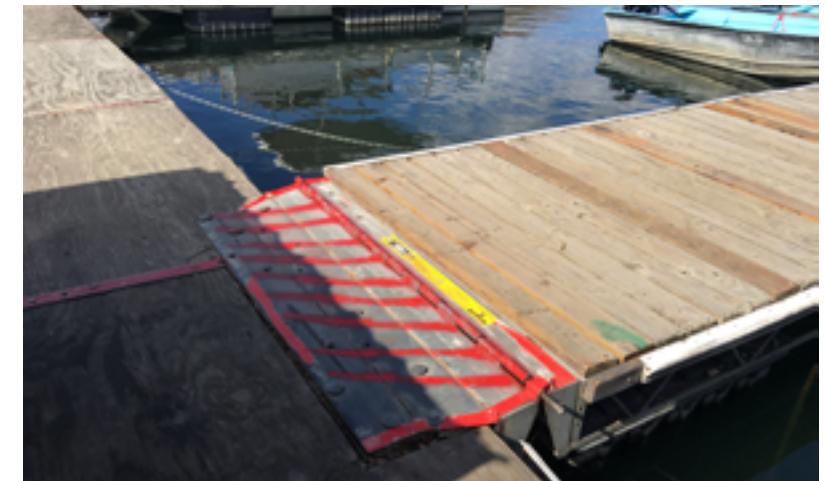
Interim safety markings.

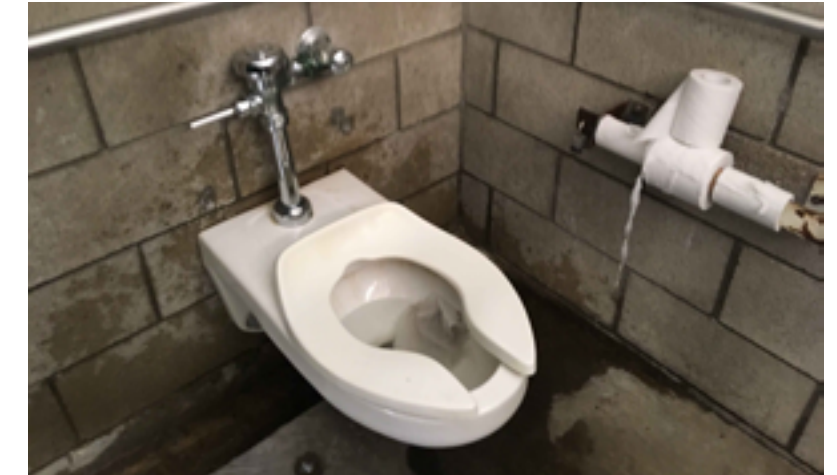
Floor drain trough does not meet accessibility standards.

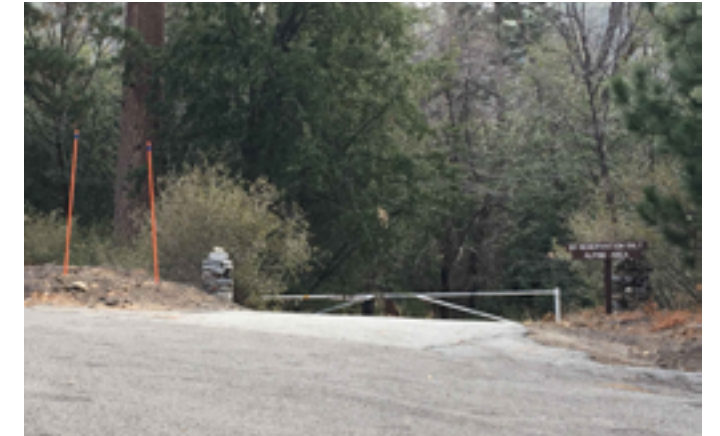
*Pictured: Entrance from State Highway 243 into the Lawler Alpine Cabins site. Visitors to the site arrive primarily through vehicles, as no improved walkways are provided into the site.*

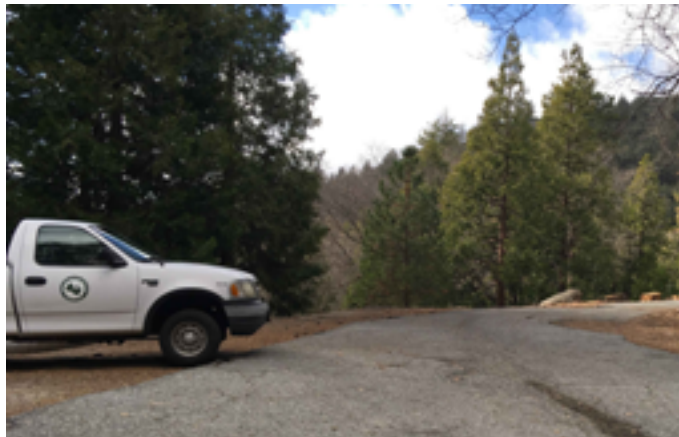
*There is currently no marked parking of any sort at Lawler Alpine Cabins (neither accessible nor general).*

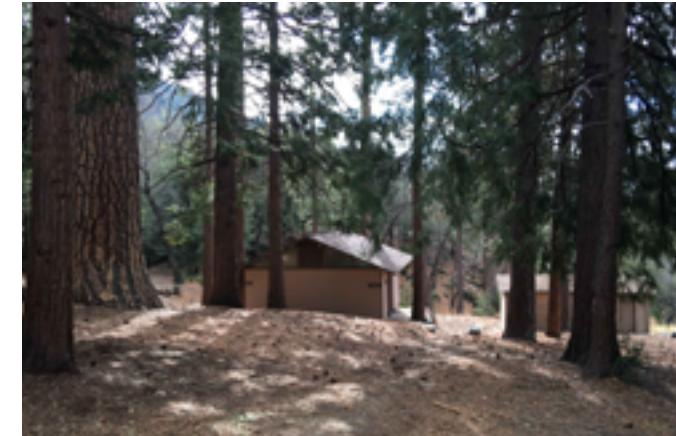
*Existing restroom and showers are located far downslope of the Dining Hall and Cabins.*

*ACTION ITEM 2.1: Provide a long-term plan to add new cabins and restroom/ shower facilities at nearly the same elevation as the dining hall, so that the major site amenities can be connected by an accessible path, without destroying the historic character of the overall site.*

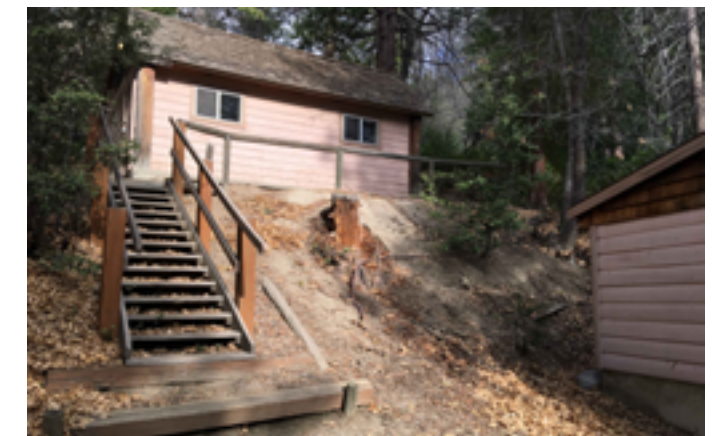
*Cabins are set at varying pad elevations, requiring travel on steep stairs to reach.*

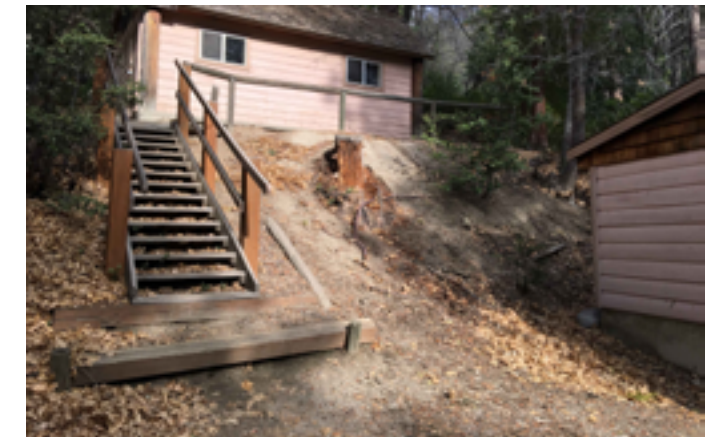
Example of current site constraints.

*ACTION: Develop a long-term plan to provide an accessible cabin building that connects to the food hall and accessible parking.*

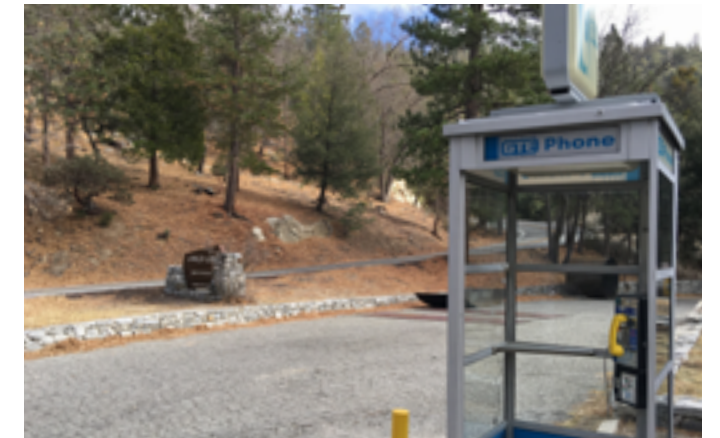
*Pictured: Entrance from State Highway 243 into the Lawler Lodge site. Visitors to the site arrive primarily through vehicles, as no improved walkways are provided into the site.*

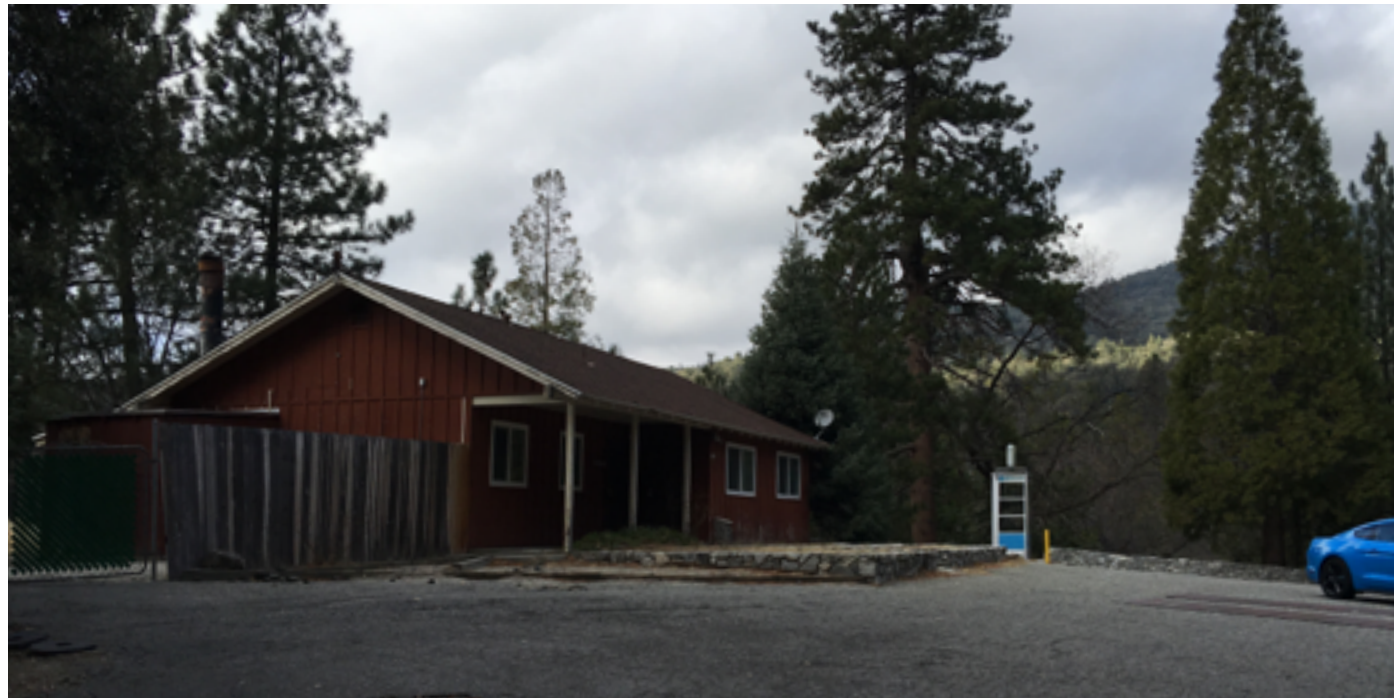
*There is currently no marked parking of any sort at Lawler Lodge (neither accessible nor general).*
