RIVERSIDE COUNTY REGIONAL PARK AND OPEN SPACE DISTRICT

# ACCESSIBILITY COMPLIANCE REPORT- 2018 UPDATE

MAY 31, 2018

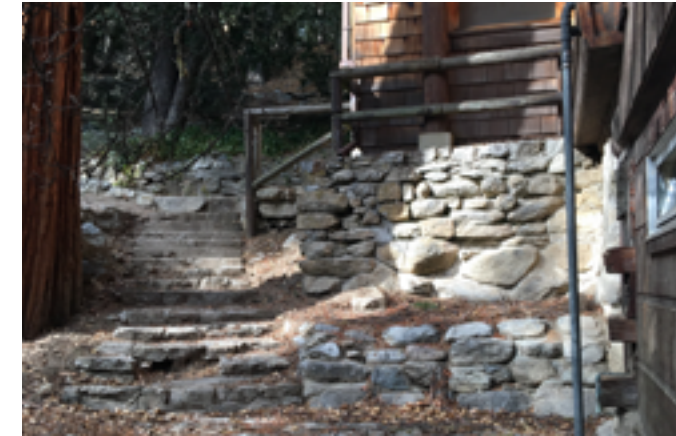
*All existing structures are built into a steep hillside, and are only accessed by stone stairways, absent of handrails.*

*ACTION ITEM 2.1: Provide a long-term plan to add new cabins and restroom/shower facilities at nearly the same elevation as the dining hall, so that the major site amenities can be connected by an accessible path, without destroying the historic character of the overall site.*

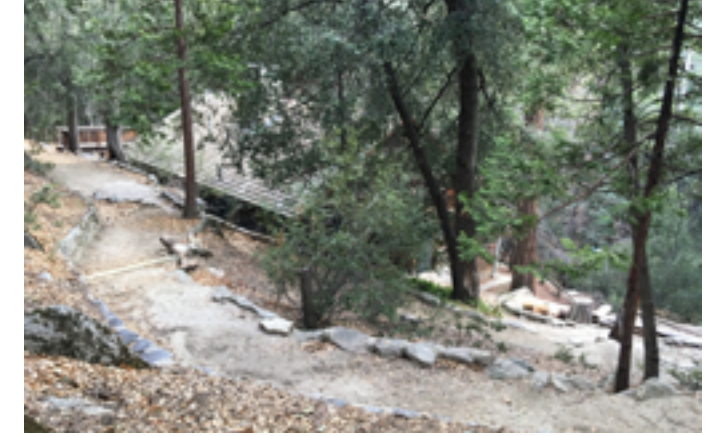
*Paths to the cabins and Lodge are treacherous.*

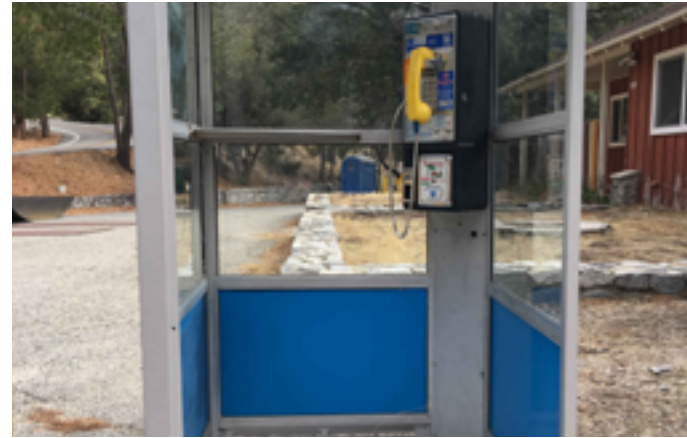
A non-accessible yet functioning pay phone booth provides a glimpse into olden days. Per CBC 11B-217.4.4, unless 4 or more pay phones are provided, a TTY is not required.

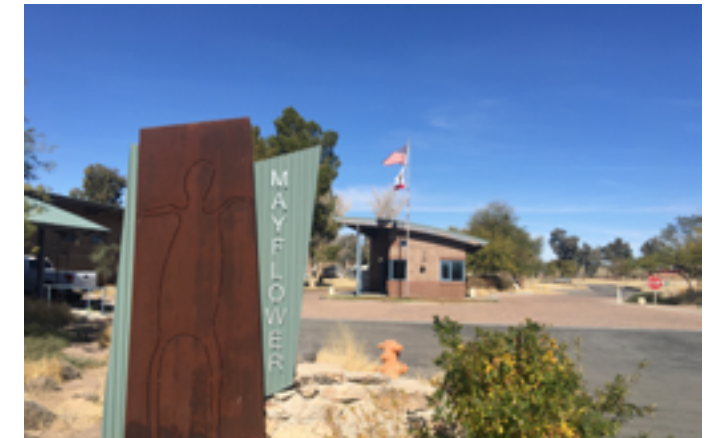
*Pictured: Entry drive from Colorado River Road into Mayflower Park. Visitors to the site arrive primarily through vehicles, as no improved walkways are provided into the site.*

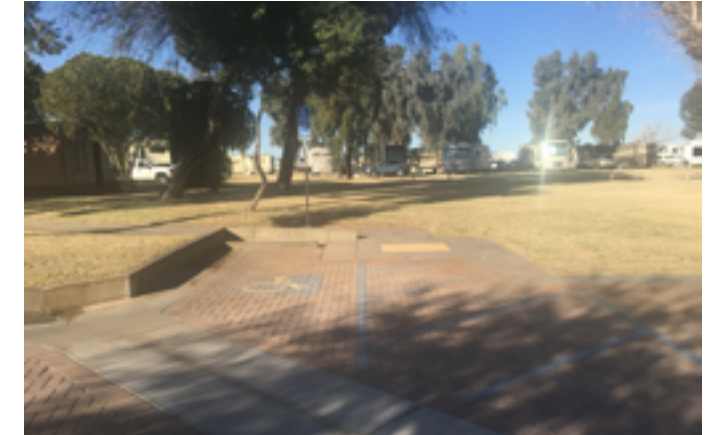
Despite the visually attractive qualities of this paver-set Designated Accessible Parking Space, there are several non-compliant attributes that need to be addressed.

*ACTION ITEM 1.3.3: Provide "NO PARKING" in 12" tall characters at the leading edge of the passenger loading zones at all designated accessible parking spaces, and hatched lines at 36" on-center maximum, in compliance with CBC 11B-502.3.3.*

1.3.1 - 1.3.3	Extend left edge of entrance parking space; rework pavers; add "NO PARKING" characters to access aisle	\$10,000	June 2020	
1.3.4	Provide "MINIMUM FINE \$250" / Replace signs with Caltrans R99 sign (Typ. of 2 locations)	\$500	Immediate	
<b>2.1 CAMPGROUND</b>

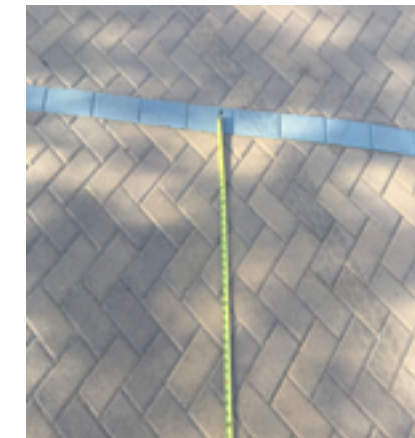
Loading zone/ access aisle striping is currently installed at over 4'; CBC requires 3' on-center, maximum.

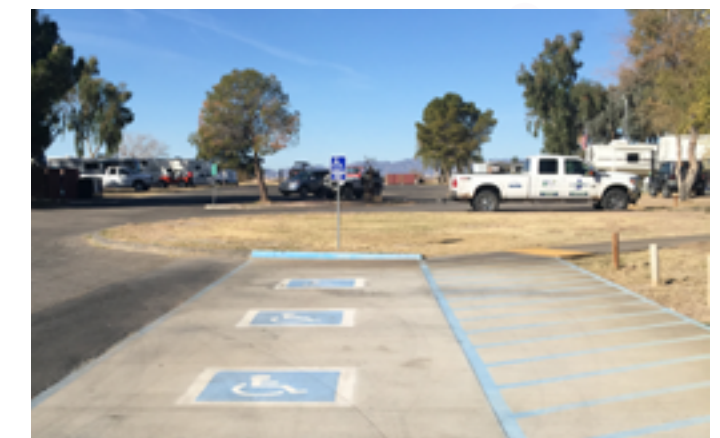
The "Boat Accessible" parking space needs to be renovated to meet the full requirements of CBC 11B-502.

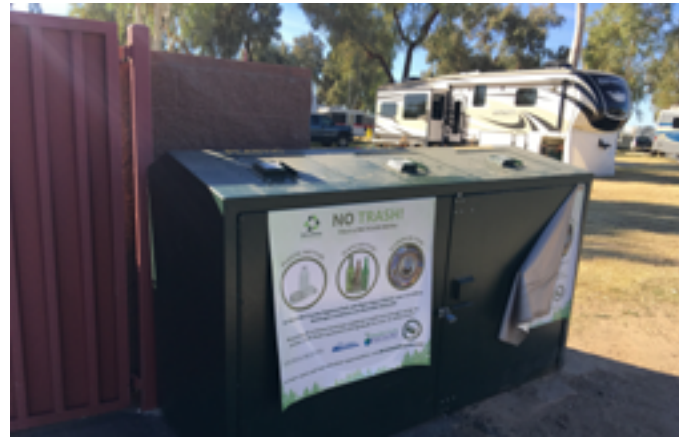
The same non-compliant waste containers previously seen at Bogart Park are also present at Mayflower.

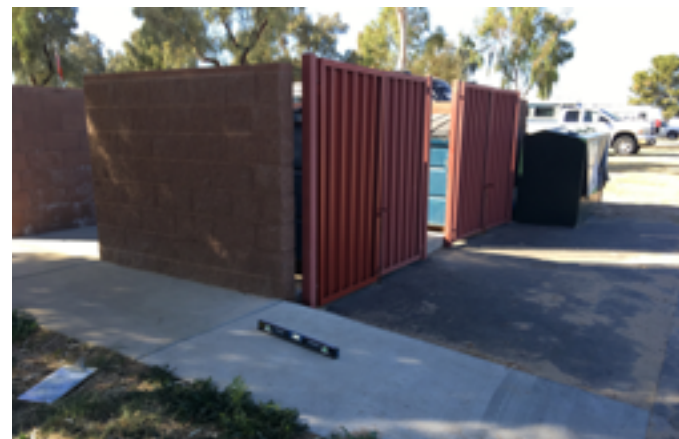
Access to trash enclosures exceeds allowable slopes, does not offer edge protection, and leads park patrons directly into hazardous vehicle area without detectable warning..

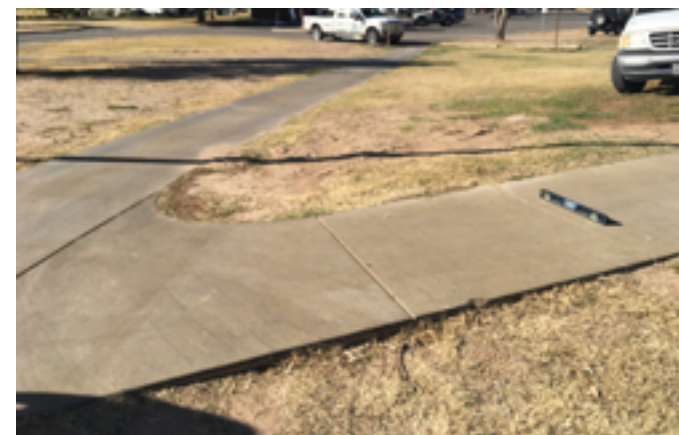
The walkway accessing the new restroom/ shower building exceeds allowable cross slope, at and near wheelchair turning space.

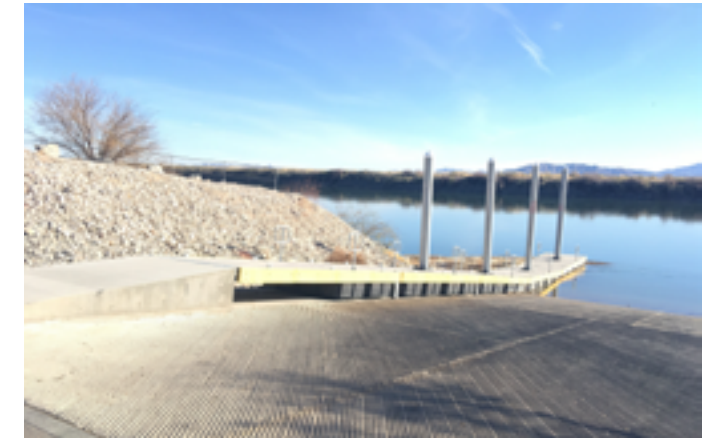
The boat launch exceeds the allowable slope for ramps, but meets the exception criteria listed in CBC 11B-1003. Due to topography constraints, signage should be provided to warn of the hazardous slope gradient.

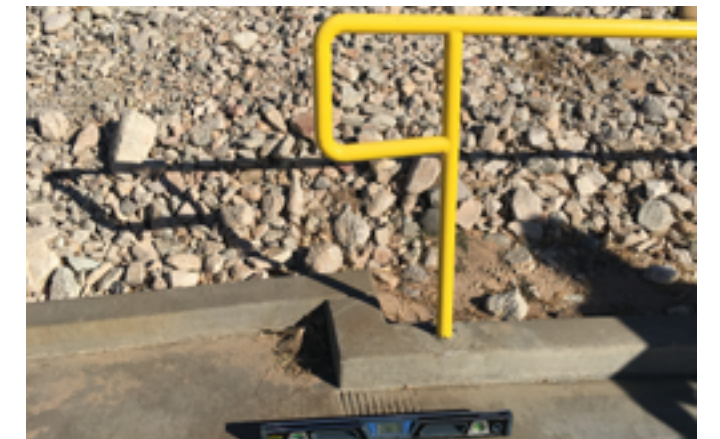
The access ramp continues to ascend past the handrail extension.

*ACTION ITEM 2.3.2: At the access ramp between the boat launch area and the designated accessible parking, modify the handrail to provide at 12" minimum extension past the grade break at the top of the ramp, in line with CBC 11B-505.10.1.*

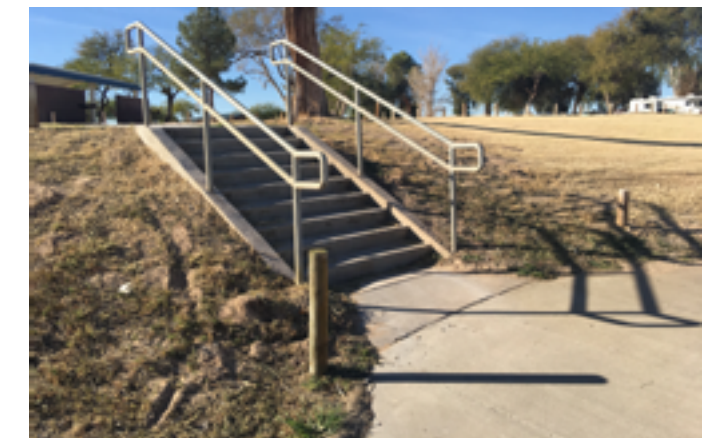
A staircase near the boat launch area has handrails that exceed 38".

*ACTION ITEM 2.3.3: Renovate stairs to be fully compliant with CBC 11B-504.*

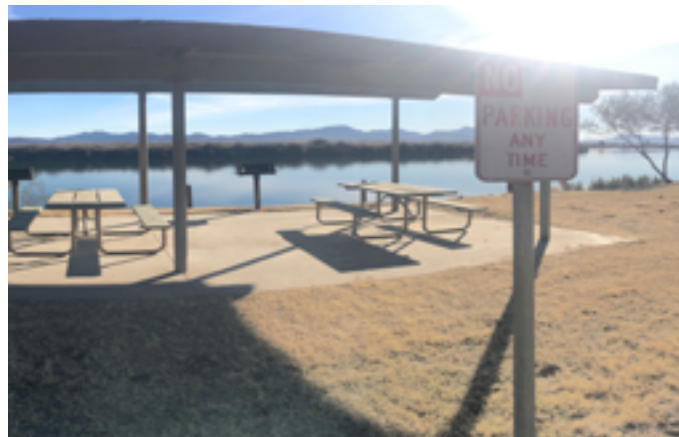
No accessible path is provided to any of the shelters from surrounding accessible park amenities.

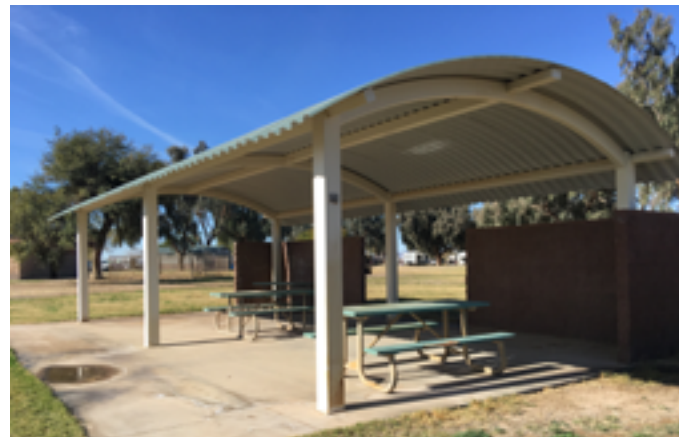
Tables nor barbecues take accessibility into account.

*ACTION ITEM 2.4.1: Provide at least one accessible picnic table in each grouping of tables, in compliance with CBC 11B-246.5 and CBC 11B-902.*

*ACTION ITEM 2.4.2: Provide wheelchair access for side approach at the barbecue, within the reach range requirements of CBC 11B-308.3*

2.4.1	Provide accessible picnic table at each group shelter and at walkway-adjacent individual table locations (est. 10 tables)	\$15,000	June 2023	
2.4.2	Provide wheelchair access / side approach to barbecues	\$1,000	June 2023	
<b>3.2 RESTROOM/ SHOWERS</b>

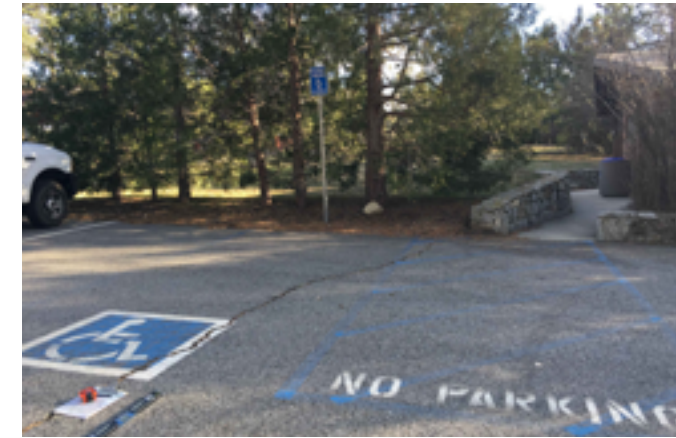
Designated Accessible Parking Space has excessive slope, faded striping, surface issues, and missing "MINIMUM FINE \$250" signage.

*ACTION ITEM 1.3.1: Renovate the existing Designated Accessible Parking Space to be fully compliant with current accessibility requirements.*

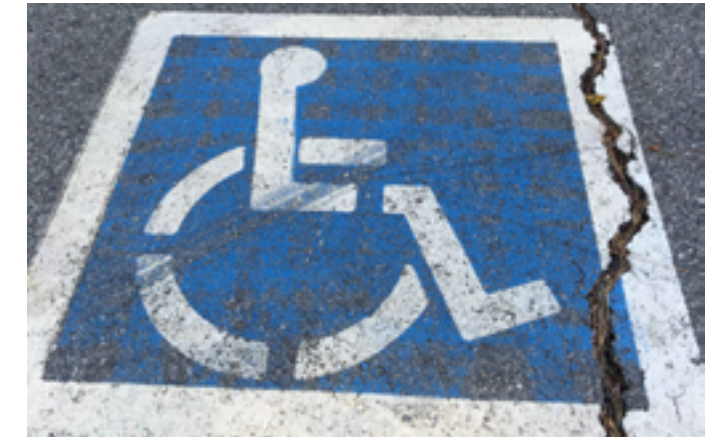
Large crack present within existing DAPS.

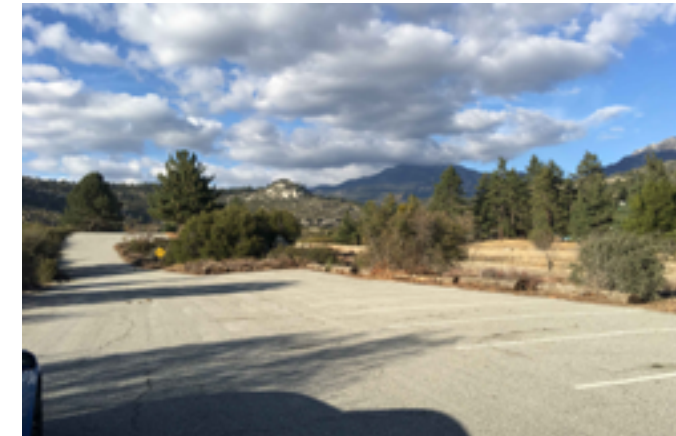
No DAPS are currently provided in the middle parking lot.

*ACTION ITEM 1.3.2: Provide one new DAPS and access aisle/loading zone at each of the middle and northern lots.*

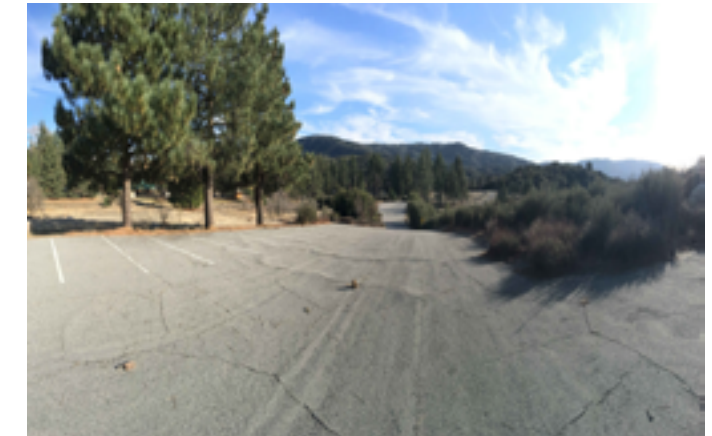
No DAPS are currently provided in the upper parking lot.

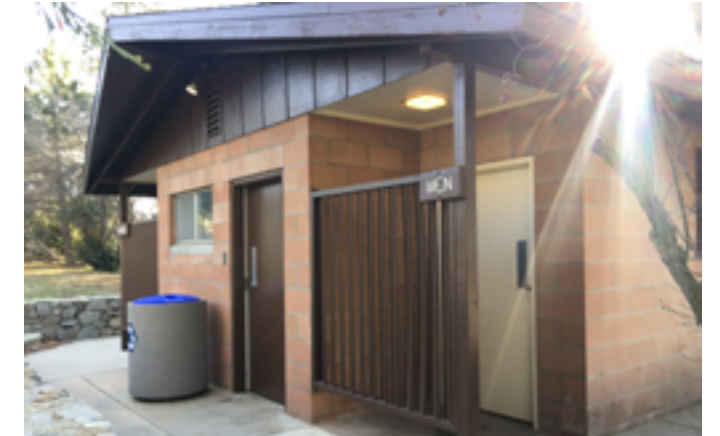
- Excessive slope and uneven concrete at restroom perimeter
- Missing Geometric Signage
- No accessible toilet rooms on either side (Men's nor Women's)
- Urinal partition impedes forward wheelchair approach
- Urinal rim too high
- Soap and mirrors too high above sink
- Sink too close to side wall
- Paper towels dispensing at 51" (40" max allowed)
- Drinking Fountain(s) missing from restroom exterior wall
- Excessive floor slope near drains (1:48 max allowed)

- Shower door opening too narrow
- Benches mounted too high, not deep enough
- Shower floor requires step to enter
- Towel hook mounted too high
- Shower controls too high
- Excessive slope to floor drains
- Soap rack too high

Exterior view of restroom.

3.1.1	Existing restroom dimensions will require extensive retrofit to accommodate wheelchair users; new adjacent or replacement building recommended	\$250,000	June 2028

3.1.1 interim	Provide Accessible Portable Restroom and hand washing station near restroom	\$1,000	Immediate	
	TOTAL OF INDIVIDUAL COSTS (will vary greatly depending on timing and grouping of repairs)	\$319,750

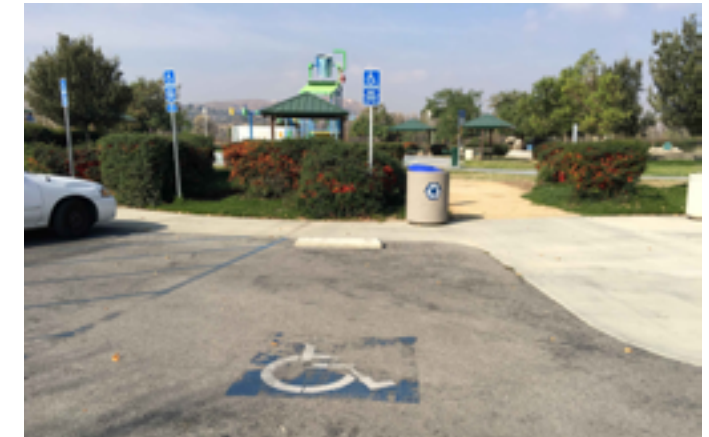
*Faded ISA; no Detectable Warning at zero curb face.*

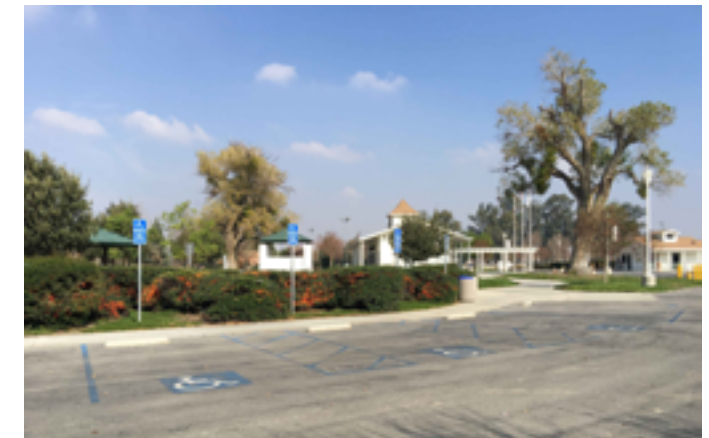
*Striping, "No Parking" wording, and International Symbol of Accessibility are in need of repainting near the splash pad.*

*ACTION ITEM 1.3.1: Where deteriorating or missing altogether, provide "NO PARKING" in 12" tall characters at the leading edge of the passenger loading zones in compliance with CBC 11B-502.3.3.*

1.3.1	Restripe/ relabel "NO PARKING" at various locations	\$1,000	June 2019	
1.3.2	Provide "MINIMUM FINE \$250" signs/ replace with Caltrans R99 signage (typ. 22 existing places)	\$5,000	December 2018

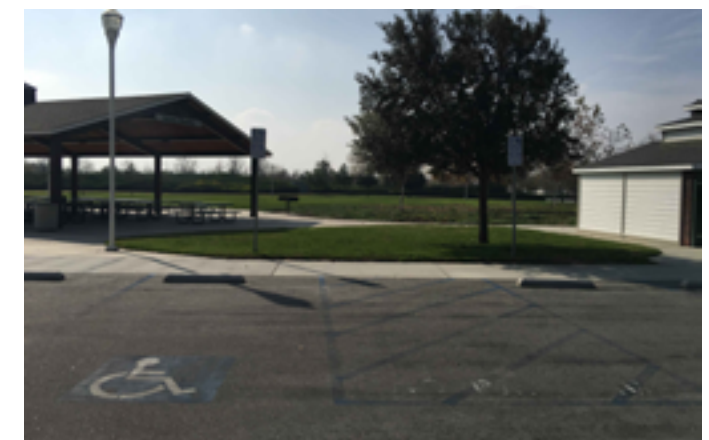
*Similar repainting efforts are needed near the large group picnic shelters.*

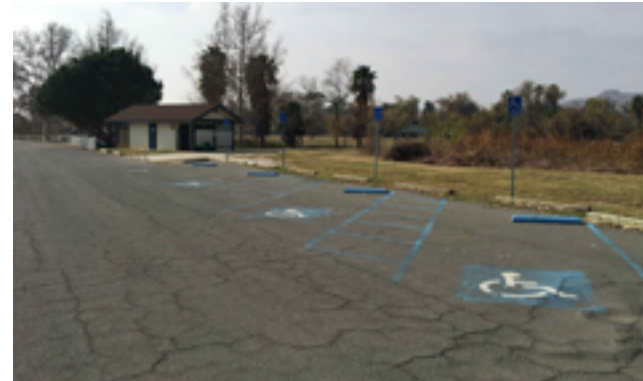
A variety of signage is provided near the Picnic Lakes restroom. Access aisles do not connect to accessible paths. "No Parking" designation is not present.

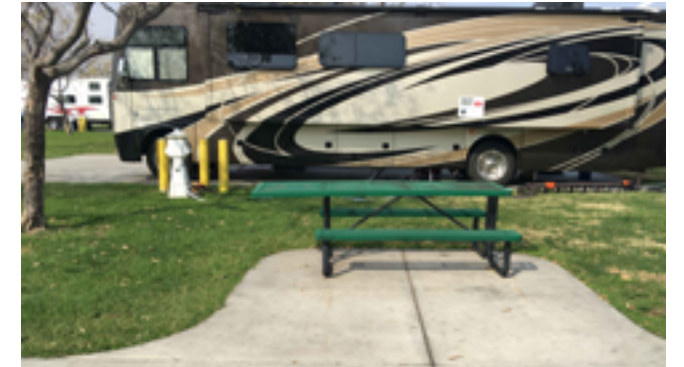
Concrete pad does not provide proper wheelchair approach clearances at accessible picnic table within campsite.

**ACTION ITEM 2.1.2:** Modify existing designated accessible campsites to provide full circulation clearances at provided picnic table.

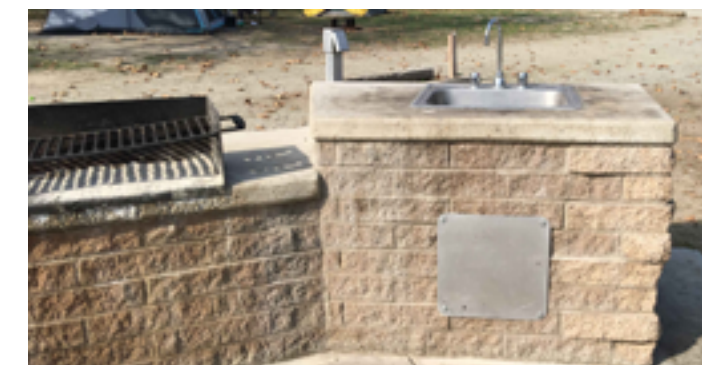
Outdoor sink is above acceptable reach ranges, and does not provide knee/ toe clearance for forward wheelchair approach.

2.2.2, 2.2.3	Extend accessible walkway to restroom at Campground	\$30,000	June 2023	
2.2.4	Renovate outdoor sink area	\$5,000	June 2023	
2.2.5	Replace one picnic table with compliant model at shelter	\$1,500	June 2023	
<b>2.4 GROUP PICNIC AREA</b>

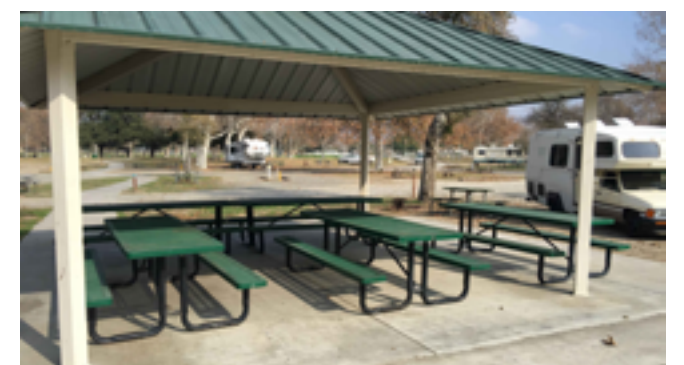
Picnic shelter does not have an accessible table, nor proper circulation clearance between tables.

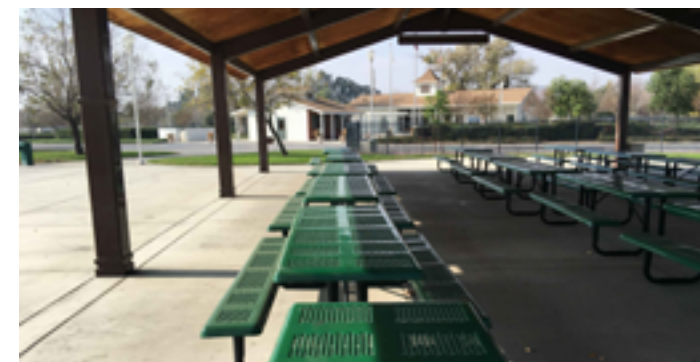
Tables are not permanently mounted, so the layout observed during the site visit may not reflect day-to-day layout.

*ACTION ITEM 2.4.5: Provide at least one accessible picnic table in each grouping of 20 tables, or fraction thereof, in compliance with CBC 11B-246.5 and CBC 11B-902.*

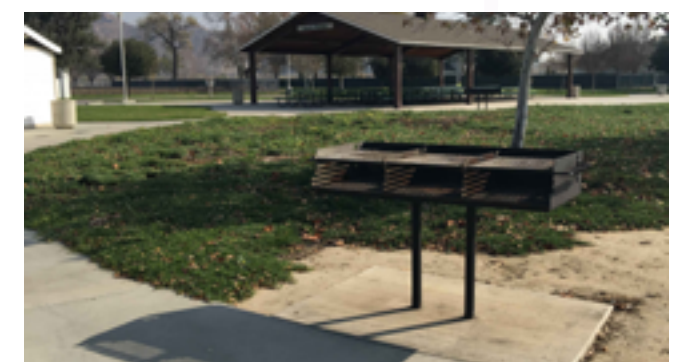
Existing barbecues allow forward and side wheelchair approach options.

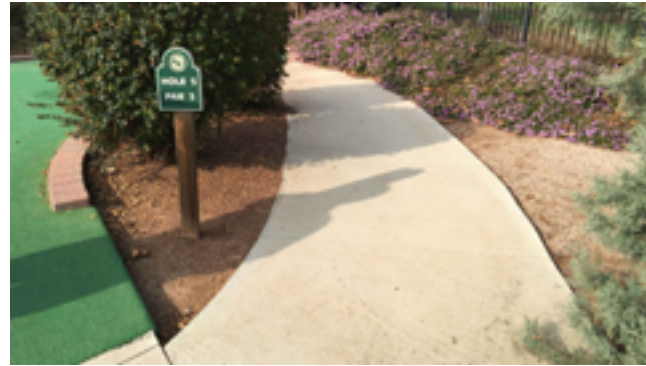
Hole 5 bypass walkway exceeds maximum allowable running slope for walks, and should be reconstructed as a ramp.

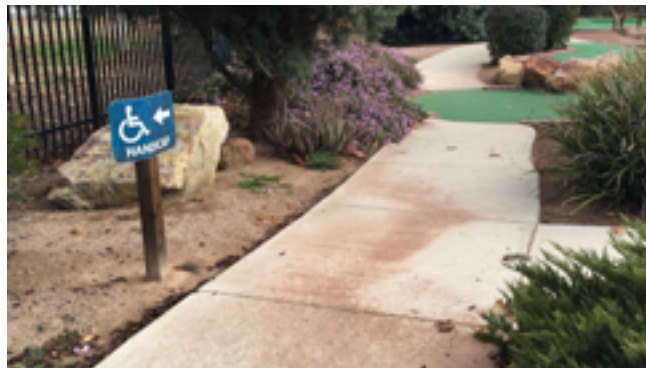
Replace signage to eliminate outdated "Handicap" terminology. The currently accepted term is "Accessible."

*ACTION ITEM 2.5.2: Remove signage stating "HANDICAP" and replace with the word "ACCESSIBLE", or just show the International Symbol of Accessibility with the arrow. Per CBC 11B-703.5.6, visual characters on directional signage shall be mounted at least 40 inches above finish floor or ground.*

2.5.2	Remove/ replace directional signage	\$500	June 2020	
2.5.3	Renovate hole #17 to provide fully accessible features	\$5,000	June 2020	
<b>2.6 NATURAL PLAYGROUND</b>

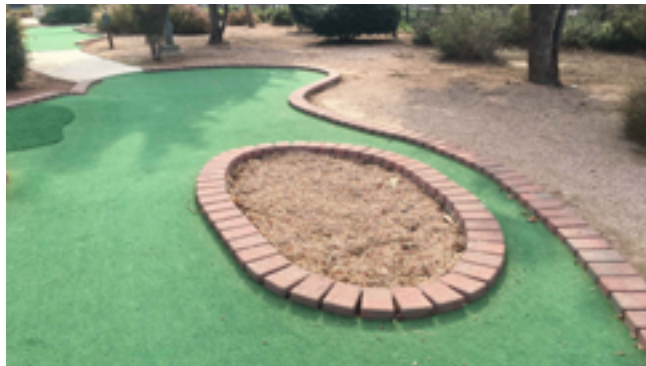
The narrow portion of green above is not accessible by wheelchair, despite being on a designated accessible hole (#17)

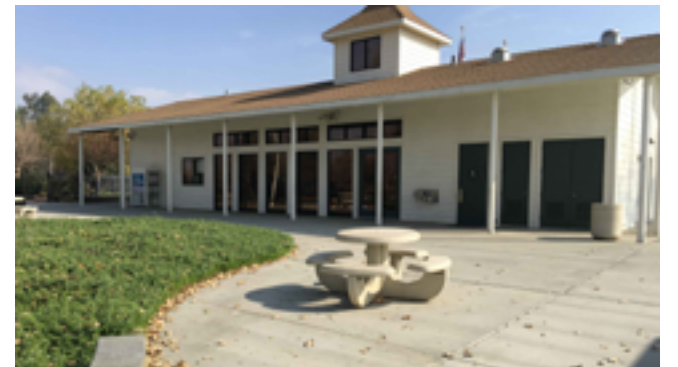
Circular benches do not accommodate wheelchair users.

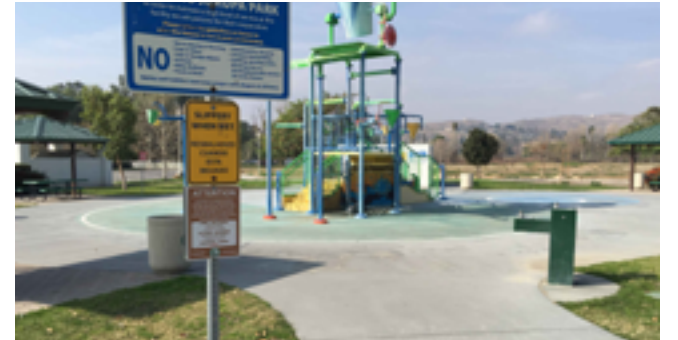
Signage overhangs above the walkway edge at 78" as measured in field. 80" min. clearance is required.

*ACTION ITEM 2.7.3: Raise sign to provide vertical clearance above walkway, as per CBC 11B-307.4.*

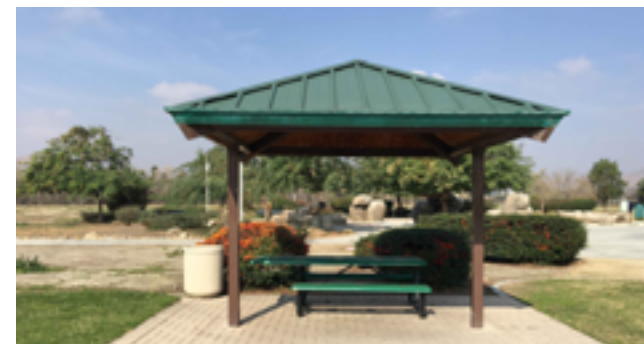
Wheelchair approach space clearances are not sufficient due to proximity of shelter posts.

ITEM #	DESCRIPTION	APPROX. COST	EST. COMPLETION	COMPLETED
2.6.2	Replace (3) benches with accessible models	\$4,000	June 2020	
<b>2.7 SPLASH PAD</b>				
2.7.1	Adjust picnic table locations to accommodate wheelchair approach	\$1,000	June 2019

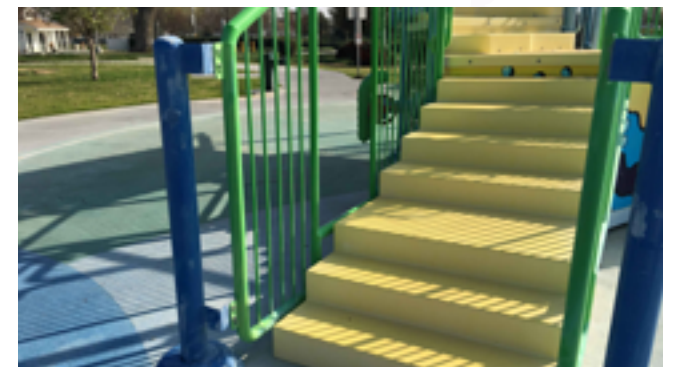
Transfer step does not have contrasting color stripe.

2.8.2	Provide contrasting stripes at transfer steps	\$150	Immediate	
2.8.3	Provide (1) accessible picnic table	\$1,500	June 2021	
2.8.4	Remove/ replace drinking fountain with high/low model	\$5,000	June 2021

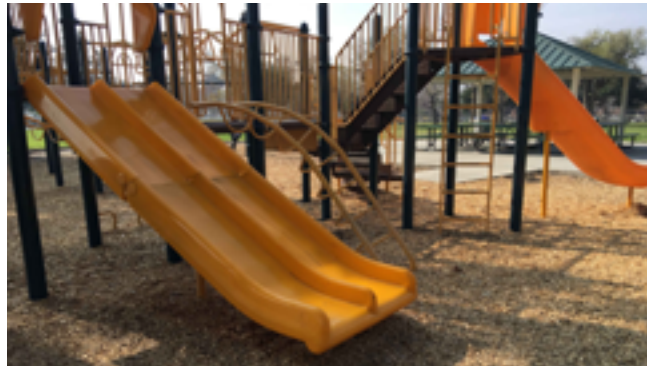
Pictured: Yellow Playground

The yellow playground includes a play structure set in loose wood fiber surfacing. There is an adjacent picnic shelter, barbecue, loose picnic tables, and a concrete walkway connecting to nearby parking and other amenities.

*ACTION ITEM 2.8.1: Maintain wood playground mulch at heights and surface continuity to allow accessible connectivity between play components, and at proper heights for transfer points and slide exits, in full compliance with CBC 11B-1008.2; Since frequent maintenance of playground surface is required by CBC 11B-1008.2.6.1, the installation of rubber safety surfacing to provide an accessible path to all accessible ground level play features and transfer stations is recommended.*

*ACTION ITEM 2.8.4: Remove existing drinking fountain and replace with a high/low unit, in compliance with the full requirements of CBC 11B-602.*

*ACTION ITEM 2.8.5: Provide wheelchair access for side approach at the barbecue, within the reach range requirements of CBC 11B-308.3*

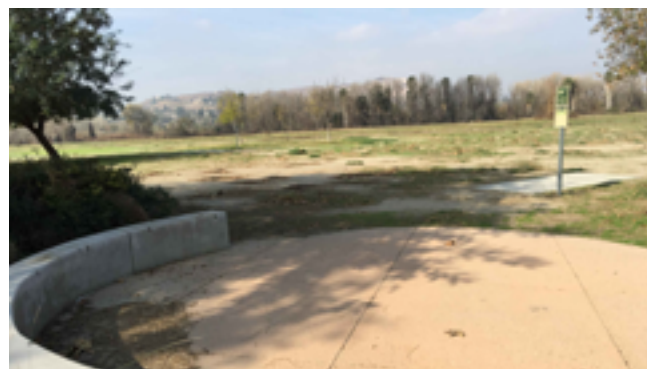
Pictured: Start of Disc Golf Course near Nature Playground.

A disc golf course is provided at Rancho Jurupa, but is generally not accessible beyond the seating area near the 1st tee.

*ACTION ITEM 2.10: Plan for future improvements that provide at least one target that is within a generally accessible area.*

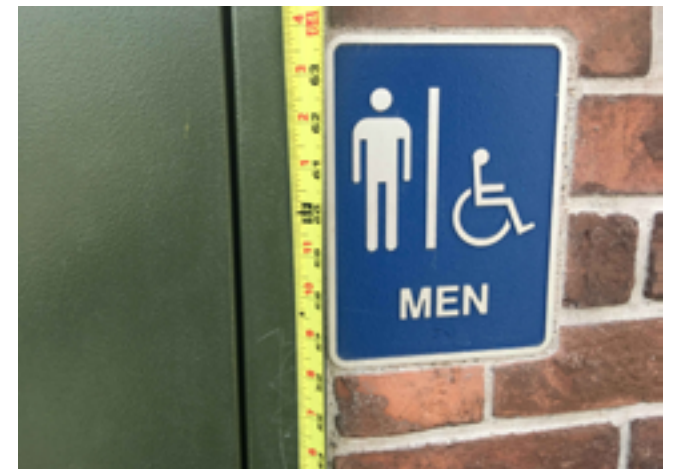
Pictogram signage at proper location.

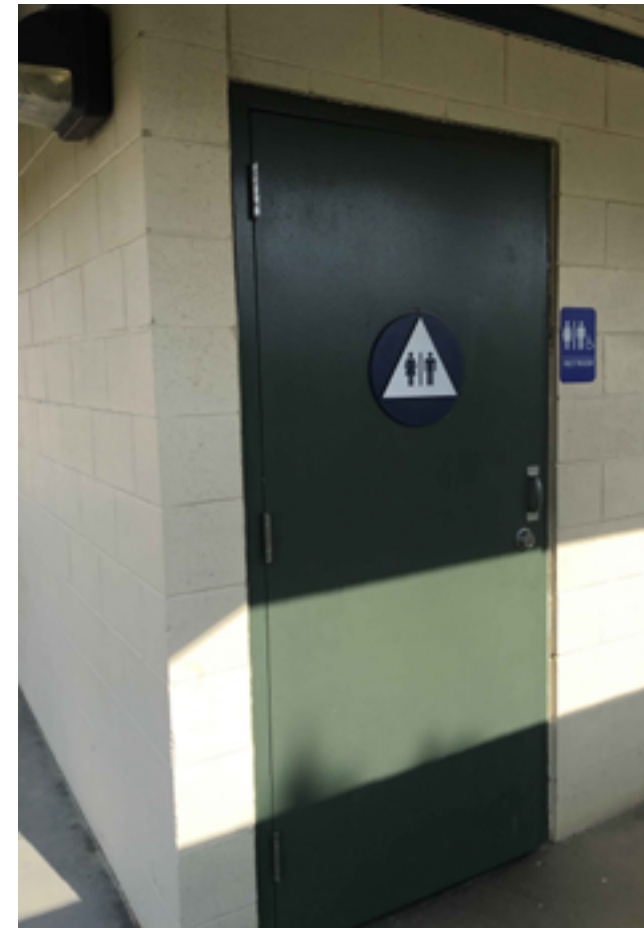
Geometric signage at proper height.

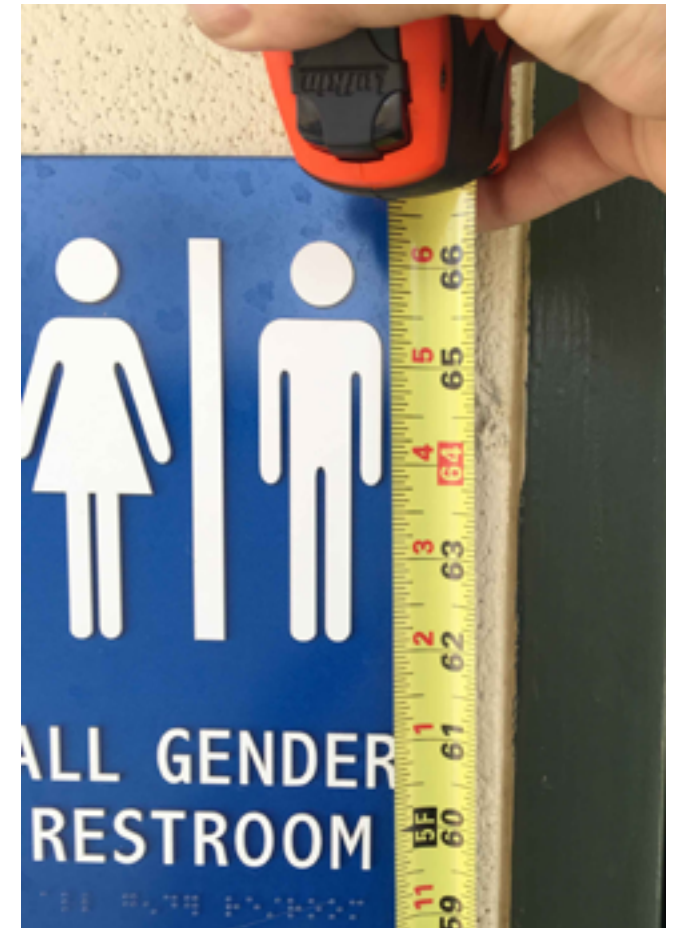
Pictogram signage mounted slightly too high.

3.6.1	Various minor repairs - see report	\$1,000	June 2019

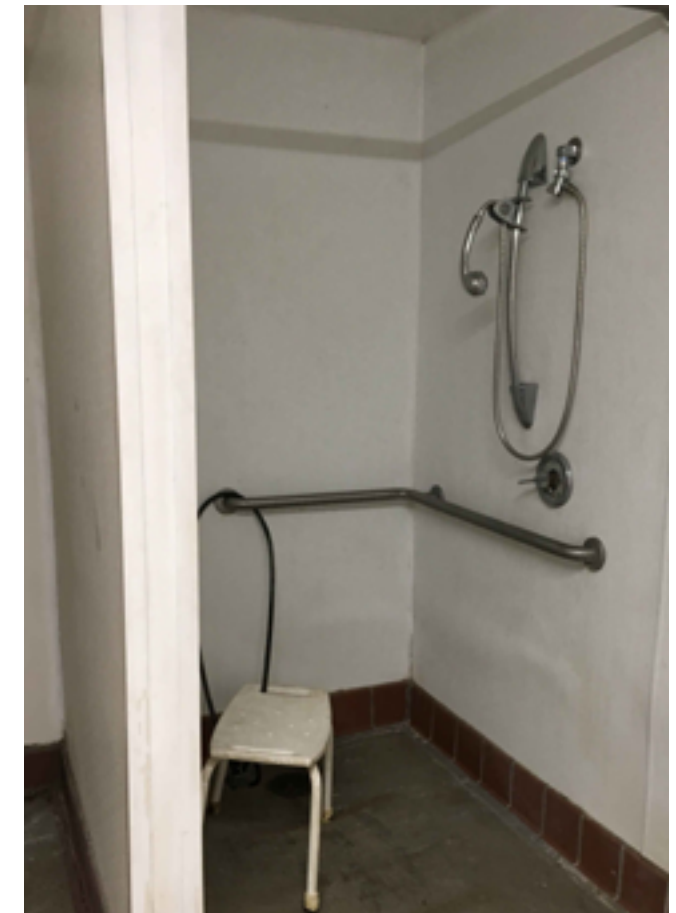
- Fixed/ foldable seat not provided.

Shower view.

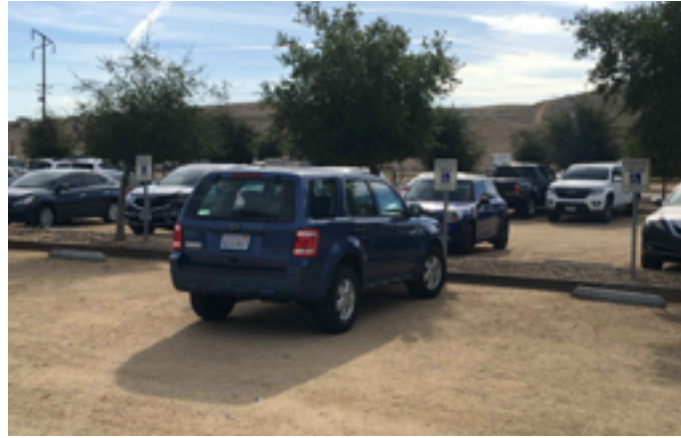
No loading zones; no striping, bad signs.

*ACTION ITEM 1.3.1: Provide Designated Accessible Parking Spaces on firm, stable surfaces, capable of being striped and painted in compliance with CBC 11B-502.*

*ACTION ITEM 1.3.2: Provide access aisles and loading zones to create an accessible path that does not cause wheelchair users to pass behind any vehicles other than their own. Connect accessible routes to the park amenities and/or buildings which they are intended to serve.*

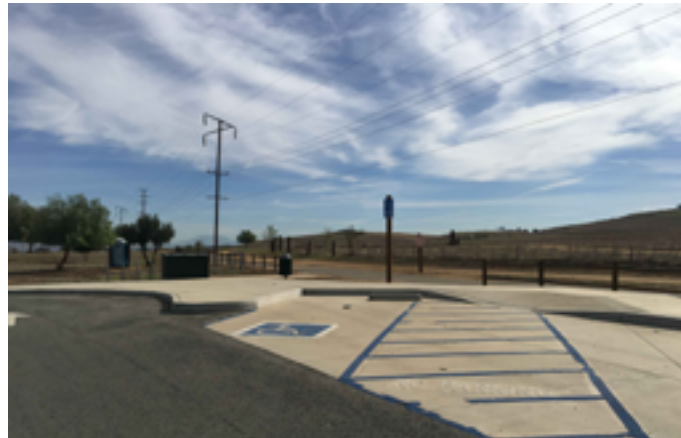
One Designated Accessible Parking space was provided with the applicable access aisle and curb ramp.

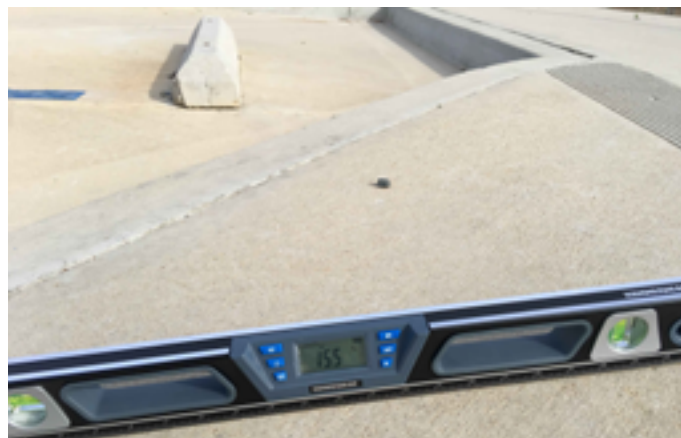
Example of excessive slope observed at the curb ramp.

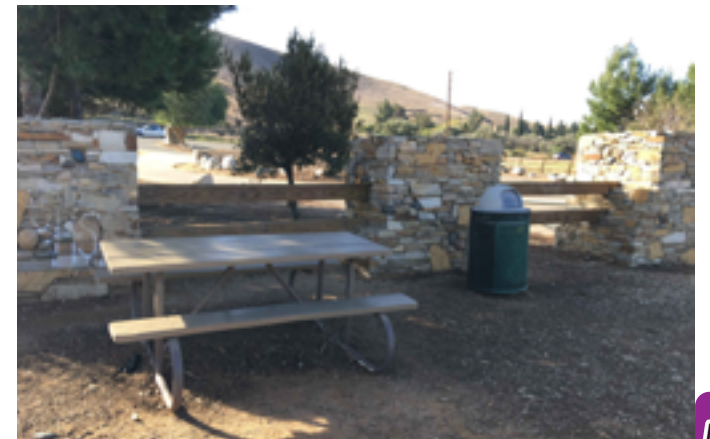
A picnic table and trash receptacle are provided near the park entrance, but are not on an accessible surface nor path.

*ACTION ITEM 2.1.1: Provide an accessible path between a Designated Accessible Parking Space and the park amenities provided.*

*ACTION ITEM 2.1.2: Once a Designated Accessible Parking space and accessible path is provided, replace the picnic table with an accessible model.*

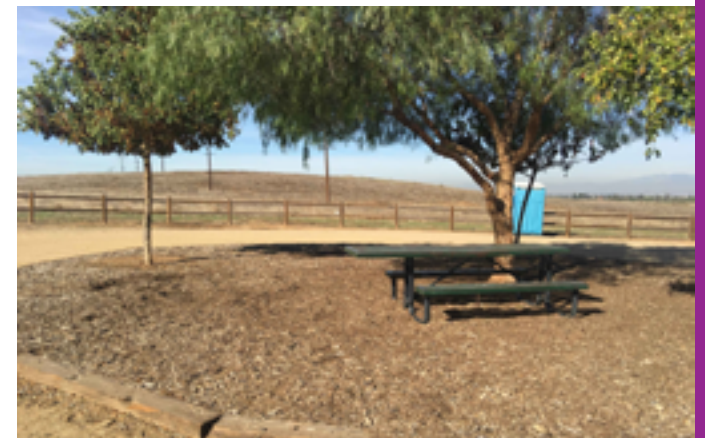
A picnic table and trash receptacle are provided near the park entrance, but are not on an accessible surface nor path.

*ACTION ITEM 2.2.1: See items 2.1 above.*

*ACTION ITEM 2.2.2: Where a portable toilet is provided, it shall be accessible. Replace current model with a wheelchair-accessible unit.*

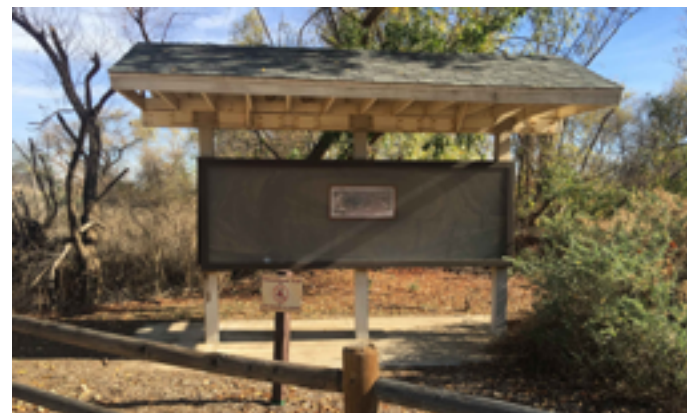
*An informational message board is provided near the Day Use Area, but is not currently loaded with information readable from wheelchair level.*

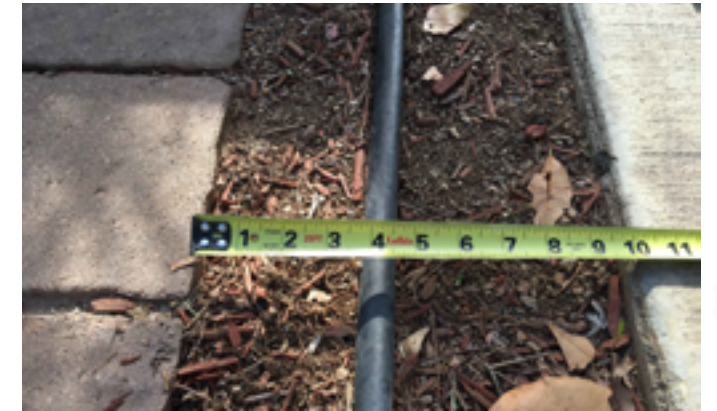
*An irrigation dripline runs across a gap between paving materials at the entrance to the "Nature's Pathway" area, effectively preventing wheelchair access into the space.*

*ACTION ITEM 2.5: Develop a long-term strategy for converting this area and its interactive features into a fully-accessible area.*

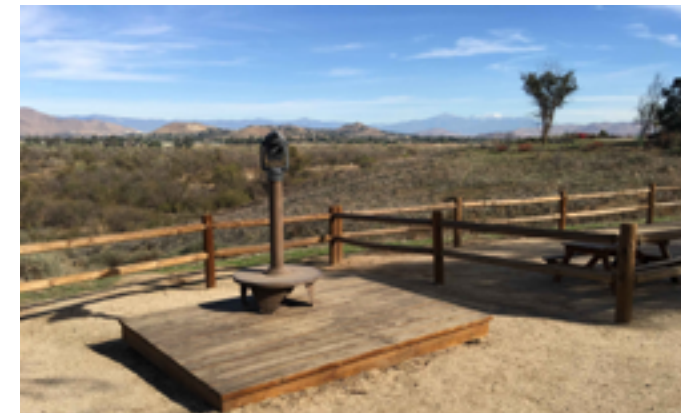
*Many interactive features have several barriers to accessibility, such as this viewing scope mounted above reach range, and mounted on a raised platform with no ramp.*

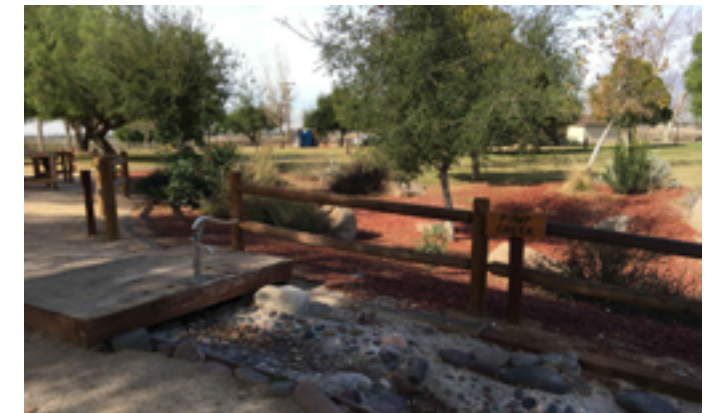
*This water feature makes no provisions for wheelchair occupants.*

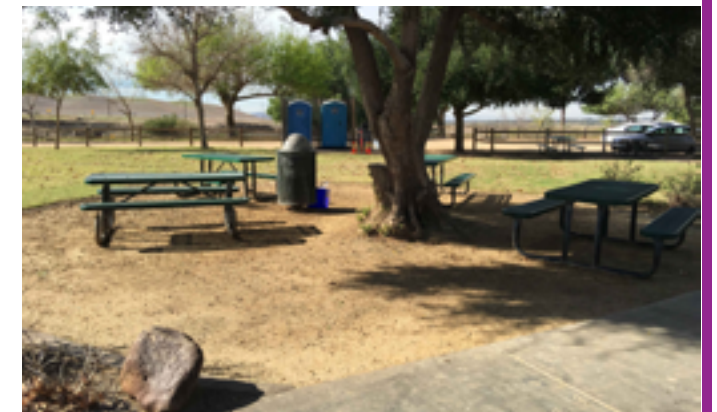
*Picnic tables under shade trees in front of the Nature Center. Portable restrooms do not include wheelchair accessible models.*

*ACTION ITEM 2.6.1: Provide at least one accessible picnic table in each grouping of tables, in compliance with CBC 11B-246.5 and CBC 11B-902.*

*ACTION ITEM 2.6.2: Where portable toilets are provided, at least one shall be accessible. Replace current model with a wheelchair-accessible unit.*

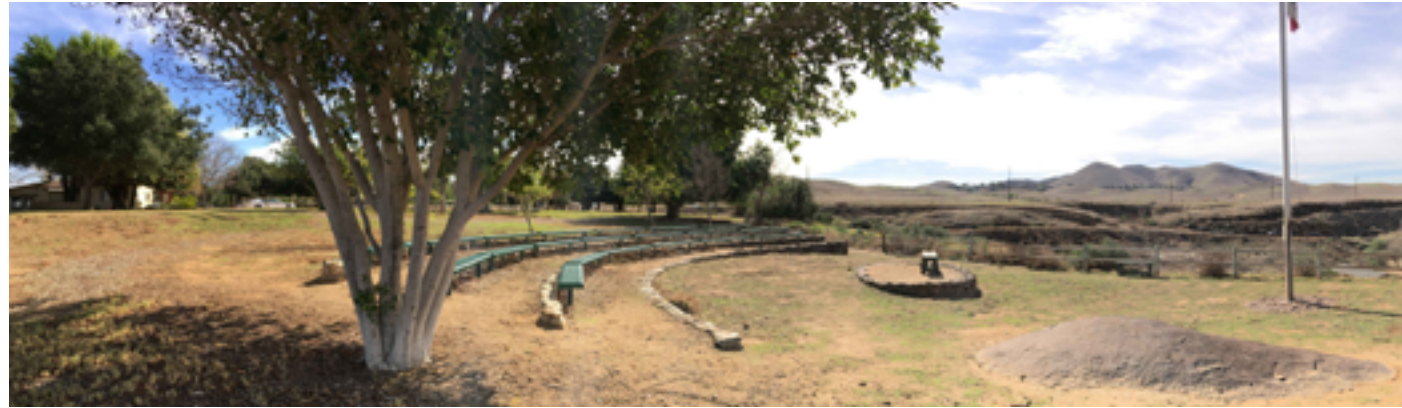
The amphitheater provides tiered bench seating, but benches have no backs and no access nor provisions are made for wheelchair users.

*ACTION ITEM 2.7: Develop a long-term strategy for converting this area and its interactive features into a fully-accessible area.*

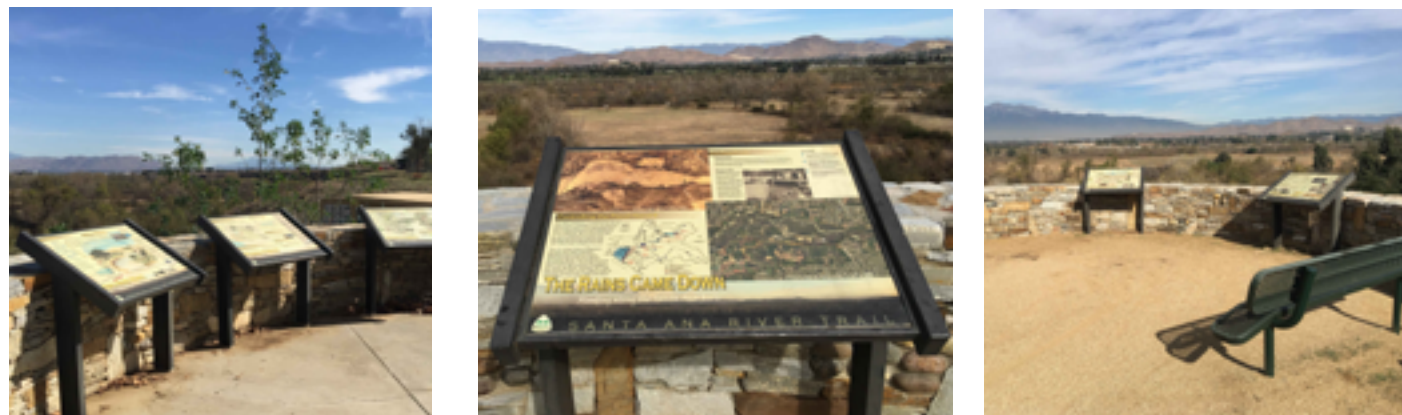
There are three distinct lookout vista points, each providing signage that showcases history and natural features within view of the park site. All three lookout areas have slopes that exceed allowable steepness for wheelchair access.

*Each of the three lookout areas have similar signage; two sites are on concrete, while the third is Decomposed Granite.*

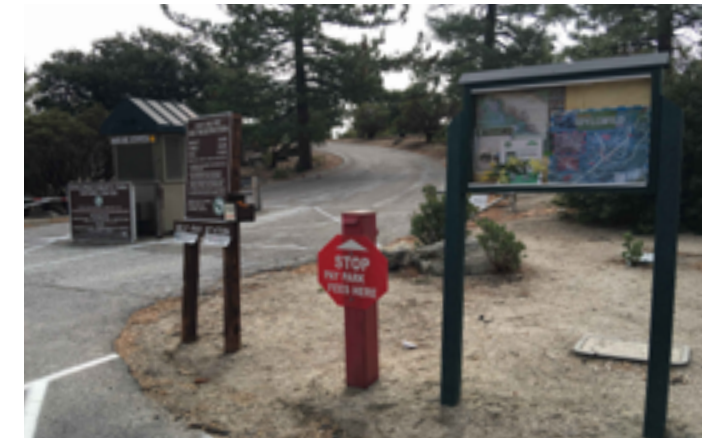
*Pictured: Guard-controlled entrance to Idyllwild Nature Center. Visitors to the site arrive primarily through vehicles, as no improved walkways are provided into the site.*

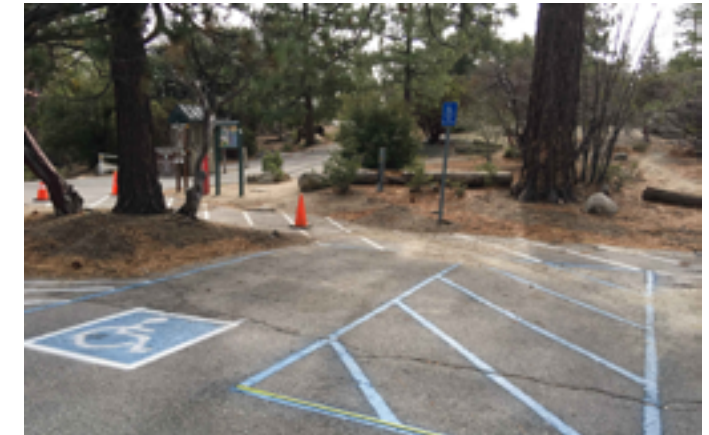
Parking area near park entry. Access aisle measured approximately 3" narrower than the required 8' width.

*ACTION ITEM 1.3.4: Restripe passenger loading zones to reflect full 8' width required for van parking spaces, in compliance with CBC 11B-502.2, Exception #1*

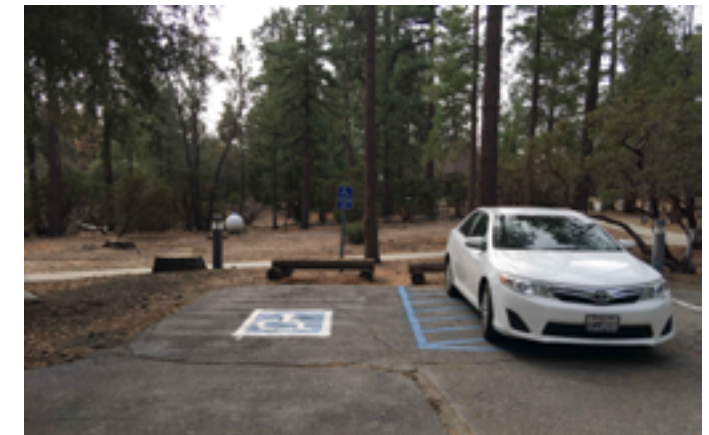
Designated Accessible Parking Space located near Nature Center, impeded by car blocking the access aisle. Access aisle is not wide enough for van accessible designation as currently painted. Signage also too low.

*ACTION ITEM 1.3.2: Provide "Minimum Fine: \$250" signage at ALL parking spaces as defined by CBC 11B-502.6.2; Recommendation is to replace all signage with the Caltrans R99 signage shown in the beginning of this report. Signage shall maintain 60" min. clearance where signs are located outside accessible routes, and 80" min. clear where located within accessible routes, as per CBC 11B-502.6.*

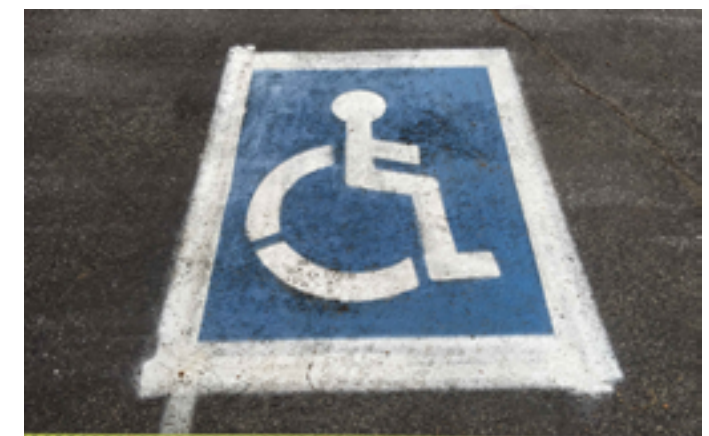
Example of improper proportions of International Symbol of Accessibility (ISA)

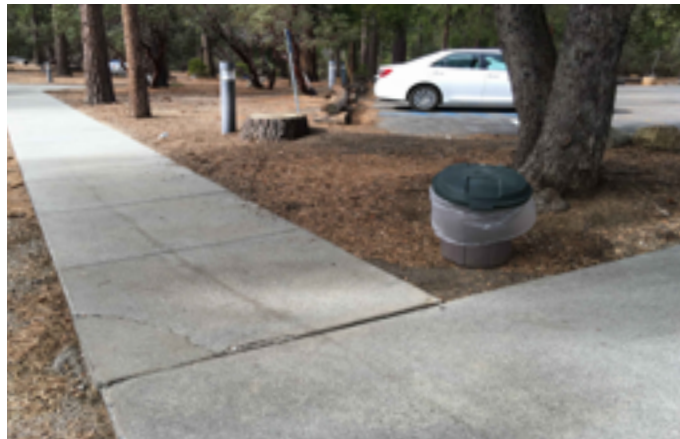
Walkway between parking and building has large gaps, excessive cross slope, and does not directly connect to the Designated Accessible Parking Space.

*ACTION ITEM 2.1.1: Provide a realigned circulation walkway to connect the Designated Accessible Parking Spaces with all provided amenities, including but not limited to nature center, trailhead and restrooms. This will likely require a substantially different walkway location in order to accommodate accessibility requirements, given the existing sloped topography.*

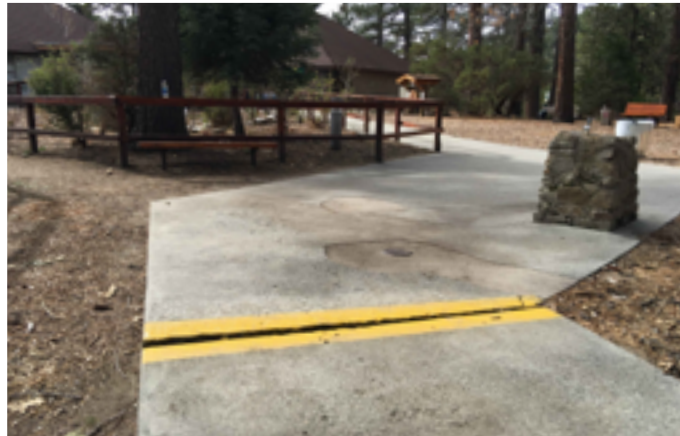
Yellow paint serves as a temporary warning of the vertical rise at the walkway joint. Note: the historic drinking fountain pictured is supplemented with an accessible high-low fountain (not pictured).
