RIVERSIDE COUNTY REGIONAL PARK AND OPEN SPACE DISTRICT

# ACCESSIBILITY COMPLIANCE REPORT- 2018 UPDATE

MAY 31, 2018

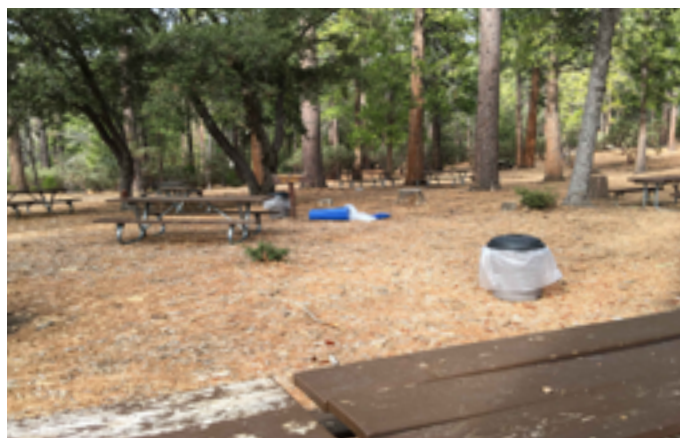
Walkway between parking and building has large gaps, excessive cross slope, and does not directly connect to the Designated Accessible Parking Space.

*ACTION ITEM 2.2.1: Provide an accessible connection to picnic areas from the restroom and accessible parking, in compliance with CBC 11B-206 and 11B-246.5.*

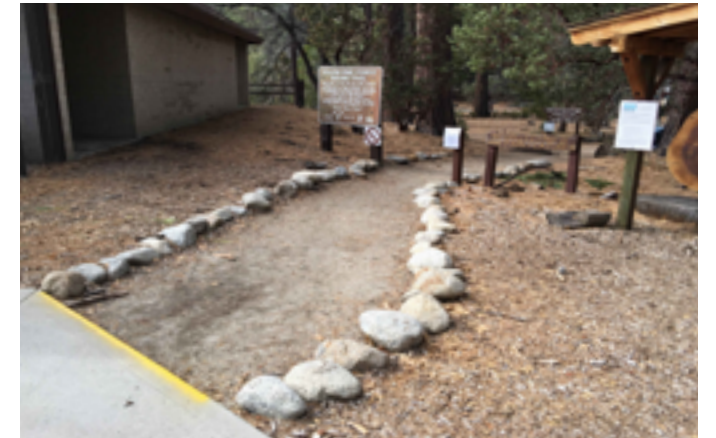
Transition to Yellow Pine Forest Nature Trail provides written description on exhibits located outside wheelchair reach range or text size requirements.

*ACTION ITEM 2.3.1: Supplement existing trails to permit the ability for wheelchair occupants to use, in compliance with CBC 11B-246.7.*

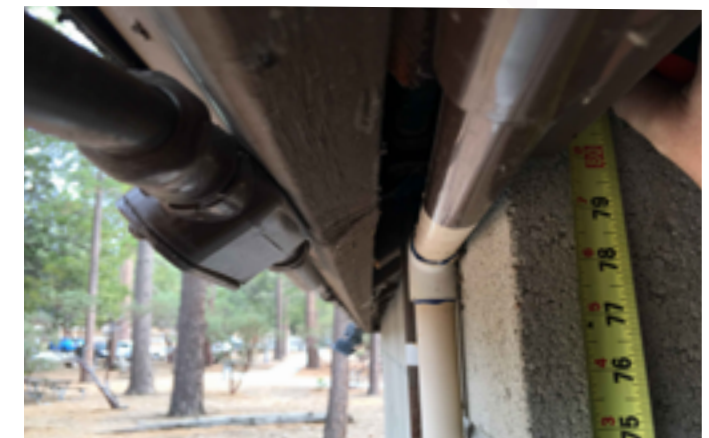
Overhead obstruction at restroom entry.

3.3.1	Existing building will not accommodate wheelchair access; recommend adding adjacent wheelchair accessible restroom	\$125,000	June 2028	
3.3.1 interim	Provide Accessible Portable Restroom and hand washing station near restroom	\$1,000	Immediate	
	<b>TOTAL OF INDIVIDUAL COSTS (will vary greatly depending on timing and grouping of repairs)</b>	<b>\$213,250</b>

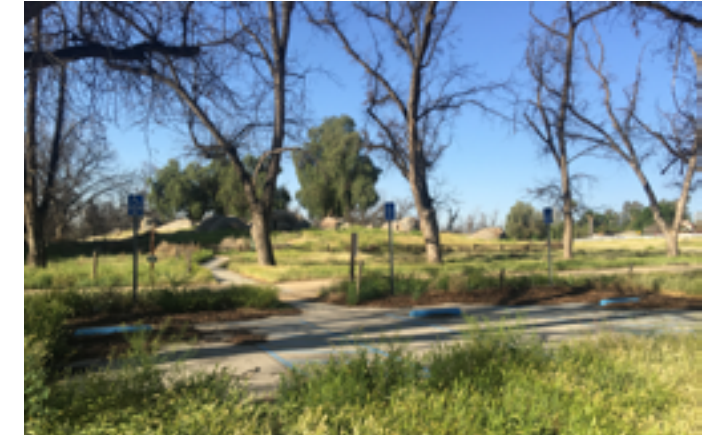
The site is currently overgrown, with vehicular access impeded to the parking area.

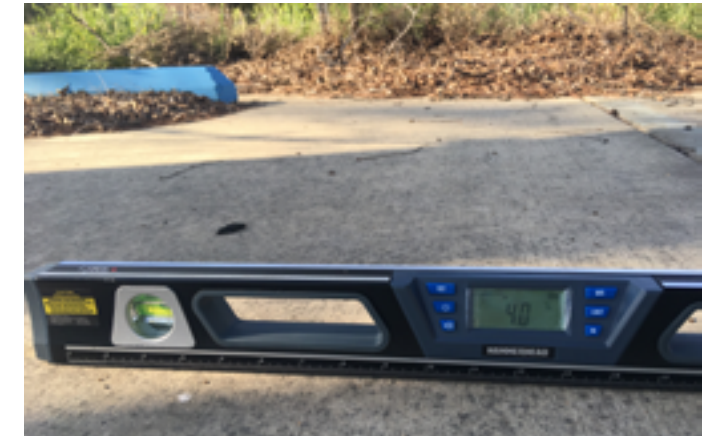
All Designated Accessible Parking Spaces and Access Aisles exceeded the 1:48 (2.08%) slope. Pictured above: 4% cross slope.

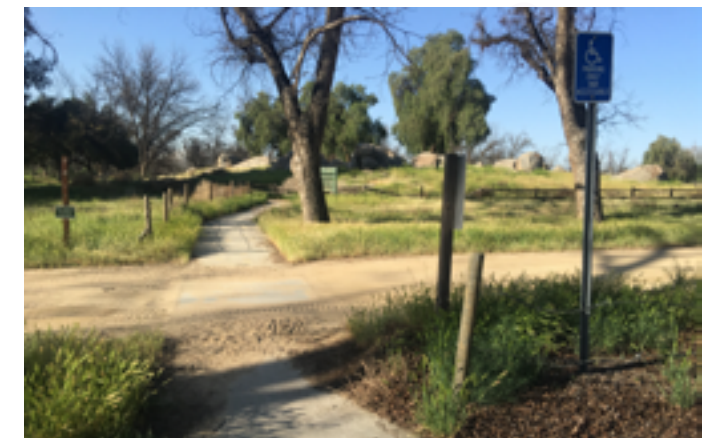
Minimum Fine signage not provided, nor are detectable warnings where the parking walkway enters the hazardous vehicular zone/ crossing.

*Recommendation is to replace all signage with the Caltrans R99 signage shown in the beginning of this report. Signage shall maintain 60" min. clearance where signs are located outside accessible routes, and 80" min. clear where located within accessible routes, as per CBC 11B-502.6.*

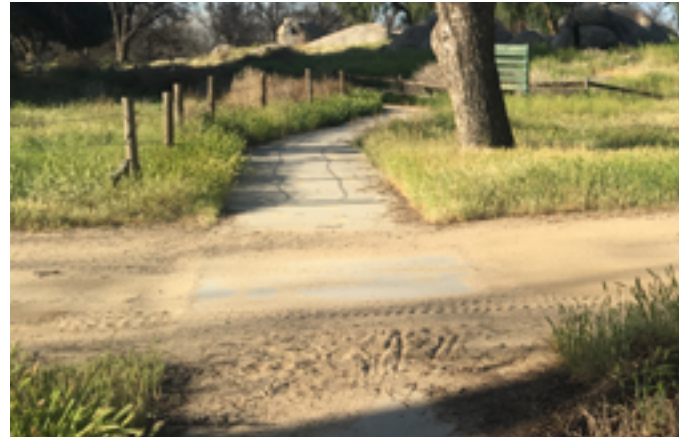
Truncated domes are not currently provided where the accessible walkway crosses the driveway.

2.1.1	Provide detectable warnings	\$1,500	Within 1 year of re-opening facility	
2.1.2	Replace portions of walkway that exceed maximum cross slope	\$5,000	Within 1 year of re-opening facility	
<b>2.2 PLAZA SURROUNDING NATURE CENTER</b>

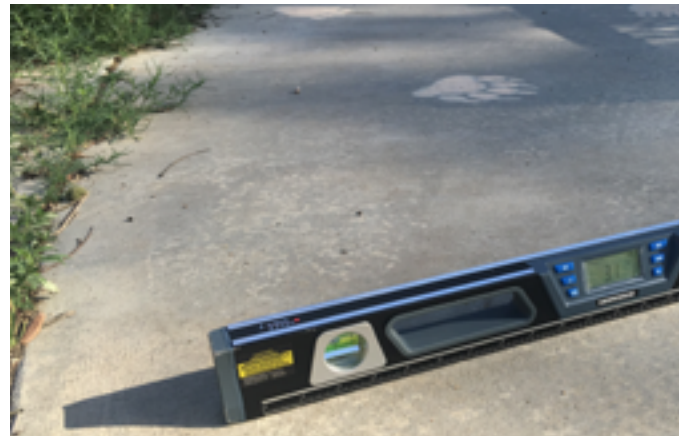
Excessive cross slope is noted on the walkway between the parking area and the Nature Center building.

*ACTION ITEM 2.1.2: Replace portions of walkway that exceed maximum cross slope, in compliance with CBC 11B-403.3.*

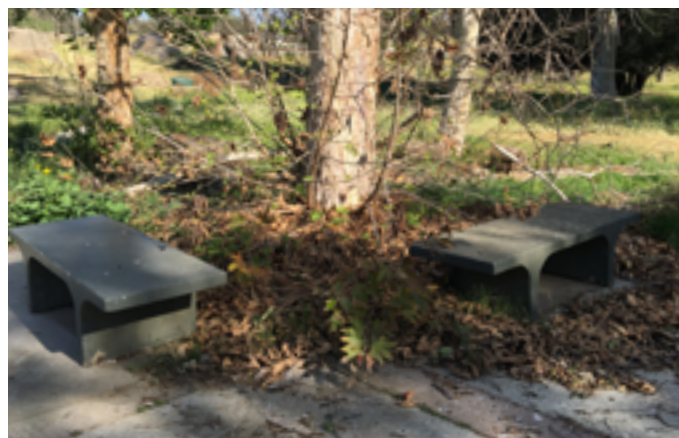
Example of benches without backs, as observed throughout the Nature Center plaza.

*ACTION ITEM 2.2.2: Replace benches with models providing back support and in full compliance with CBC 11B-903.*

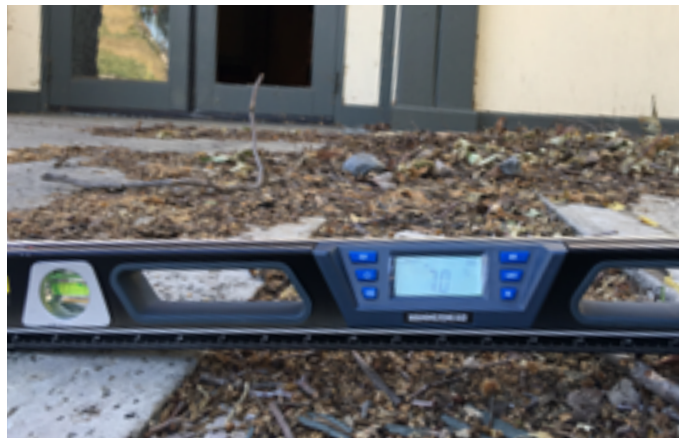
Excessive slope, vertical changes in level, and scattered debris is present throughout the concrete plaza and walkways surrounding the Nature Center building.

*ACTION ITEM 2.2.1: Replace portions of plaza that exceed maximum cross slope, in compliance with CBC 11B-403.3. Eliminate all gaps exceeding 1/2" in width.*

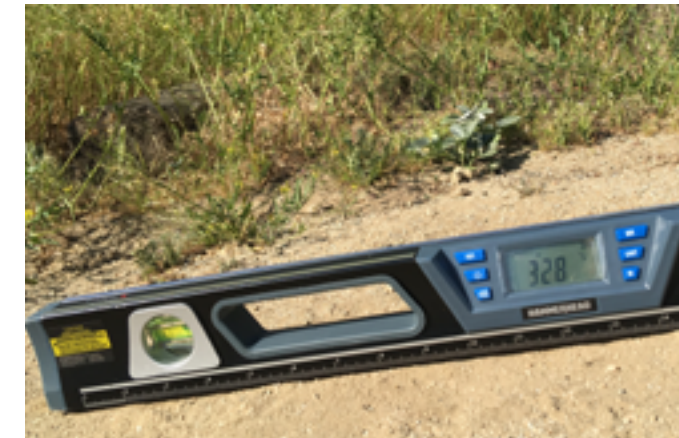
Extreme running slope of more than 30% is observed near the amphitheater. The amphitheater seating is currently fully overgrown and equally inaccessible for all.

*ACTION ITEM 2.3.1: Develop a long-term plan to provide at least partial wheelchair access to trails, as per CBC 11B-246.7, and wheelchair seating at amphitheater. Since the Sunny Slope Creek Trail cannot be reached without crossing the existing bridge, an accessible bridge crossing shall be included in the long-term plan.*

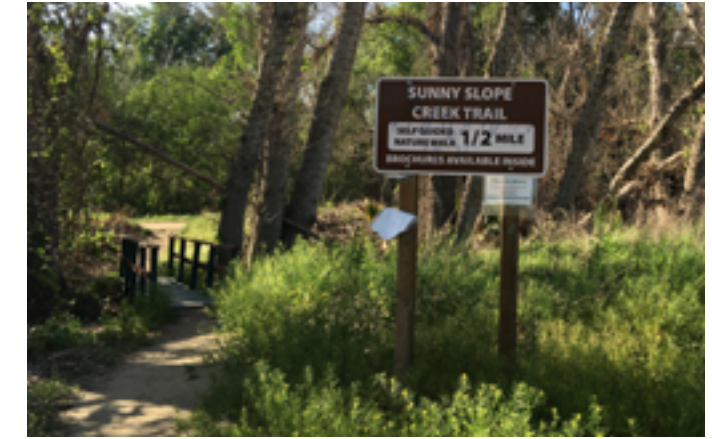
Access to the Sunny Slope Creek Trail requires users to cross a narrow footbridge with excessive cross slope and running slope, as well as lifted boards.

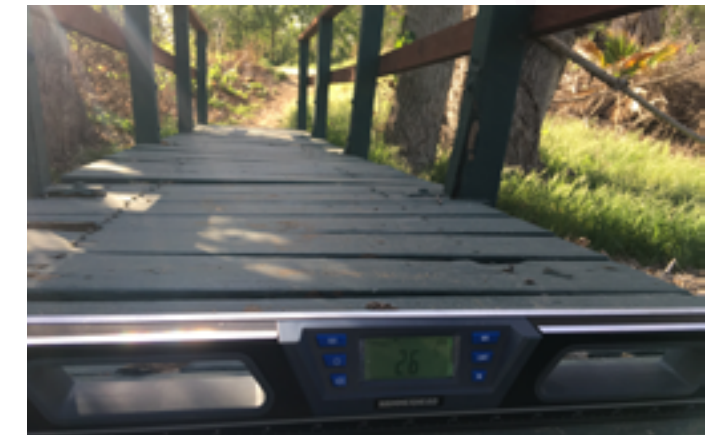
Excessive cross slope is noted on the bridge.

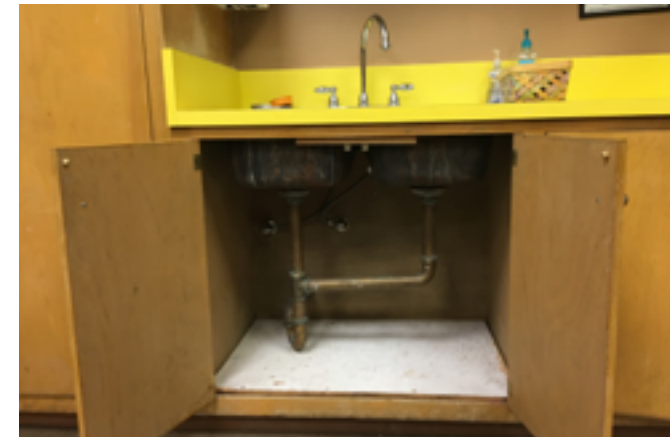
No knee/ forward wheelchair approach at sink.

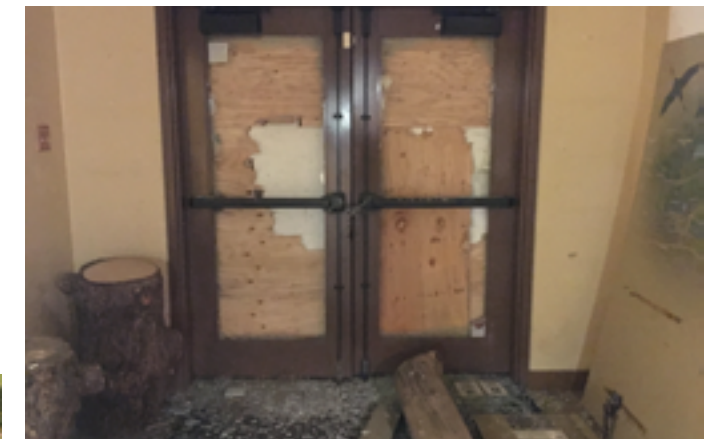
Insufficient kick plate height at exit doors.

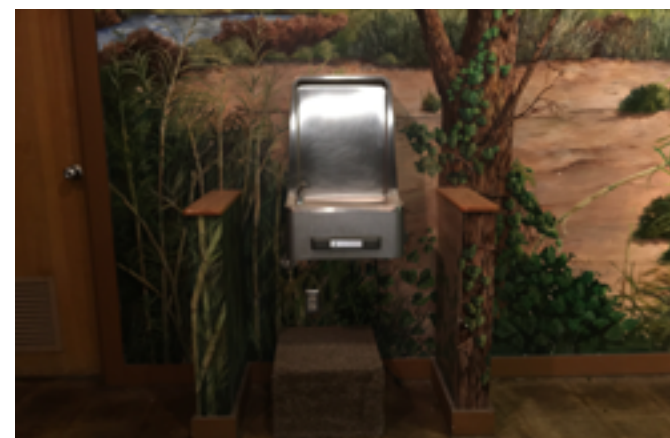
Drinking fountain missing its standing height counterpart.

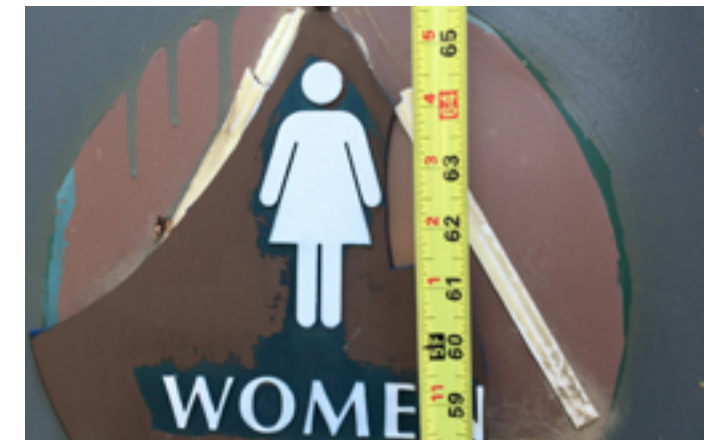
- Women's Room Geometric sign is damaged

Women's room geometric sign is damaged.

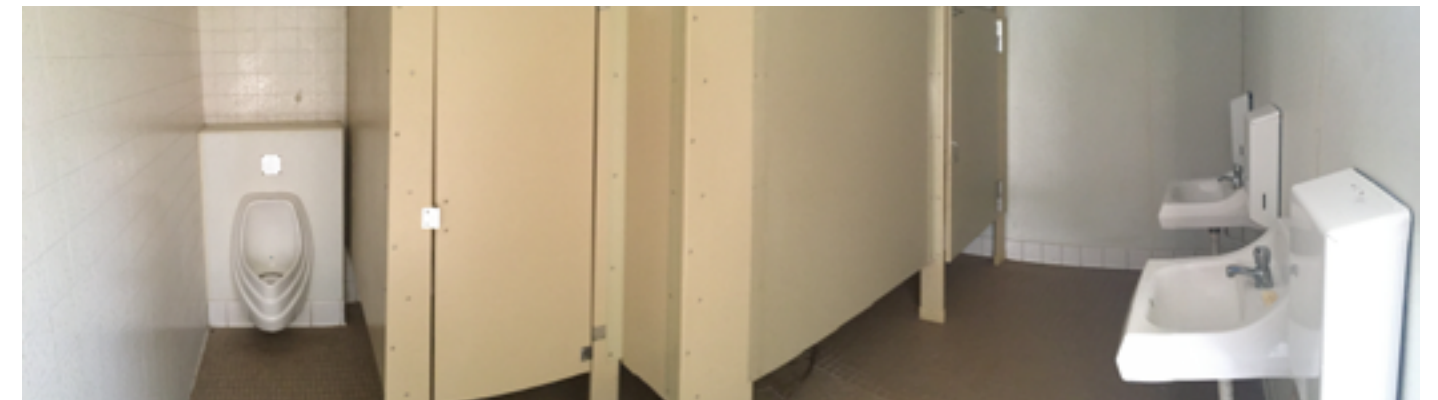
- Access to urinal does not allow wheelchair access as required by CBC 11B-605.3.
- Toilet partition framework creates overhead hazard at 78" AFF (80" min. required by CBC 11B-307.4)

Panoramic view of men's room interior.

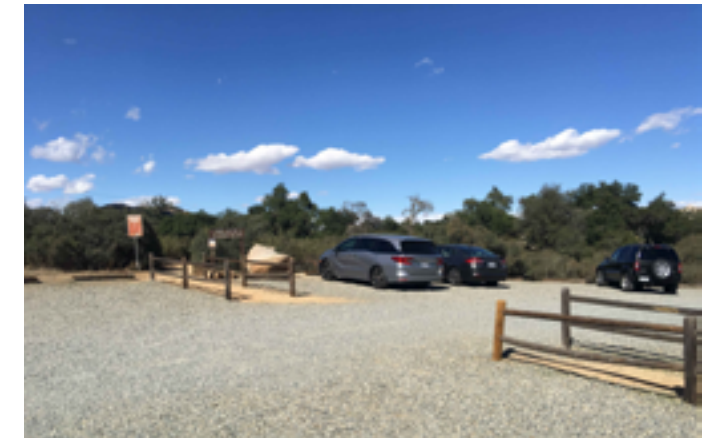
*Pictured: Unpaved parking and trail crossing. Visitors to the site arrive primarily through vehicles, as no improved walkways are provided into the site.*

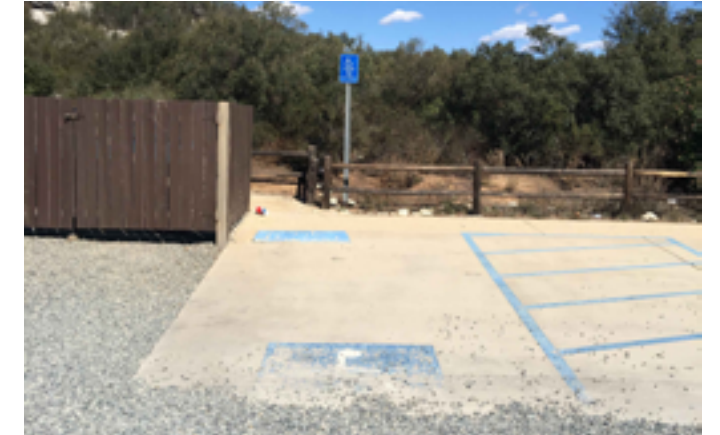
The Designated Accessible Parking Spaces were observed to be grouped near the building entrance. These spaces were the only concrete spaces present, with the remainder of the parking lot having a gravel surface. The concrete surface does not extend beyond the end of the parking spaces nor access aisle. Accordingly, gravel was seen strewn over the Designated Accessible Parking Spaces. The gravel also appeared to be expediting the wear and tear of the striping and International Symbol of Accessibility in each space. See action items on next page.

Designated Accessible Parking Spaces near the Nature Center entrance.

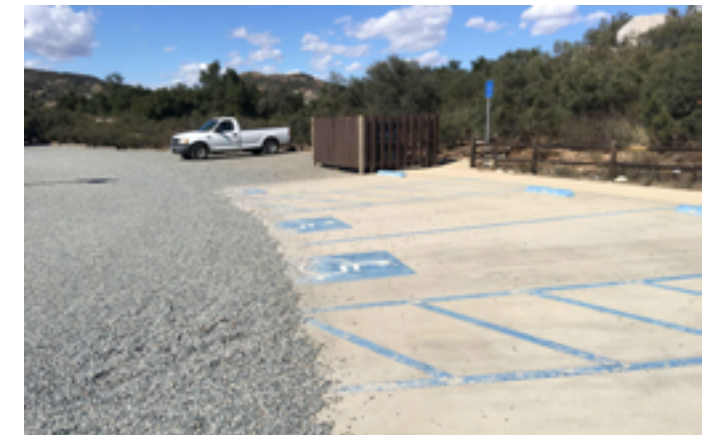
Gravel, worn striping, lack of No Parking paint.

*ACTION ITEM 1.3.2: Provide “NO PARKING” in 12” tall characters at the leading edge of the passenger loading zones at all designated accessible parking spaces, in compliance with CBC 11B-502.3.3.*

*ACTION ITEM 1.3.3: Repaint International Symbol of Accessibility and striping at each DAPS.*

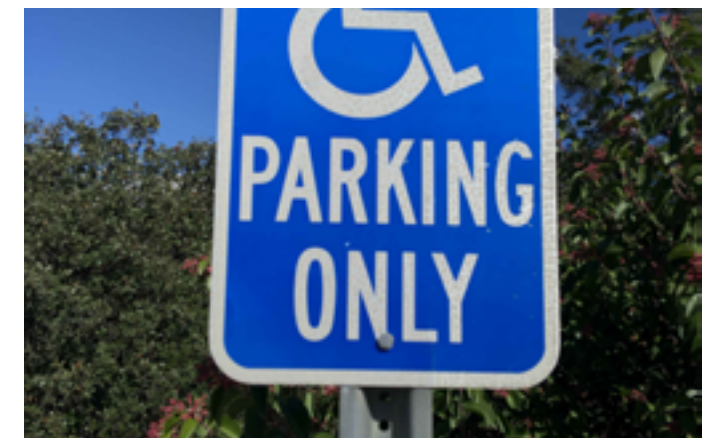
No “MINIMUM FINE \$250” Sign.

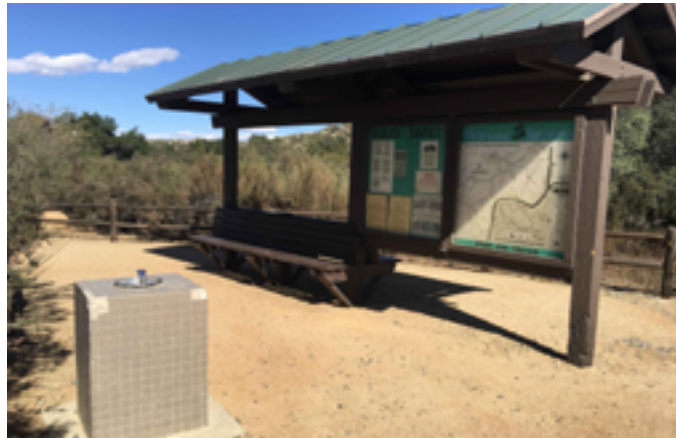
Drinking Fountain, Kiosk, and Benches within Parking Area: none of these provided amenities are compliant with current accessibility codes.

*ACTION ITEM 2.1.2: Where portable toilets are provided, at least one shall be accessible. Replace current model with a wheelchair-accessible unit.*

*ACTION ITEM 2.1.3: Replace drinking fountain with high-low accessible model, as per CBC 11B-602.*

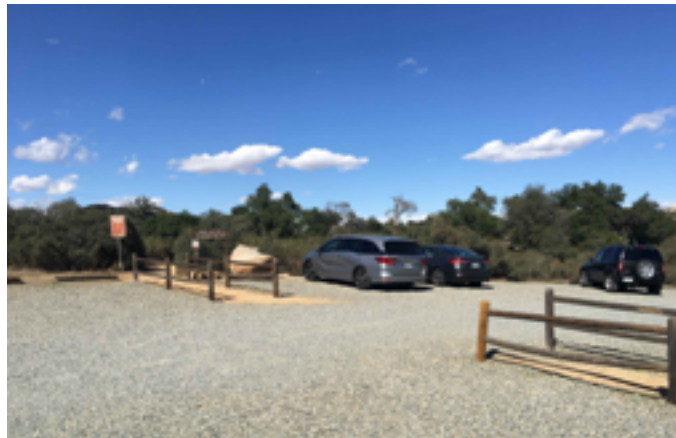
Gravel unmarked crossings do not allow for safe wheelchair or blind travel across the parking lot.

*ACTION ITEM 2.1.4: Provide accessible paths through parking areas at a minimum before transitioning to earthen trails. Currently, the only warning of entering a hazardous vehicle area is the tactile difference in material between the earth and gravel.*

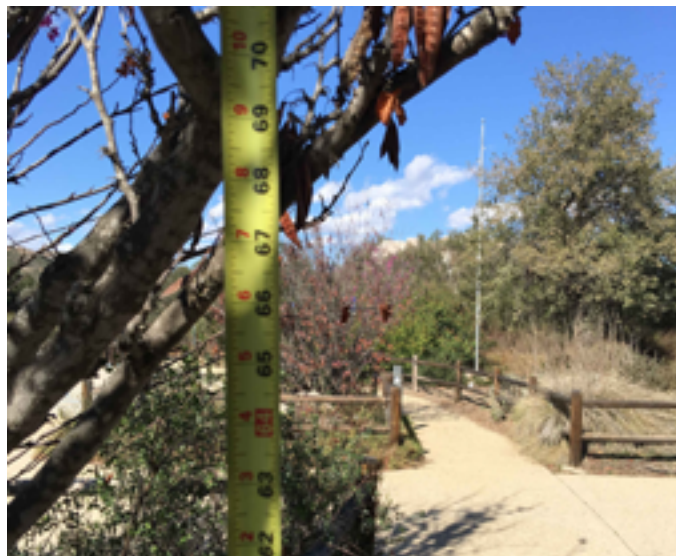
Low tree branches within walkway areas present overhead clearance issues. 80" minimum is required.

*ACTION ITEM 2.1.5: Trim tree branches to provide a minimum vertical clearance of 80 inches at all walkways.*

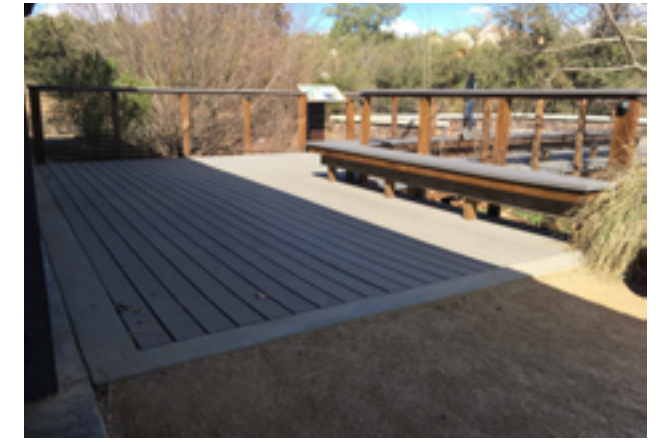
Provided benches do not meet 20" minimum seat depth requirement listed in CBC 11B-903.3, nor do they provide adequate back support with the cable rails.

Integral benches at the boardwalk measure approximately 18" in depth, which does not meet the minimum required depth of 20".

*ACTION ITEM 2.2: Modify benches to provide minimum depth and back support per CBC 11B-903.*

2.2.1	Modify benches for accessibility	\$5,000	June 2023	
2.2.2	Replace portable toilet with accessible model	\$1,000	June 2023	
<b>2.3 PRESENTATION STAGE</b>

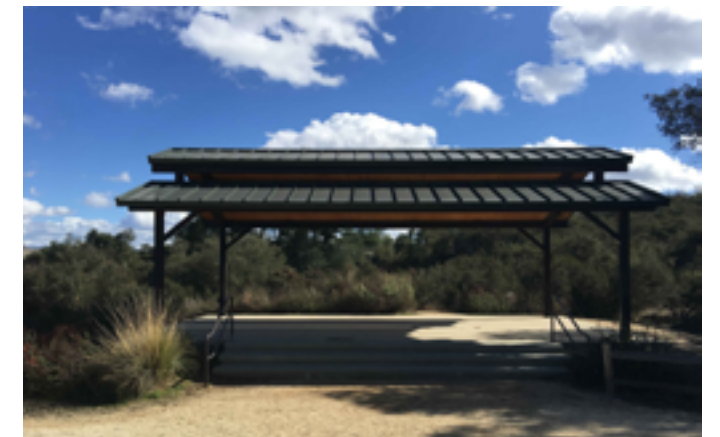
Gravel unmarked crossings do not allow for safe wheelchair or blind travel across the parking lot.

*ACTION ITEM 2.3.1: Provide cane rail at post bases to warn of overhead obstruction*

*ACTION ITEM 2.3.2: Provide contrasting paint stripe at stair treads.*

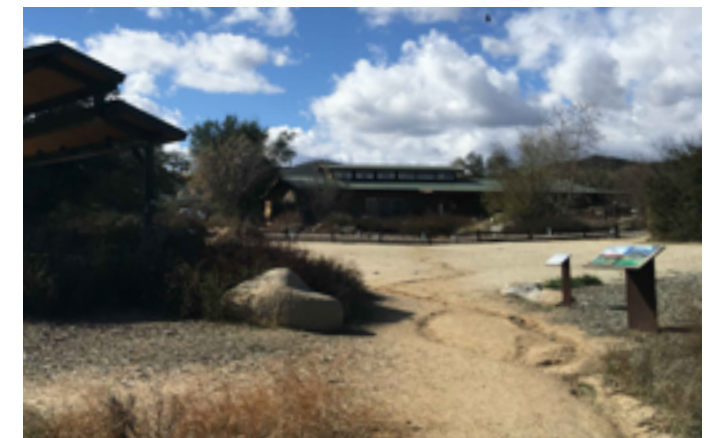
Santa Rosa Plateau Ecological Reserve serves as a trailhead for many trails extending into the Elfin Forest from the Park site. The California Building Code currently states that trails, paths, and nature walk areas, or portions of them, shall be constructed with gradients permitting at least partial use by wheelchair occupants. (CBC 11B-246.7)

Maintain trails at informational signage, especially where erosion ruts prevent park users from having a stable base to read the signage.

*ACTION ITEM 2.4.1: Supplement existing trails to permit the ability for wheelchair occupants to use, in compliance with CBC 11B-246.7.*

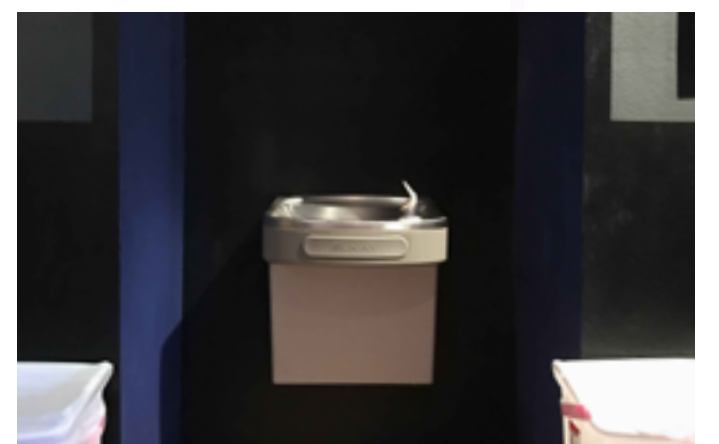
- General**
- Drinking fountain in alcove does not provide high/low reach ranges, and alcove is too narrow to add second fountain
- Restroom**
- Geometric signage mounted too high (Womens)/ too low (Mens)
  - Paper towel dispenser too high
  - Some sink plumbing not wrapped
  - Wheelchair accessible toilet compartment too narrow
  -

Drinking fountain missing its 2nd fountain companion.

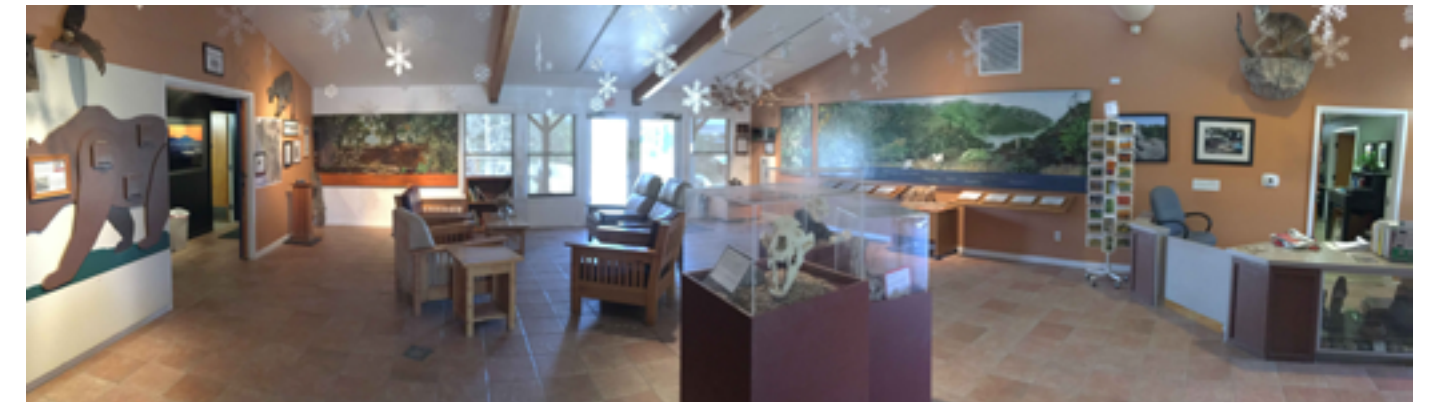
Panoramic view of Visitor Center interior.

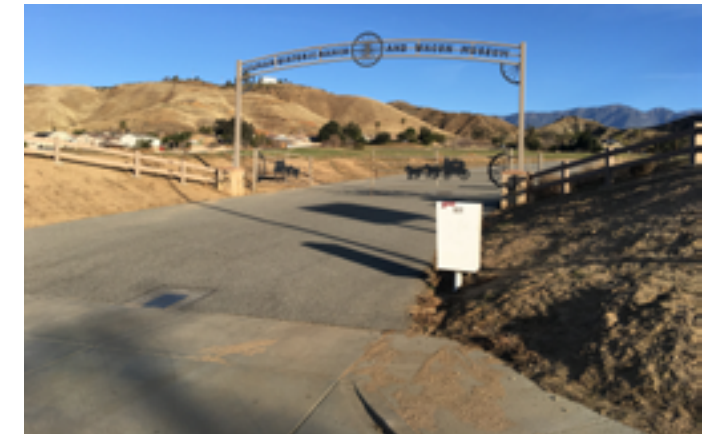
*Pictured: While a sidewalk is present at Wilson Street, there is not currently any pedestrian connection between the sidewalk and the accessible portions of the facility.*

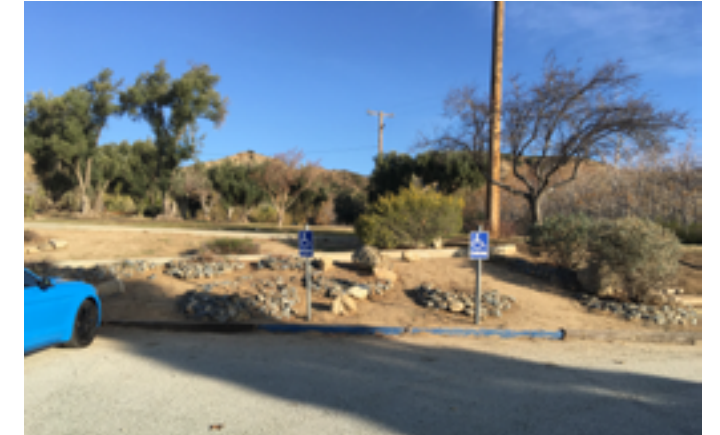
All Designated Accessible Parking Spaces were deficient in terms of current accessibility codes. The two spaces located near the historic house only had concrete surface at the access aisle, with gravel in the spaces themselves. This does not allow for the International Symbol of Accessibility to be permanently affixed. The designated spaces near the wagon museum were entirely on gravel surface. See next page for action items.

The Wagon Museum parking area currently utilizes only signage to designate the accessible parking spaces.

*ACTION ITEM 1.3.3: Provide “Minimum Fine: \$250” signage at ALL parking spaces as defined by CBC 11B-502.6.2; Recommendation is to replace all existing signage with the Caltrans R99 signage shown in the beginning of this report. Signage shall maintain 60” min. clearance where signs are located outside accessible routes, and 80” min. clear where located within accessible routes, as per CBC 11B-502.6.*

*ACTION ITEM 1.3.4: Provide accessible connections between Designated Accessible Parking Spaces and the buildings in which they serve. This includes the provision of clearly marked crossings and appropriate curb ramps and detectable warnings per CBC 11B-247.*

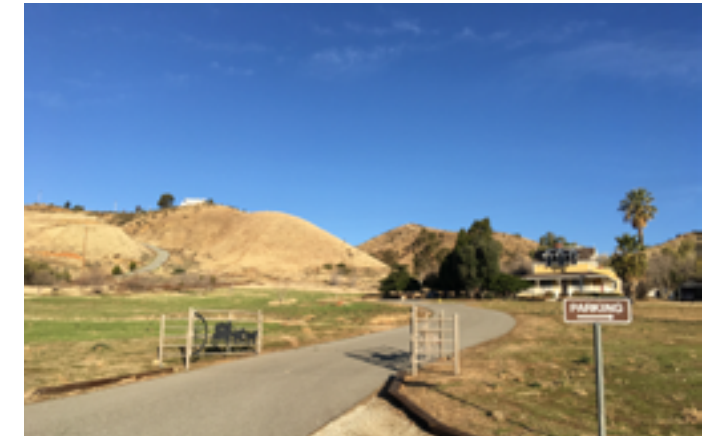
Directional signage indicating location of parking, but does not mention the two Designated Accessible Parking Spaces near the historic house.

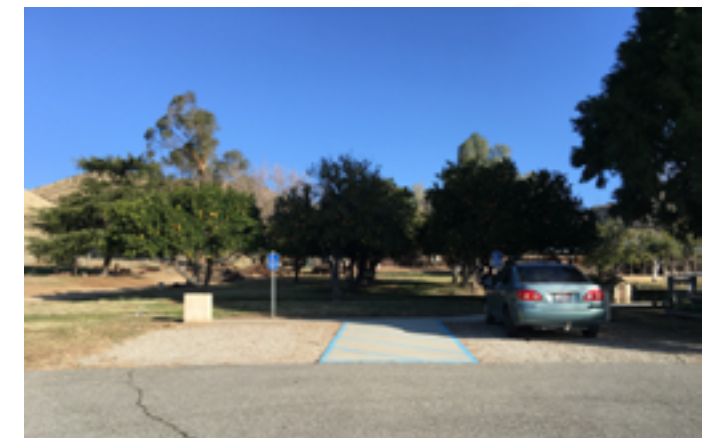
No van signage; no continuous smooth surface. No International Symbol of Accessibility.

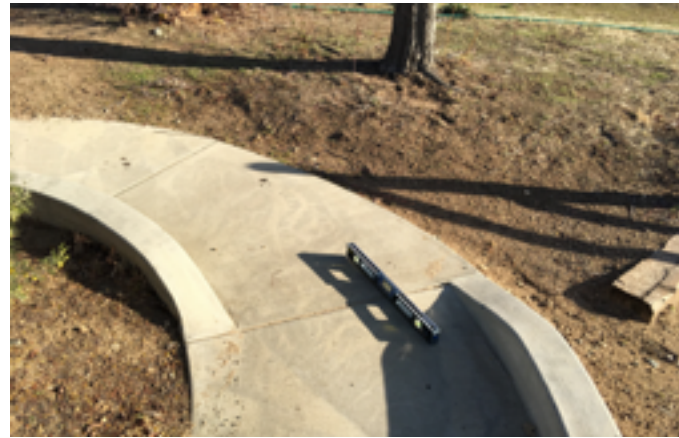
Circulation paths through the Gilman Ranch site generally do not provide accessible connections between amenities. There are no paths leading to the parking lot restroom. One concrete walkway extends down the slope toward the wagon museum, but it lacks the proper slopes and widths. Areas in front of the Wagon Museum entrance have slope issues, gaps, etc. Site furnishings are not compliant.

*Narrow, steep turn in walkway connecting upper site features with Wagon Museum.*

*ACTION ITEM 2.1: Revisit site connectivity and function, and provide a long-term plan for providing an accessible route that connects key site features to one another and to Designated Accessible Parking Spaces.*

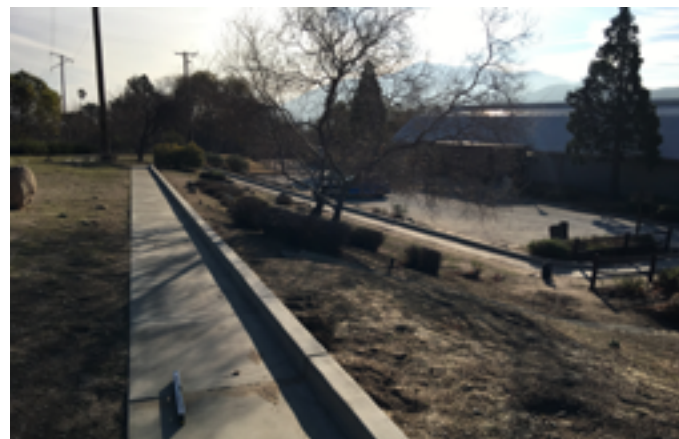
*Long, narrow run with no landing or opportunity to pass; debris present on walkway surface; gaps present.*

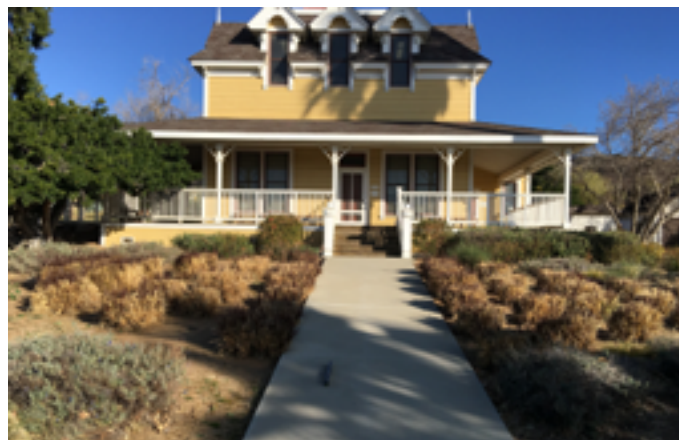
*Very steep grade present at entry walk to historic house.*

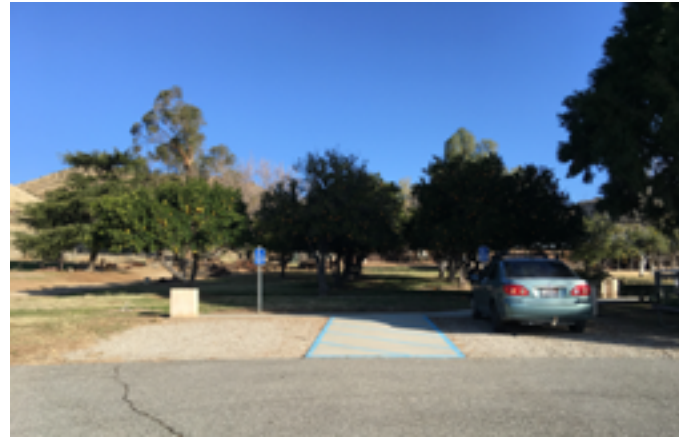
*No van signage; no continuous smooth surface. No International Symbol of Accessibility.*

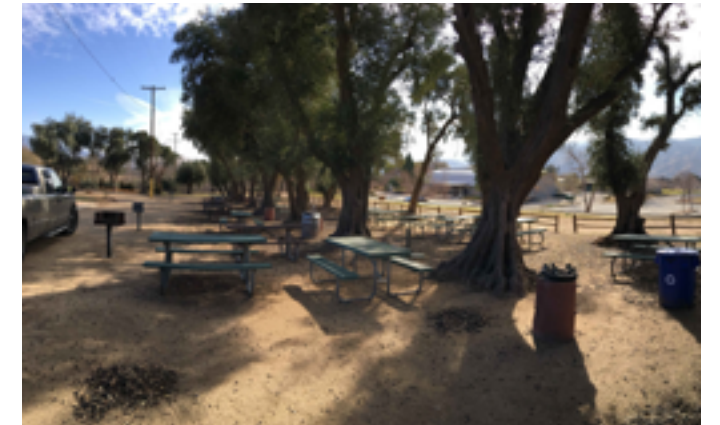
The outdoor picnic area and other field trip amenities, such as sluice boxes for panning minerals, are generally far from compliant with current accessibility requirements. Existing site topography poses the biggest challenge, as even if individual features are made accessible, it will be difficult for wheelchair users to access said amenities.

*Picnic tables located on noticeably steep slope (>5%) and covered with olives..*

*ACTION ITEM 2.2: Provide a long-term plan to regrade and or relocate amenity areas to provide an accessible route connecting them to one another and to the nearest sanitation facilities and Designated Accessible Parking Spaces.*

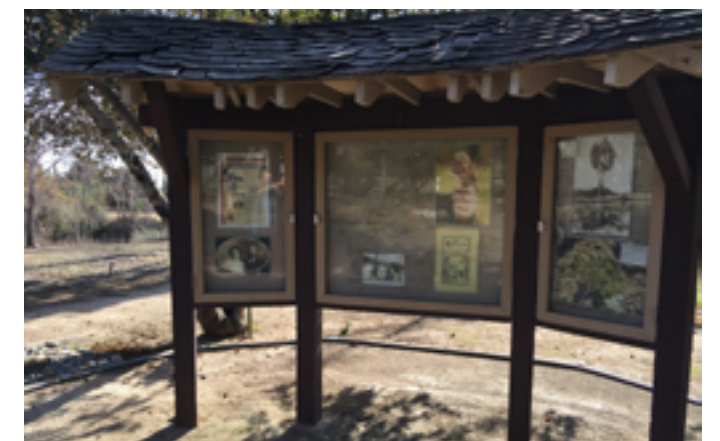
The Marshall French Gilman Native Plant Garden is located next to the Wagon Museum. Topographic challenges are also present within the garden.

*Low overhead clearance at informational signage within Demonstration Garden.*

*ACTION ITEM 2.3: See Action Item 2.2 above.*

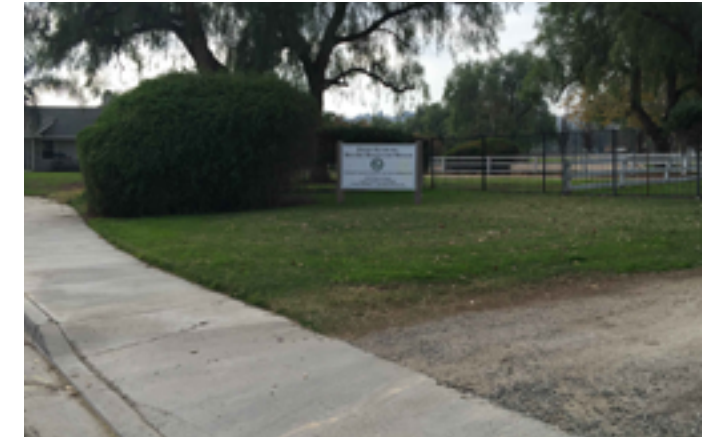
*Pictured: Entry drive from Briggs Street into Jensen Alvarado Ranch. Visitors to the site arrive primarily through vehicles, as no improved walkways are provided into the site.*

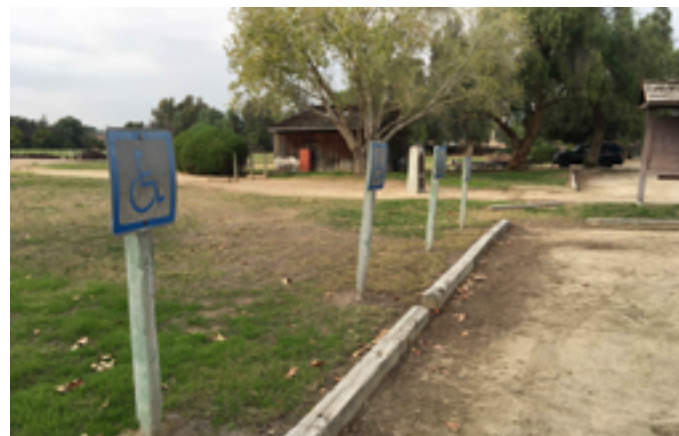
The existing Designated Accessible Parking Spaces consist of dilapidated signage only, and do not provide any sort of connection to the facility amenities.

*Designated Accessible Parking Spaces are currently by suggestion only, and are completely out of compliance in every way.*

*ACTION ITEM 1.3.1: See Action Item 1.1 above, and provide an accessible path from the new Designated Accessible Parking Spaces to the major accessible amenities throughout the site.*

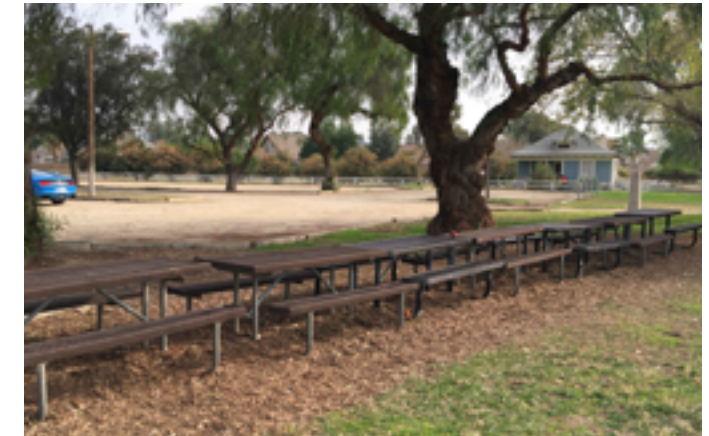
*Picnic tables present at site currently offer no option for accessibility.*

*ACTION ITEM 2.1: See Action Item 2.1 above. While small steps can be taken, such as providing an accessible picnic table at the grouping of existing tables, getting from one place to another remains to be a challenge for wheelchair users and persons with limited mobility.*

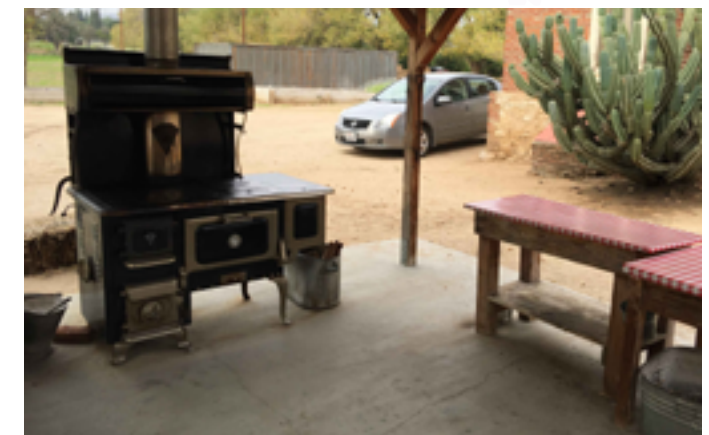
As the majority of the site does not have concrete or other permanent surfacing, accessibility is currently a site-wide challenge.

*Most site circulation areas are on native soil, and are subject to seasonal changes in firmness and stability, with erosion a key factor.*

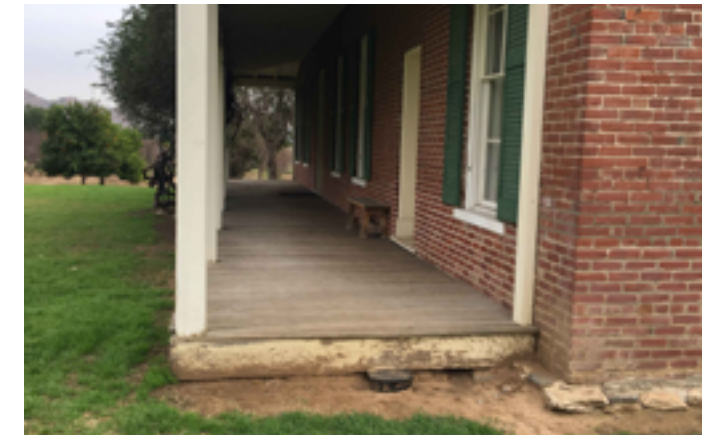
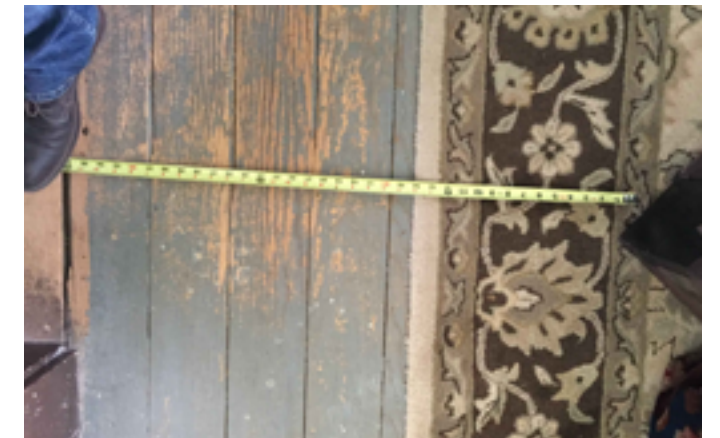
- Building access is limited by stairs. Wheelchair path not compliant between nearest Designated Accessible Parking Space and entry point.
- Entry threshold exceeds vertical maximum.
- Area rug impedes wheelchair circulation

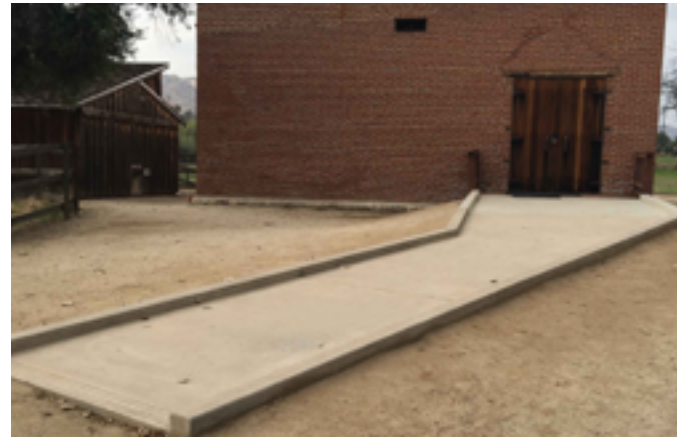
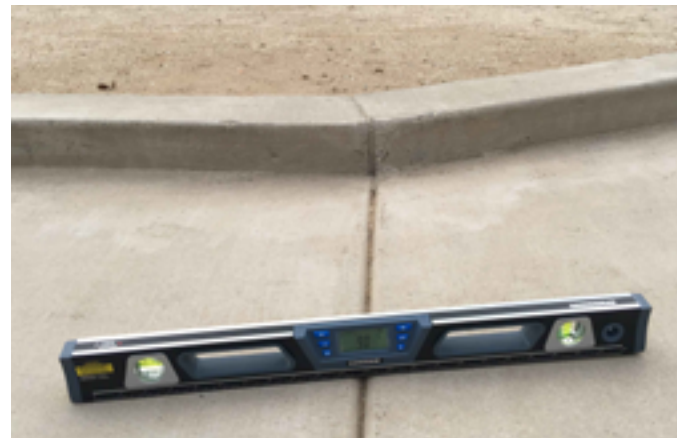
- No accessible path from parking nor other site buildings
- Access walk needs to be reconstructed as a ramp to accommodate the change in elevation with handrails and landings

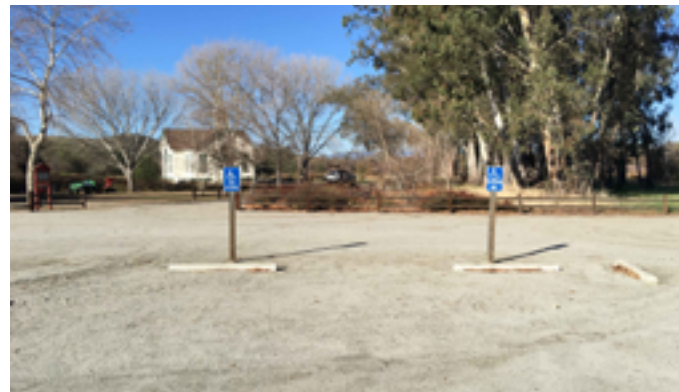
Designated Accessible Parking Spaces near Alamos Schoolhouse consists of signage only.

*ACTION ITEM 1.1.1: Provide one Designated Van-Accessible Parking Space in compliance with CBC 11B-502.*

*ACTION ITEM 1.1.2: In addition to Action Item 1.1.2 above, provide one Standard Accessible Parking Space in the Oak Parking lot, in compliance with CBC 11B-502.*

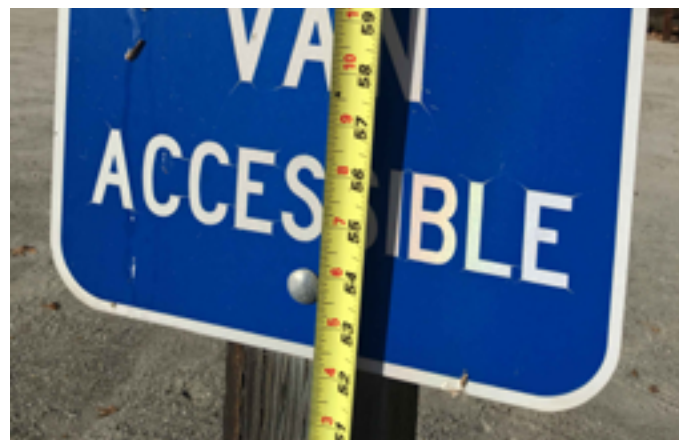
Accessible Parking near Alamos Schoolhouse is designated by signage only, but does not meet any of the other current requirements.

The existing signage does not meet the current mounting heights outlined in the California Building Code.

*ACTION ITEM 1.3.1: See Action Items 1.1.1 and 1.1.2 above.*

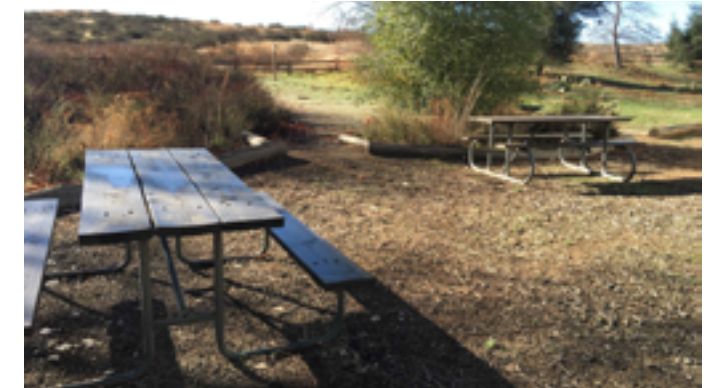
Picnic tables near schoolhouse.

*ACTION ITEM 2.1.2: Provide an accessible picnic table at the grouping of picnic tables near the schoolhouse.*

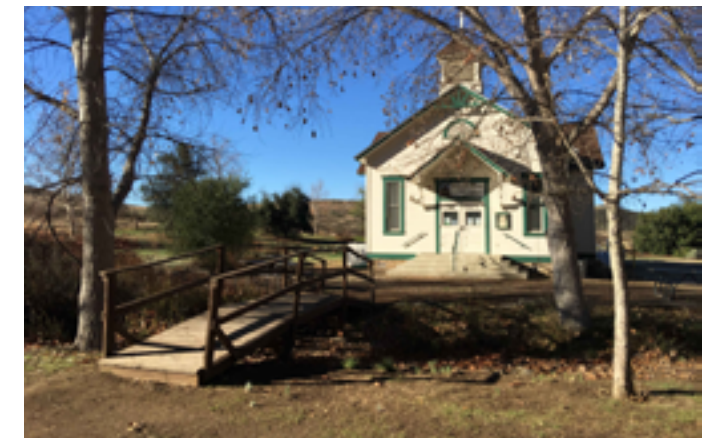
A wooden bridge provides a picturesque, yet non-accessible connection to the schoolhouse.

*ACTION ITEM 2.1.1: Provide an accessible path connecting the Designated Accessible Parking Spaces to the school entrance.*

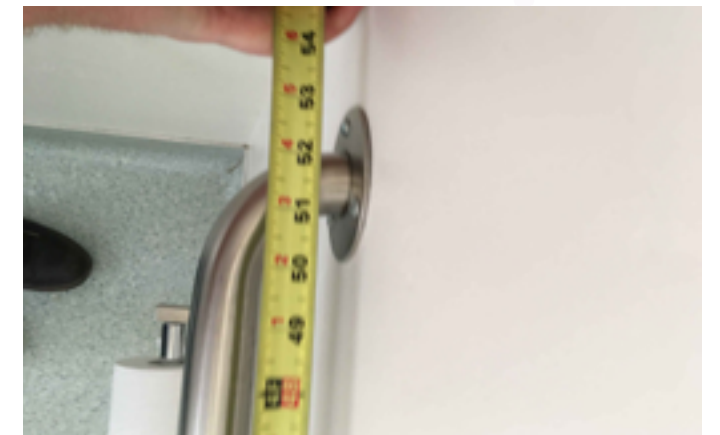
- Restrooms do not provide geometric signage
- Restroom width too narrow for wheelchair circulation
- Hand dryer mounted above maximum reach range
- Toilet paper mounted too far in front of toilet rim
- Mirrors mounted too high
- Side grab bars too short

3.1 SCHOOLHOUSE				
3.1.1	Minor/ moderate corrective items - see report	\$25,000	June 2023	
3.1.2	Restrooms too narrow for wheelchair circulation; provide accessible "outhouse" building	\$50,000	June 2028

3.1.2 interim	Provide Accessible Portable Restroom and hand washing station near schoolhouse	\$1,000	Immediate	
	TOTAL OF INDIVIDUAL COSTS (will vary greatly depending on timing and grouping of repairs)	\$216,500

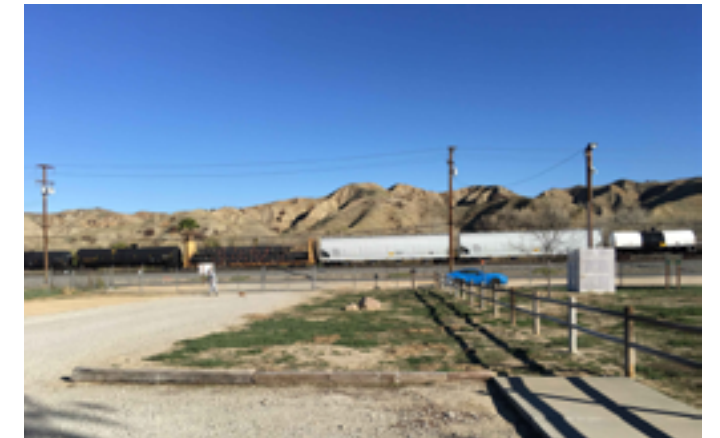
*Pictured: Gravel parking lot at San Timoteo Canyon Schoolhouse.*

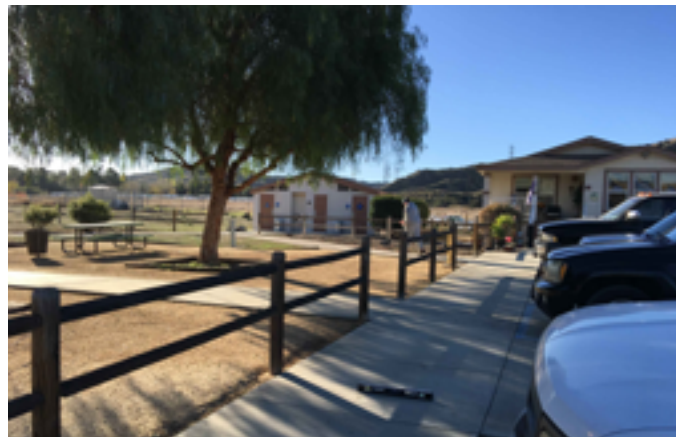
Designated Accessible Parking Spaces are located in close proximity to the ramped entrance to the schoolhouse and restroom building.

*ACTION ITEM 1.1.1: Renovate the designated accessible parking spaces to meet full compliance with CBC 11B-502. This includes removal and replacement of concrete with a surface that does not exceed 1:48 slope in any direction, as well as all applicable signage and striping.*

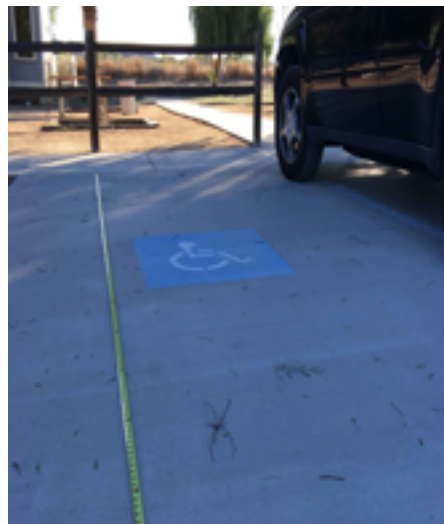
Parking space and access aisle exceeds 1:48 slope. Signage is not present. International Symbol of Accessibility is located deep within the space.

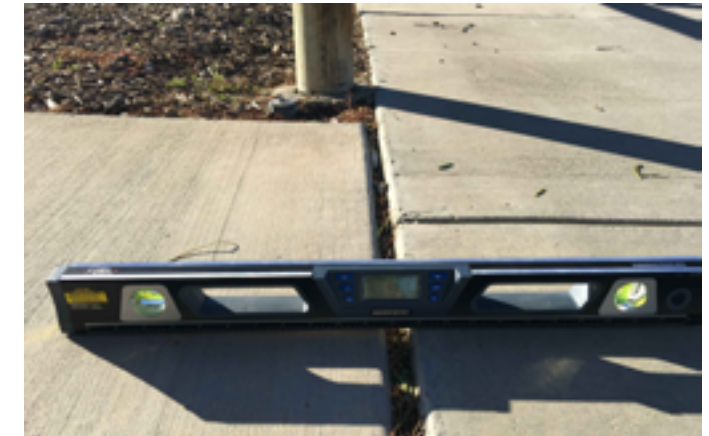
Large gaps were present at concrete joints.

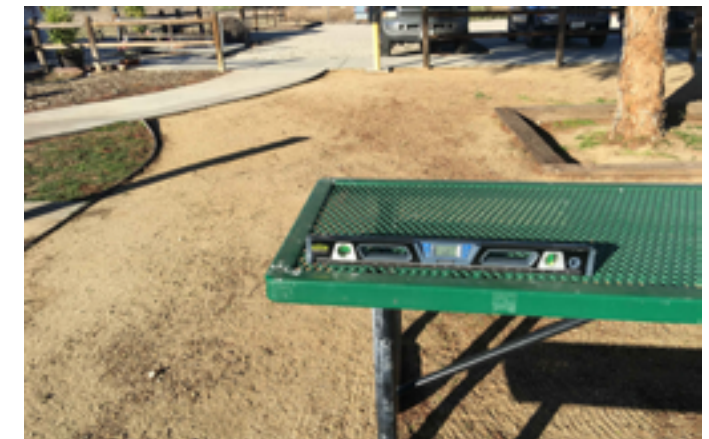
The picnic table area has a running slope, falling toward the north at approximately 6%.

Picnic tables measured over 6% of slope, parallel with the sloped Decomposed Granite surface on which they are placed.

*ACTION ITEM 2.2: Provide at least one accessible picnic table on an accessible route.*
