RIVERSIDE COUNTY REGIONAL PARK AND OPEN SPACE DISTRICT

# ACCESSIBILITY COMPLIANCE REPORT- 2018 UPDATE

MAY 31, 2018

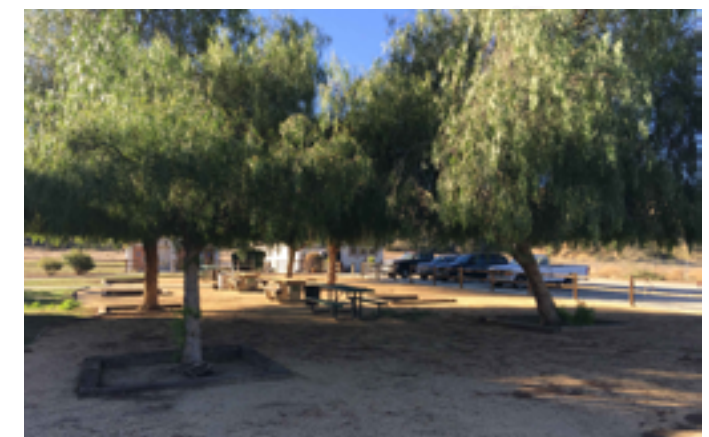
The picnic table area can potentially be regraded to provide a level surface, allowing for an accessible picnic table to be provided.

2.2.1	Regrade for slope compatibility; provide accessible tables (3)	\$25,000	June 2023	
<b>3.1 SCHOOLHOUSE</b>				
3.1.1	Minor/ moderate corrective items - see report	\$10,000	June 2020	
<b>3.2 RESTROOM</b>

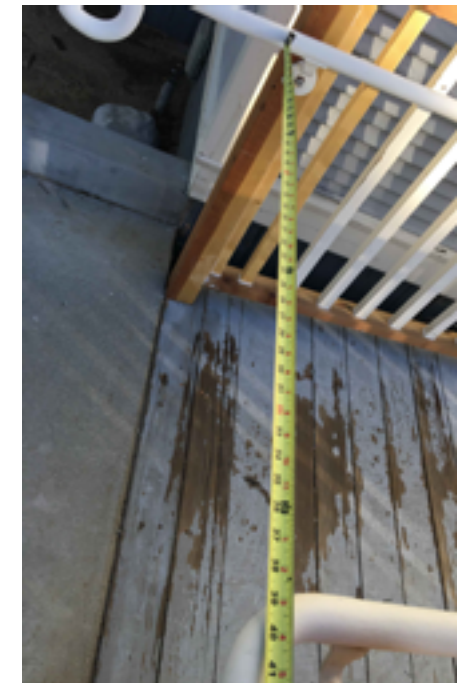
- Exterior wood ramp needs servicing to maintain a firm, stable and slip resistant surface
- Continuous accessible path not present to parking nor restroom

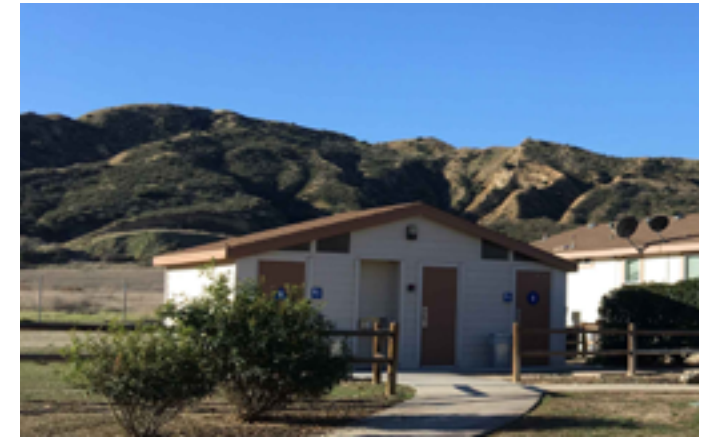
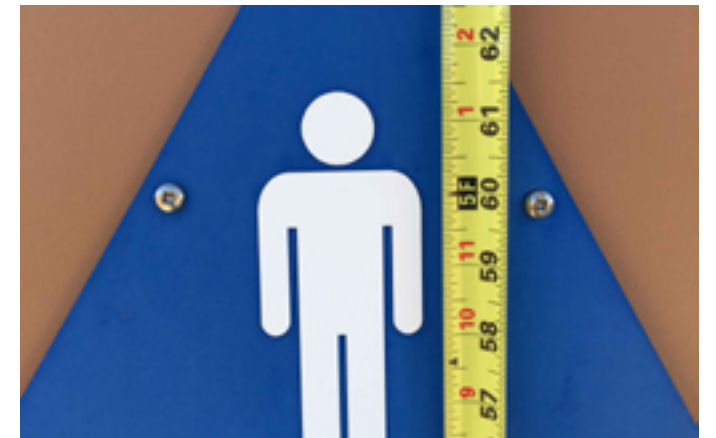
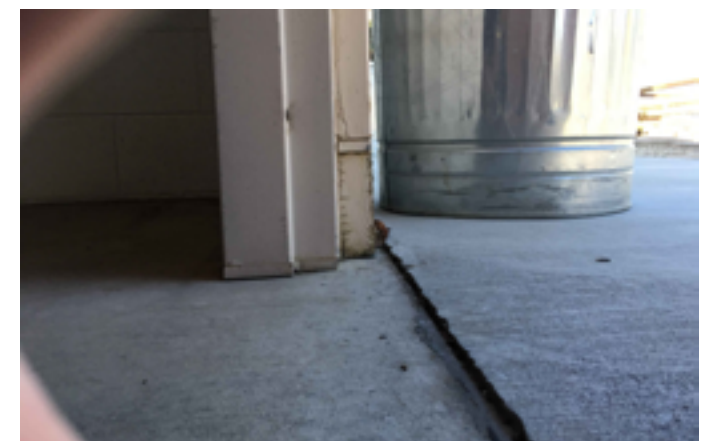
- No continuous accessible path from parking nor other site buildings
- Vertical/horizontal gap present where building slab meets on-site concrete flatwork at men's room door threshold.
